1958 Corvette: Service Bulletin: Electric Windshield Wiper Information

Subject: Electric Windshield Wiper Information
Model and Year: 1958 Passenger Cars and Trucks
Source: Chevrolet Technical Service Bulletin
Bulletin No: DR #359
Section: I
Date: May 28, 1958

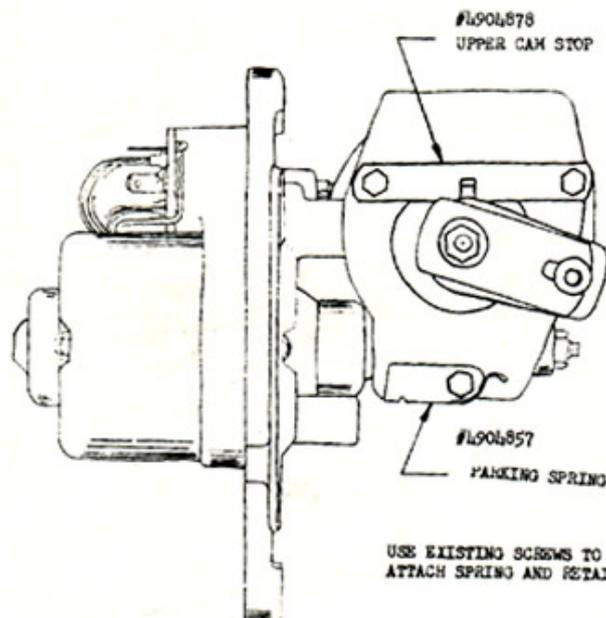
FIGURE #1.

In some cases the wiper motor, after being shut off, may over travel the effective length of the parking cam and continue to run in a reverse direction. This condition may occur even though the blades are properly positioned as covered in TSB #508, DR #359.

If the right hand blade slaps against the moulding excessively even though the blade is correctly positioned and parks properly, the upper cam stop is probably bent or broken. This damage can occur if the mechanism is coated with ice when the wiper is turned on.

SKETCH SHOWING INSTALLATION OF PARKING SPRING AND CAM STOP ON 1956 ELECTRIC WINDSHIELD WIPERS.

A parking spring has been released for production and service which enables the motor to shut off without depending on the resistance of the wiper blades. The spring is designed to clear the revolving arm in the "ON" position and stop the arm in the "PARK" position when switch is turned off. Figure #1 shows installation of parking spring.

A more durable replacement cam stop is available for service. Figure #1 shows details of installation. The existing tab must be bent flat before installation of the new stop.

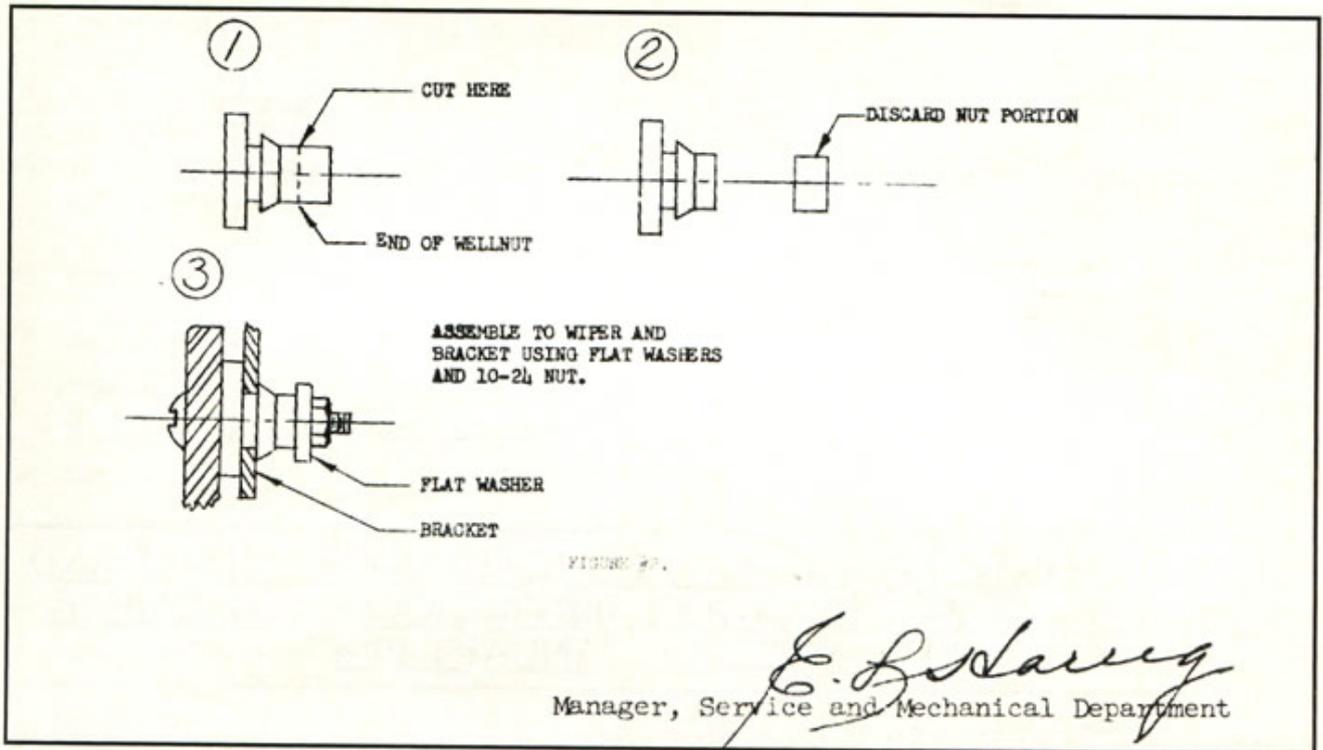
If loosening of the wiper motor on the support bracket or failure of the rubber "Wellnut" attachment is experienced, modify the "Wellnuts" and attach motor to bracket as shown in Figure #2.
