1958 Corvette: Service Bulletin: Electric Windshield Wiper Information

Subject: Electric Windshield Wiper Information
Model and Year: 1958 Passenger Cars and Trucks
Source: Chevrolet Technical Service Bulletin
Bulletin No: DR #359
Section: I
Date: May 28, 1958

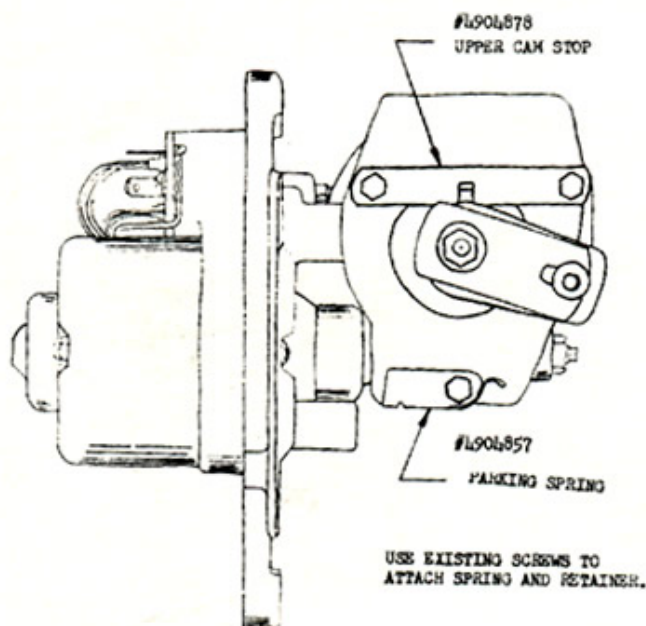
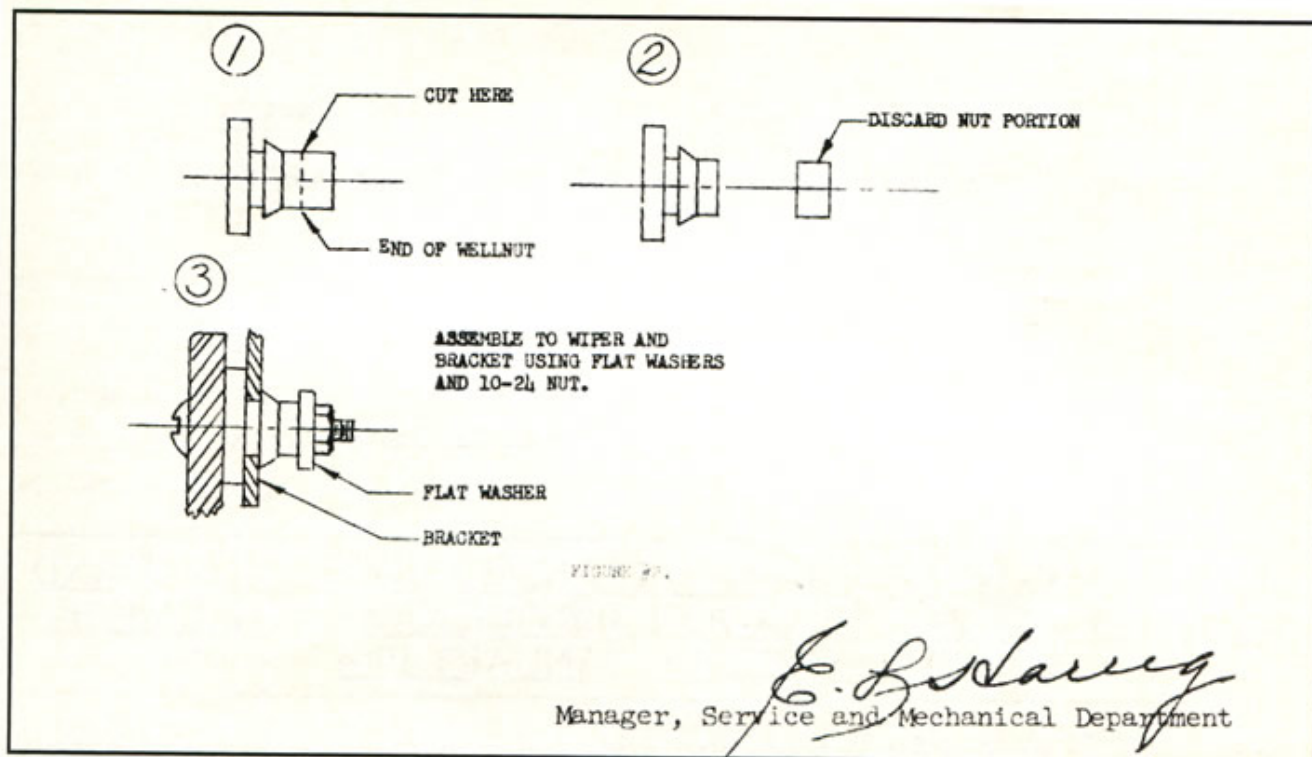
FIGURE #1.

In some cases the wiper motor, after being shut off, may over travel the effective length of the parking cam and continue to run in a reverse direction. This condition may occur even though the blades are properly positioned as covered in TSB #508, DR #359.

If the right hand blade slaps against the moulding excessively even though the blade is correctly positioned and parks properly, the upper cam stop is probably bent or broken. This damage can occur if the mechanism is coated with ice when the wiper is turned on.

SKETCH SHOWING INSTALLATION OF PARKING SPRING AND
CAM STOP ON 1956 ELECTRIC WINDSHIELD WIPERS.

A parking spring has been released for production and service which enables the motor to shut off without depending on the resistance of the wiper blades. The spring is designed to clear the revolving arm in the "ON" position and stop the arm in the "PARK" position when switch is turned off. Figure #1 shows installation of parking spring.

A more durable replacement cam stop is available for service. Figure #1 shows details of installation. The existing tab must be bent flat before installation of the new stop.
