1968 Corvette: Service Bulletin: General Information

Subject: 1968 Corvette General Information
Model and Year: 1968 Corvette
Source: Chevrolet Dealer Service Technical Bulletin
Bulletin No: 68-T-43
Section: XV
Date: April 24, 1968

Subject: 1968 CORVETTE
GENERAL INFORMATION

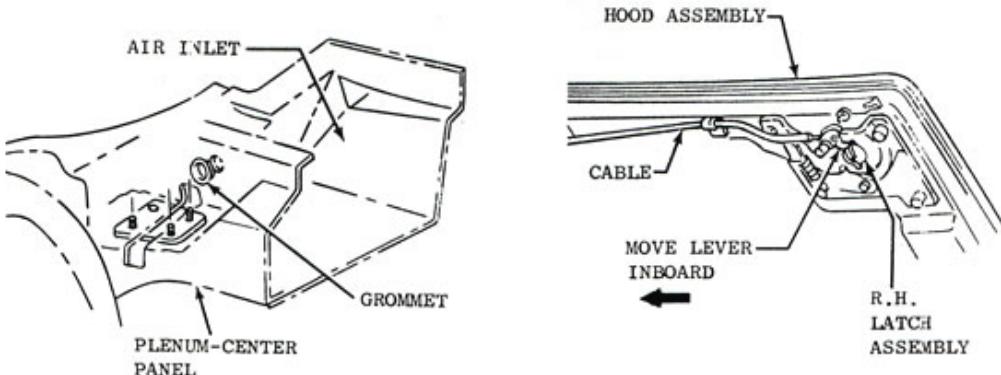
Corvette Hood Lock - Fails To Release

In the event the hood lock fails to release by pulling on the release handle, it may be released by reaching up through one of the left fender louvres with a 30" rod and pushing forward on the latch release lever as noted on Page 9, of the September - October, 1967 issue of Chevrolet Service News. If the right hand lock does not release when this is done, the cable that links the right and left side locks may be inoperative. The right lock assembly may be released as follows:

1. Remove the air inlet grille panel by removing 8 mounting screws.
2. Push out the rubber grommet located on the front of the center plenum panel.
3. Insert a screwdriver through the hole in the center plenum panel and prying against the outside edge of the lock housing, move the lock release lever inboard until the latch releases.

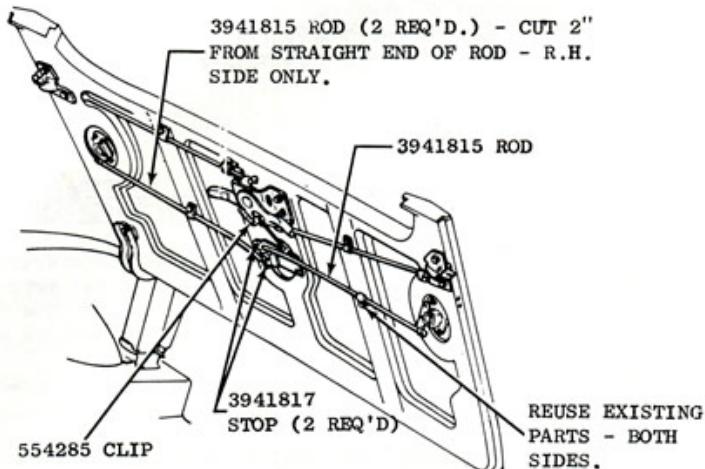
Rear Bow Lock Remote Control Cable Rattle

Remote control cables used on early 1968 Corvette Convertible models could rattle against the rear compartment lid. Production replaced these cables with rods on 1/2/68.

Complaint vehicles may be updated by installing the rear bow lock remote control rods as indicated on the sketch below.

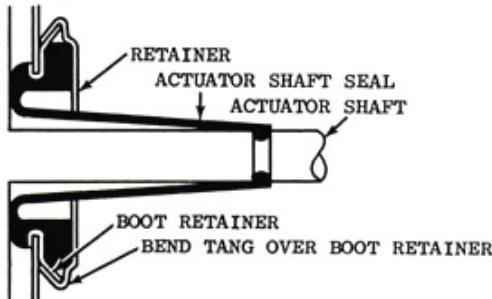
Headlamp Doors - Inoperative

Headlamp doors which become inoperative due to sticking actuator shaft seals, should be corrected by replacing the inner shaft seal. This seal, in some cases, will stick to the actuator shaft causing the seal to pull out of the actuator. The headlamps may be operated manually as outlined in the 1968 Corvette Owners Manual when this occurs. The new style actuator seals went into production effective with Serial No. S410514. The actuator seals may be replaced as follows:

1. Remove actuator assembly per Section 12, Chassis Service Manual
2. Remove the outer boot from the actuator
3. Remove the inner seal and wipe the seal flange and actuator shaft dry
4. Installation and lubrication of actuator shaft seal
 - a) Install seal using protective cover over shaft threads (protection is needed to avoid cutting of internal seal bead by threads)
 - b) Make certain seal grommet is properly seated in the actuator cover and interior bead at small diameter of seal fits in the groove on the shaft (See sketch)
 - c) Apply a liberal film of silicone lubricant over entire exterior surface of actuator shaft seal, excluding grommet
5. Install the retainer by bending the three (3) tabs over edge of boot retainer. (See sketch)

IMPORTANT: Do not distort boot retainer when bending over the tabs. If distorted, leakage can occur

6. Install the outer boot and reinstall the actuator assembly as described in Section 12 of the Chassis Service Manual
