1968 Corvette: Service Bulletin: General Information

Bulletin No: 68-T-43

Date: April 24, 1968

Subject: 1968 CORVETTE
GENERAL INFORMATION

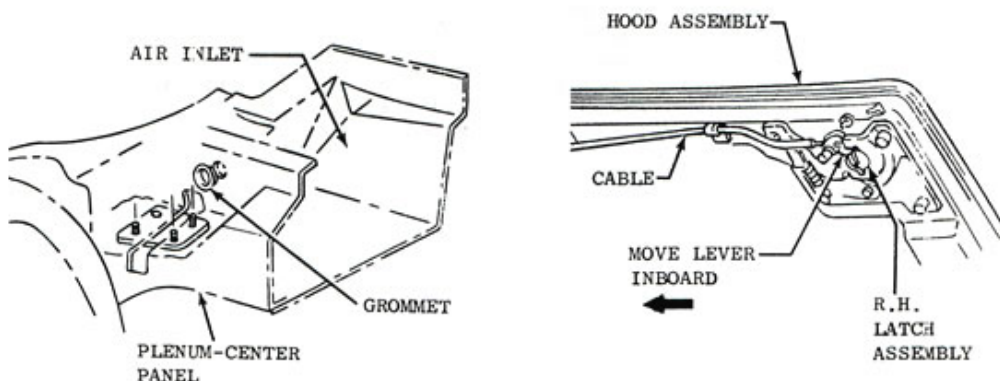
Corvette Hood Lock - Fails To Release

In the event the hood lock fails to release by pulling on the release handle, it may be released by reaching up through one of the left fender louvers with a 30" rod and pushing forward on the latch release lever as noted on Page 9, of the September - October, 1967 issue of Chevrolet Service News. If the right hand lock does not release when this is done, the cable that links the right and left side locks may be inoperative. The right lock assembly may be released as follows:

1. Remove the air inlet grille panel by removing 8 mounting screws.
2. Push out the rubber grommet located on the front of the center plenum panel.
3. Insert a screwdriver through the hole in the center plenum panel and prying against the outside edge of the lock housing, move the lock release lever inboard until the latch releases.

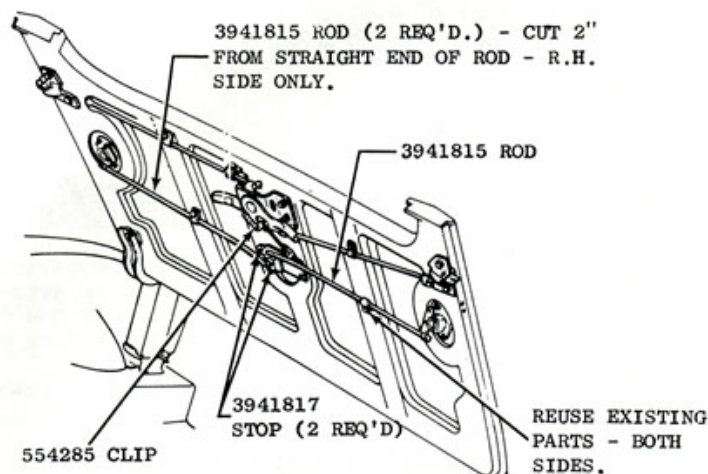
Rear Bow Lock Remote Control Cable Rattle

Remote control cables used on early 1968 Corvette Convertible models could rattle against the rear compartment lid. Production replaced these cables with rods on 1/2/68.

Complaint vehicles may be updated by installing the rear bow lock remote control rods as indicated on the sketch below.

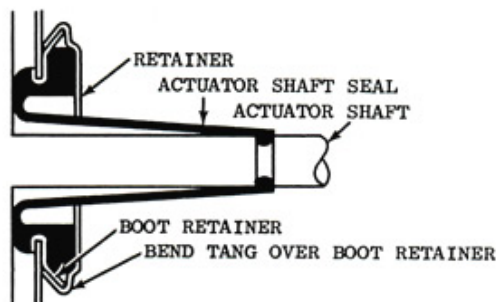
Headlamp Door - Inoperative

Headlamp doors which become inoperative due to sticking actuator shaft seals, should be corrected by replacing the inner shaft seal. This seal, in some cases, will stick to the actuator shaft causing the seal to pull out of the actuator. The headlamps may be operated manually as outlined in the 1968 Corvette Owners Manual when this occurs. The new style actuator seals went into production effective with Serial No. S410514. The actuator seals may be replaced as follows:

1. Remove actuator assembly per Section 12, Chassis Service Manual
2. Remove the outer boot from the actuator
3. Remove the inner seal and wipe the seal flange and actuator shaft dry
4. Installation and lubrication of actuator shaft seal
 - a) Install seal using protective cover over shaft threads (protection is needed to avoid cutting of internal seal bead by threads)
 - b) Make certain seal grommet is properly seated in the actuator cover and interior bead at small diameter of seal fits in the groove on the shaft (See sketch)
 - c) Apply a liberal film of silicone lubricant over entire exterior surface of actuator shaft seal, excluding grommet
5. Install the retainer by bending the three (3) tabs over edge of boot retainer. (See sketch)

IMPORTANT: Do not distort boot retainer when bending over the tabs. If distorted, leakage can occur

6. Install the outer boot and reinstall the actuator assembly as described in Section 12 of the Chassis Service Manual
