# 1968 Corvette: Service Bulletin: General Information

**Bulletin No:** 68-T-43

**Date:** April 24, 1968

Subject: 1968 CORVETTE  
GENERAL INFORMATION

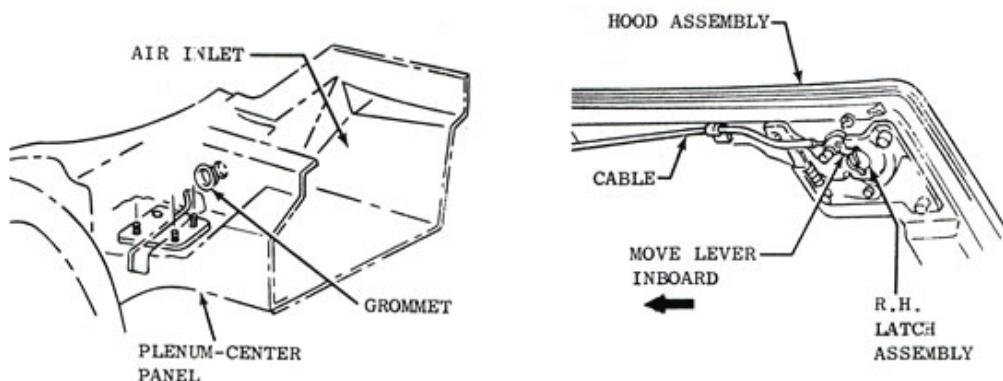
In the event the hood lock fails to release by pulling on the release handle, it may be released by reaching up through one of the left fender louvres with a 30" rod and pushing forward on the latch release lever as noted on Page 9, of the September - October, 1967 issue of Chevrolet Service News. If the right hand lock does not release when this is done, the cable that links the right and left side locks may be inoperative. The right lock assembly may be released as follows:

1. Remove the air inlet grille panel by removing 8 mounting screws.
2. Push out the rubber grommet located on the front of the center plenum panel.
3. Insert a screwdriver through the hole in the center plenum panel and prying against the outside edge of the lock housing, move the lock release lever inboard until the latch releases.

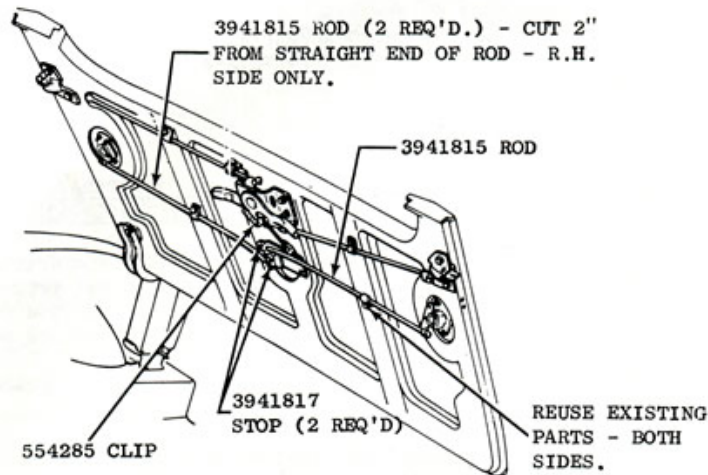
Remote control cables used on early 1968 Corvette Convertible models could rattle against the rear compartment lid. Production replaced these cables with rods on 1/2/68.

Complaint vehicles may be updated by installing the rear bow lock remote control rods as indicated on the sketch below.

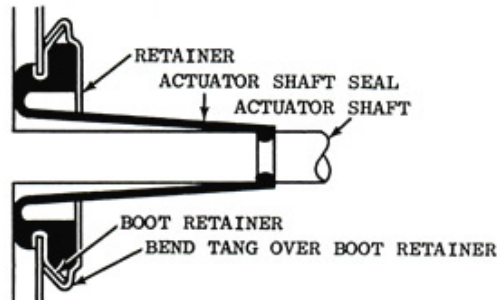
Headlamp doors which become inoperative due to sticking actuator shaft seals, should be corrected by replacing the inner shaft seal. This seal, in some cases, will stick to the actuator shaft causing the seal to pull out of the actuator. The headlamps may be operated manually as outlined in the 1968 Corvette Owners Manual when this occurs. The new style actuator seals went into production effective with Serial No. S410514. The actuator seals may be replaced as follows:

- b) Make certain seal grommet is properly seated in the actuator cover and interior bead at small diameter of seal fits in the groove on the shaft (See sketch)

- c) Apply a liberal film of silicone lubricant over entire exterior surface of actuator shaft seal, excluding grommet
  5. Install the retainer by bending the three (3) tabs over edge of boot retainer. (See sketch)
