# 1968 Corvette: Service Bulletin: General Information

**Bulletin No:** 68-T-43

Subject: 1968 CORVETTE  
GENERAL INFORMATION

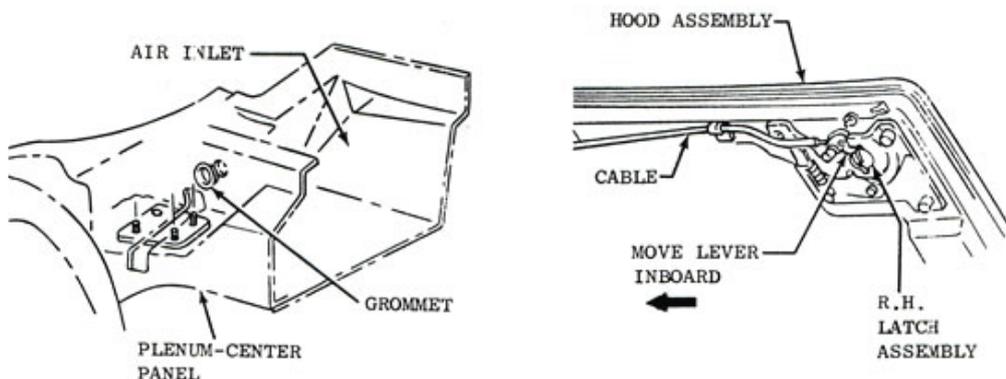
Corvette Hood Lock - Fails To Release

In the event the hood lock fails to release by pulling on the release handle, it may be released by reaching up through one of the left fender louvres with a 30" rod and pushing forward on the latch release lever as noted on Page 9, of the September - October, 1967 issue of Chevrolet Service News. If the right hand lock does not release when this is done, the cable that links the right and left side locks may be inoperative. The right lock assembly may be released as follows:

1. Remove the air inlet grille panel by removing 8 mounting screws.
2. Push out the rubber grommet located on the front of the center plenum panel.
3. Insert a screwdriver through the hole in the center plenum panel and prying against the outside edge of the lock housing, move the lock release lever inboard until the latch releases.

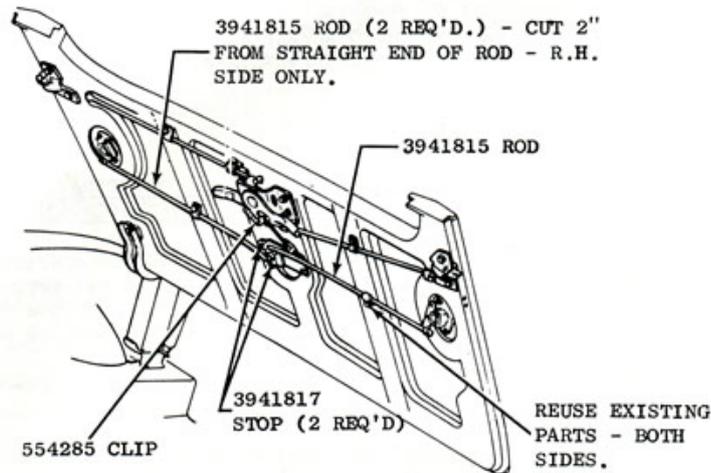
Rear Bow Lock Remote Control Cable Rattle

Remote control cables used on early 1968 Corvette Convertible models could rattle against the rear compartment lid. Production replaced these cables with rods on 1/2/68.

Complaint vehicles may be updated by installing the rear bow lock remote control rods as indicated on the sketch below.

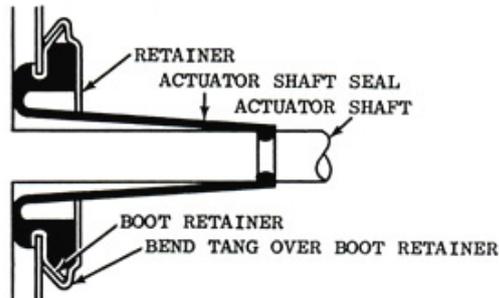
Headlamp Door - Inoperative

Headlamp doors which become inoperative due to sticking actuator shaft seals, should be corrected by replacing the inner shaft seal. This seal, in some cases, will stick to the actuator shaft causing the seal to pull out of the actuator. The headlamps may be operated manually as outlined in the 1968 Corvette Owners Manual when this occurs. The new style actuator seals went into production effective with Serial No. S410514. The actuator seals may be replaced as follows:

- b) Make certain seal grommet is properly seated in the actuator cover and interior bead at small diameter of seal fits in the groove on the shaft (See sketch)

- c) Apply a liberal film of silicone lubricant over entire exterior surface of actuator shaft seal, excluding grommet
  5. Install the retainer by bending the three (3) tabs over edge of boot retainer. (See sketch)

- IMPORTANT:** Do not distort boot retainer when bending over the tabs. If distorted, leakage can occur
6. Install the outer boot and reinstall the actuator assembly as described in Section 12 of the Chassis Service Manual
