1957 - 1965 Corvette: Service Bulletin: Diagnosis and Fitting Main and Rod Bearings

Source: Chevrolet Technical Service Bulletin

Bulletin No: DR #742

Date: May 27, 1965

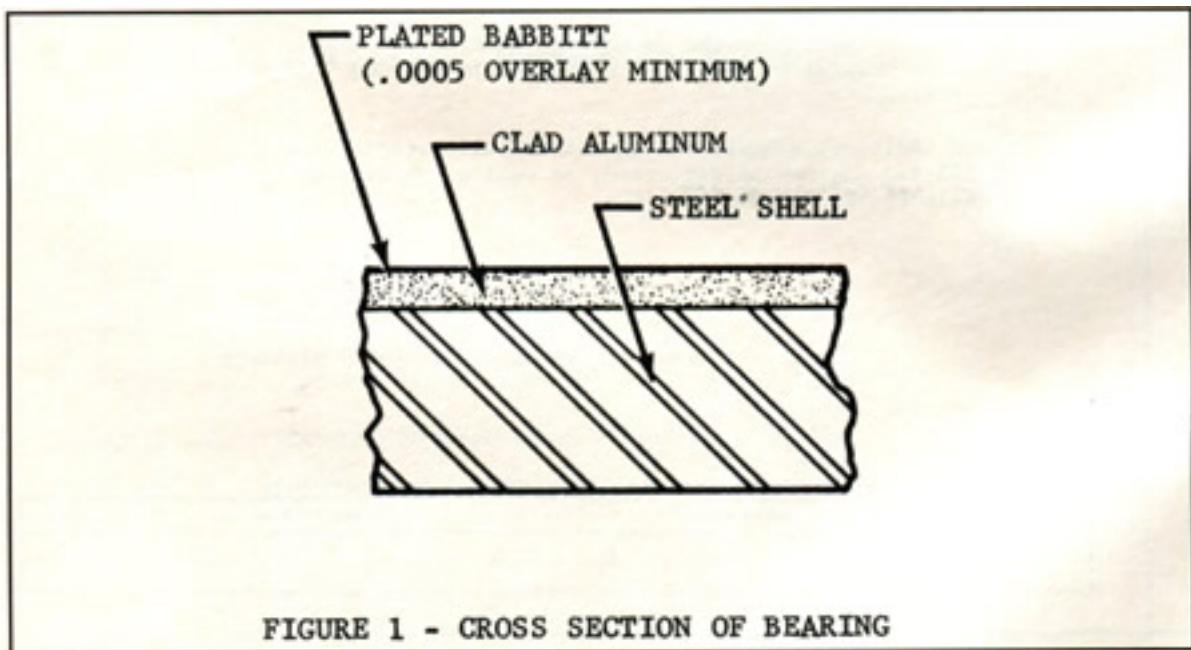
The babbitt overlay on the bearing faces (See Fig. 1) can be as thin as .0005 and in normal short mileage this can be removed from limited areas. This can cause a difference in color or appearance in the bearing face which is sometimes mistaken for being defective bearings.

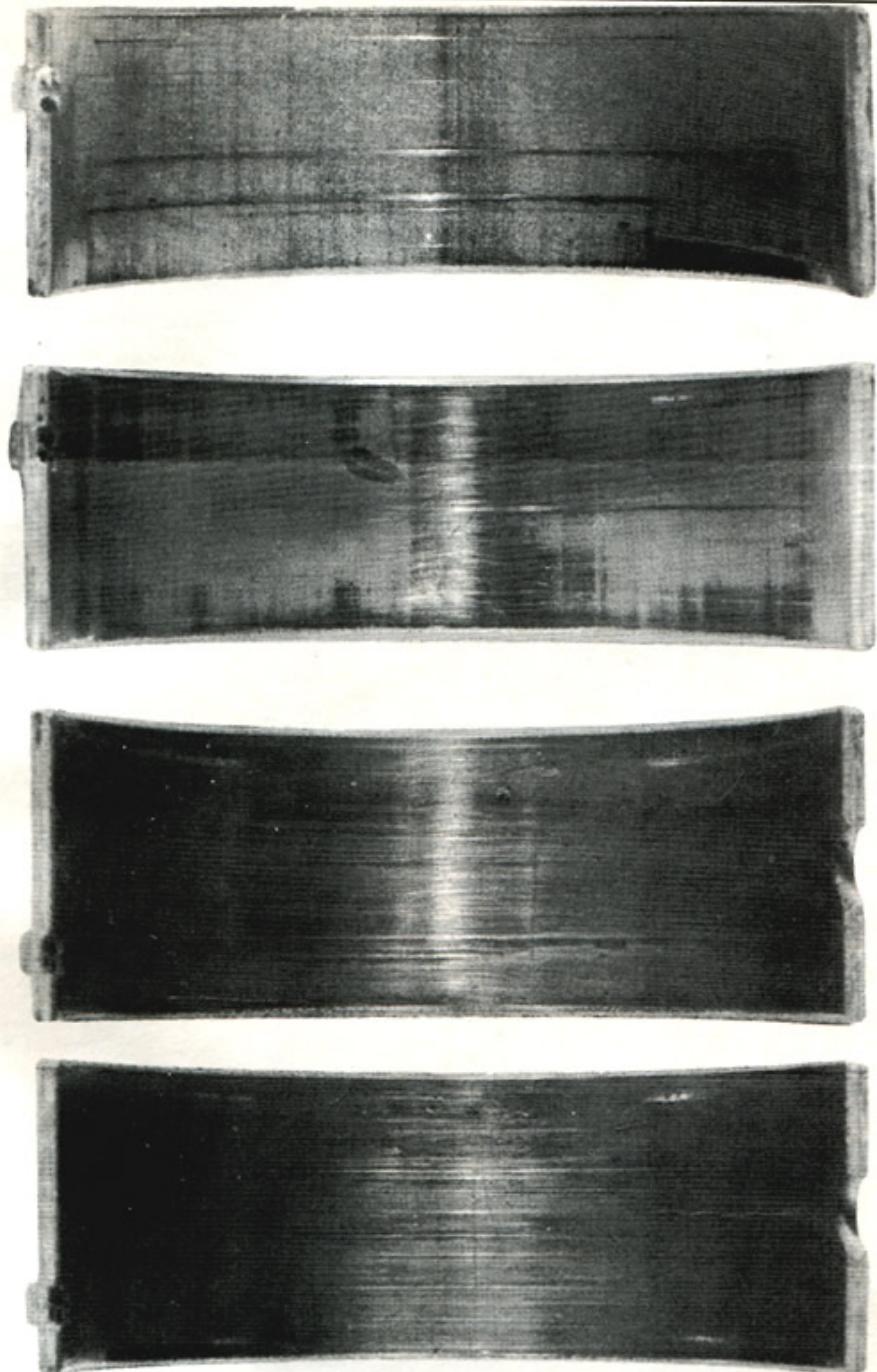
FIGURE 2 - BEARING WEAR PATTERNS

The bearings shown in Figure 2 have been operated for a short period of time, fitted within specified clearances and show initial wear patterns. This includes examples of minor scratches resulting from minute particles being circulated with the lubricant into the bearing clearance space. This type of wear is considered acceptable and has no detrimental effect on the function of the bearing. Extended operation will complete the wear pattern over the entire surface of the bearings.

When servicing crankshaft bearings, it is essential to use plastigage as outlined in the 1965 Shop Manuals to determine the actual clearance of the bearings. Also, it is important to understand and properly diagnose bearing wear patterns.
