1957 - 1965 Corvette: Service Bulletin: Diagnosis and Fitting Main and Rod Bearings

Subject: Diagnosis and Fitting Main and Rod Bearings

Bulletin No: DR #742

Date: May 27, 1965

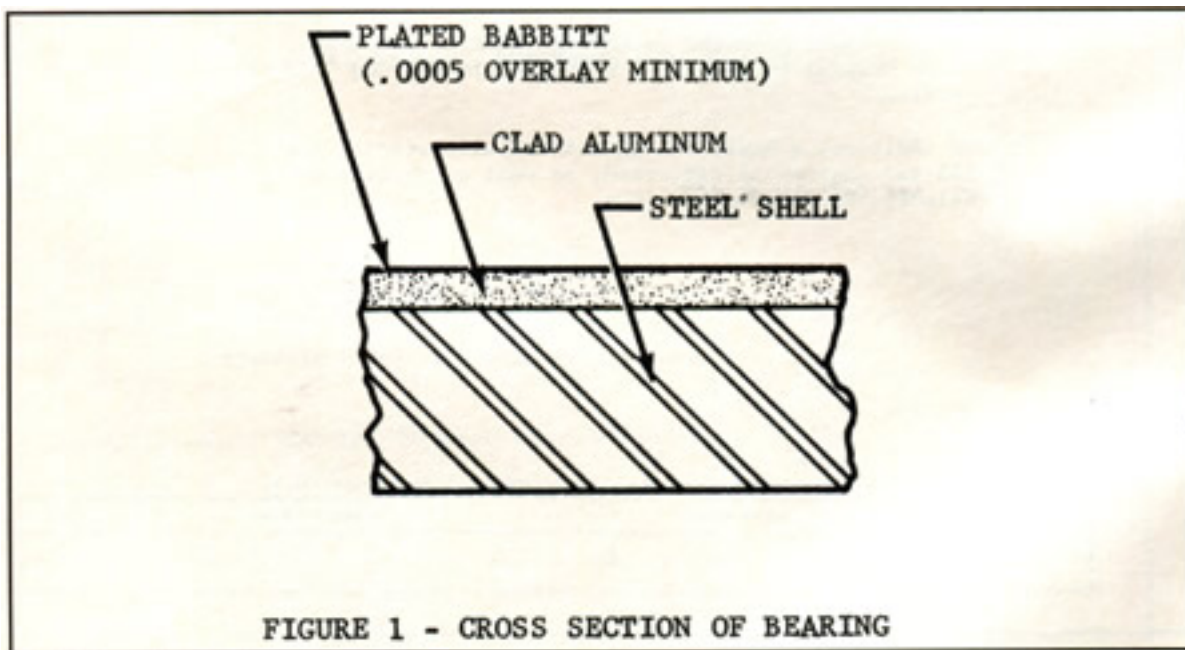
The babbitt overlay on the bearing faces (See Fig. 1) can be as thin as .0005 and in normal short mileage this can be removed from limited areas. This can cause a difference in color or appearance in the bearing face which is sometimes mistaken for being defective bearings.

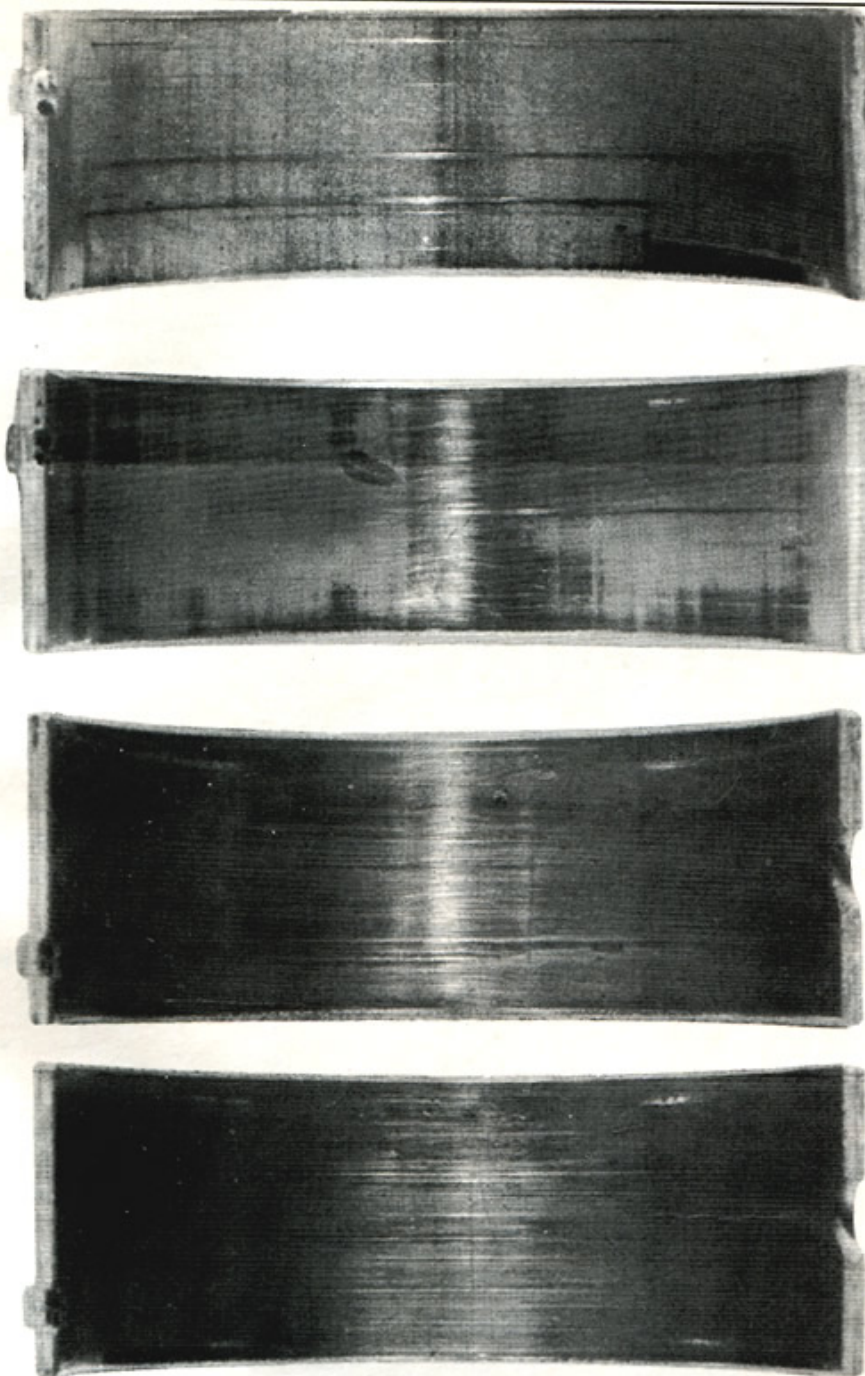
FIGURE 2 - BEARING WEAR PATTERNS

The bearings shown in Figure 2 have been operated for a short period of time, fitted within specified clearances and show initial wear patterns. This includes examples of minor scratches resulting from minute particles being circulated with the lubricant into the bearing clearance space. This type of wear is considered acceptable and has no detrimental effect on the function of the bearing. Extended operation will complete the wear pattern over the entire surface of the bearings.

When servicing crankshaft bearings, it is essential to use plastigage as outlined in the 1965 Shop Manuals to determine the actual clearance of the bearings. Also, it is important to understand and properly diagnose bearing wear patterns.
