1963 - 1965 Corvette: Service Bulletin: Drive Line Noise

Subject: Drive Line Noise

Model and Year: 1963 - 1965 Corvette

Bulletin No: #1069

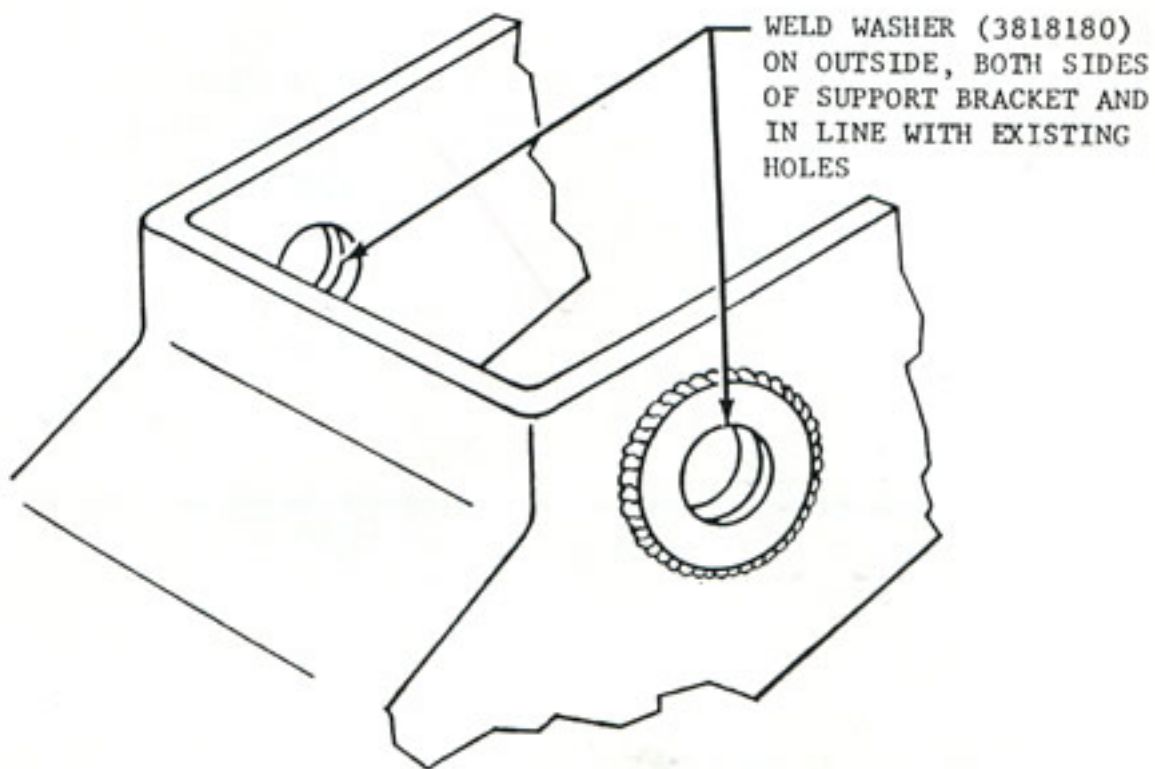
FIGURE 1

A clunking noise may occur in the drive line of some 1963-65 Corvette on initial vehicle movement in either forward or reverse gear. This could be caused by loosening of the differential carrier support bracket front attaching bolts. Loosening of these bolts will also result in elongation of the bracket bolt holes.

1. If reinforced bracket, Part No. 3868799 is not available, obtain Part No 3820186 and weld one flat washer, (Part No. 3818180) on each outside surface in line with existing holes (See Figure 1.)
