1963 - 1965 Corvette: Service Bulletin: Drive Line Noise

Source: Chevrolet Technical Service Bulletin

Bulletin No: #1069

Date: January 7, 1965

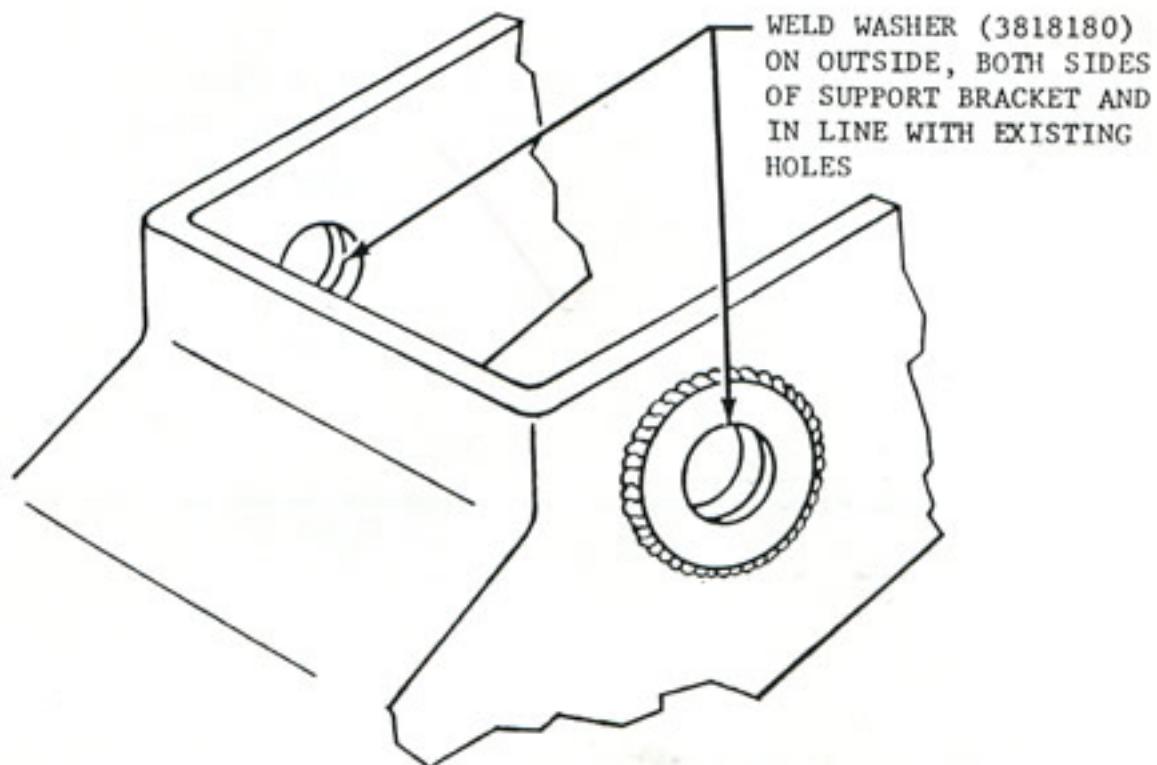
FIGURE 1

A clunking noise may occur in the drive line of some 1963-65 Corvette on initial vehicle movement in either forward or reverse gear. This could be caused by loosening of the differential carrier support bracket front attaching bolts. Loosening of these bolts will also result in elongation of the bracket bolt holes.

1. If reinforced bracket, Part No. 3868799 is not available, obtain Part No 3820186 and weld one flat washer, (Part No. 3818180) on each outside surface in line with existing holes (See Figure 1.)
