# 1963 - 1965 Corvette: Service Bulletin: Drive Line Noise

**Subject:** Drive Line Noise  
**Model and Year:** 1963 - 1965 Corvette  
**Source:** Chevrolet Technical Service Bulletin  
**Bulletin No:** #1069  
**Section:** IV  
**Date:** January 7, 1965

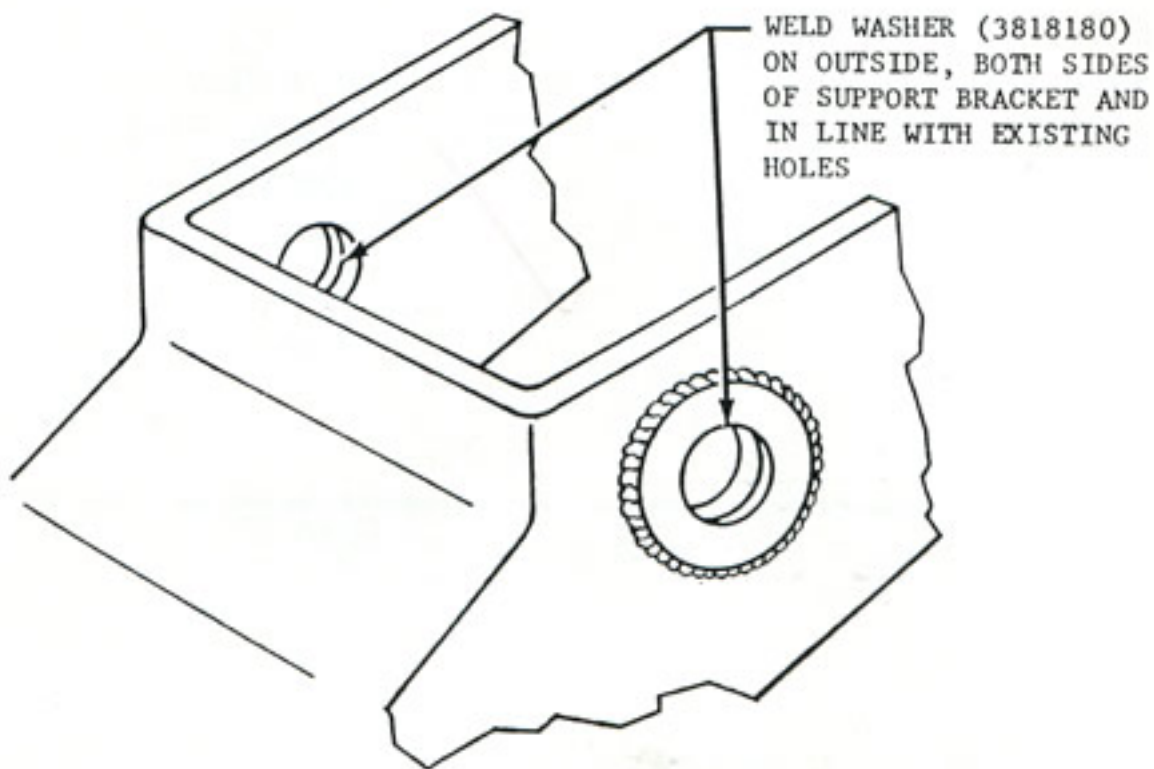
FIGURE 1

A clunking noise may occur in the drive line of some 1963-65 Corvette on initial vehicle movement in either forward or reverse gear. This could be caused by loosening of the differential carrier support bracket front attaching bolts. Loosening of these bolts will also result in elongation of the bracket bolt holes.

### PART I - Re-work of Bracket Part No. 3820186

1. If reinforced bracket, Part No. 3868799 is not available, obtain Part No 3820186 and weld one flat washer, (Part No. 3818180) on each outside surface in line with existing holes (See Figure 1.)
