1984 - 1996 Corvette: Service Bulletin: Windshield Wipers Chatter and/or Wipe Unevenly

Subject: Windshield Wipers Chatter and/or Wipe Unevenly

Source: Chevrolet Dealer Service Bulletin

Bulletin No: 87-104

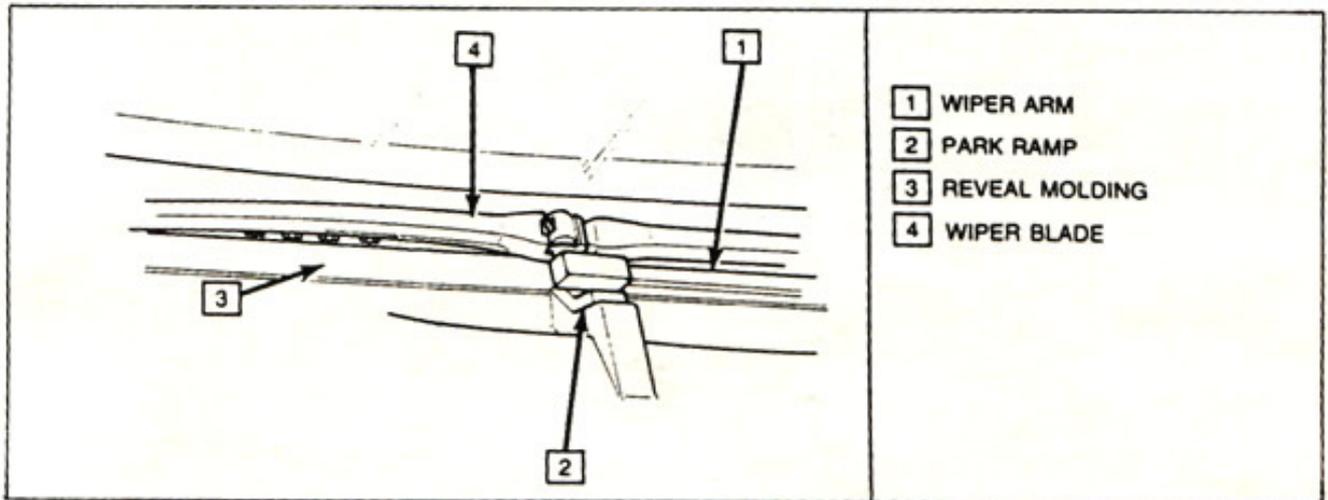
FIGURE 1

Check Fit of Windshield Reveal Molding (Figure 1)

On vehicles equipped with depressed park (hidden) wiper blades and windshield lower reveal molding, check the fit of the reveal molding across the base of the windshield. The lower reveal molding must fit uniformly along the glass surface to allow the wiper blades to move freely from the glass wiper area to the park position when the wipers are turned off. Gaps in excess of 1.0mm (.040 in.) should be corrected using the following procedure.

1. Remove both wiper arm assemblies.
2. Remove self drilling screws which retain the reveal molding.
3. Clean the underside of the lower reveal molding and the windshield glass. Remove any obstructions which prevent the reveal molding from matching the glass contour.
4. If necessary, the lower reveal molding should be reformed as required to improve the fit. Care should be used to prevent marring the molding surface.
5. Reinstall the lower reveal molding using new self-sealing screws (P/N 20564495) starting with the center screw and work outward. Use over sized screws if necessary.

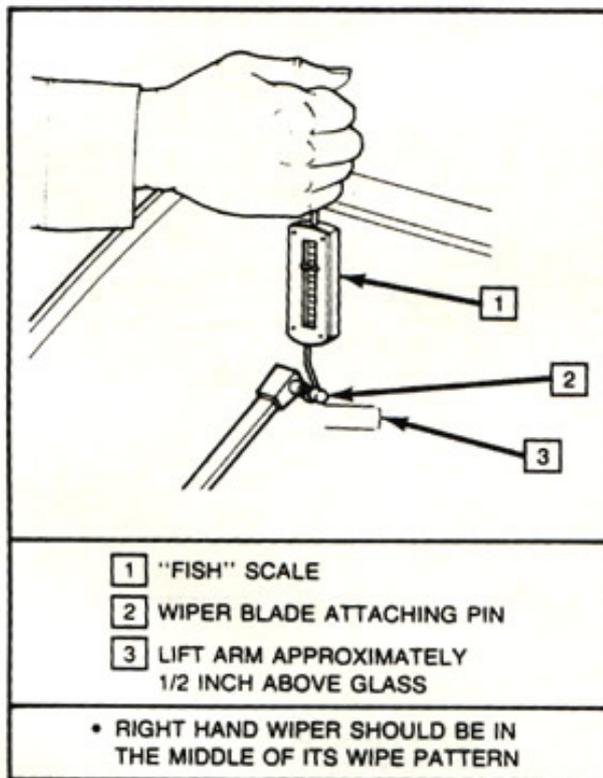
FIGURE 2

Check Windshield Wiper Arm Pressure (Figure 2)

3. Attach a scale to the wiper arm attaching pin and measure the force required to lift the wiper arm perpendicular to the windshield to the normal working height (i.e., the height of the blade attached).
4. if the force required is not within the specifications given below, the wiper arm assembly should be replaced.

1. Turn on ignition switch and wipers. When the right hand wiper is in the middle of a wipe stroke,, stop the wiper system by turning off the ignition switch. Proceed with the following steps to measure the right hand arm pressure. prior to measuring the left hand arm pressure be sure the left hand arm is in the middle of the wipe stroke.
2. Remove the wiper blade assembly from the wiper arm.

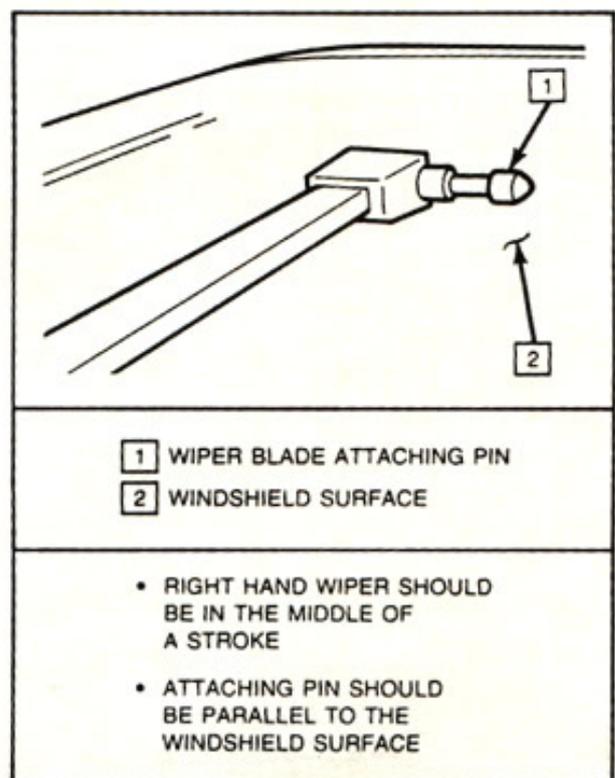
FIGURE 3

Check Wiper Blade Mounting Angle (Figure 3)

With the right hand wiper arm assembly in the middle of a wipestroke and the wiper blade assemblies removed, visually check that the blade assembly mounting pin on each wiper arm is parallel to the windshield. Replace the wiper arm if necessary.

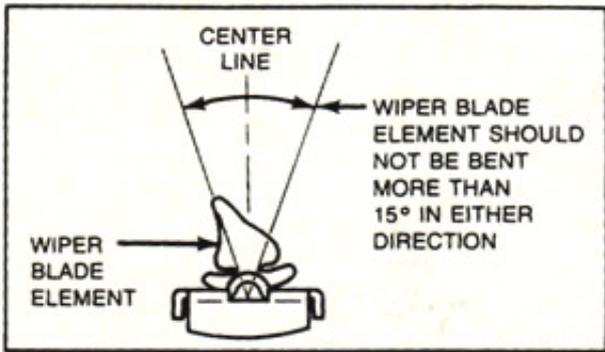
FIGURE 4

Check For Blade Set (Figure 4)

Remove the wiper blade assemblies from the wiper arms being careful to note orientation for reassembly. Look down the length of the blade element. The rubber element which contacts the glass must be on the center line of the blade assembly +/- 15 degrees. Replace the element if necessary.

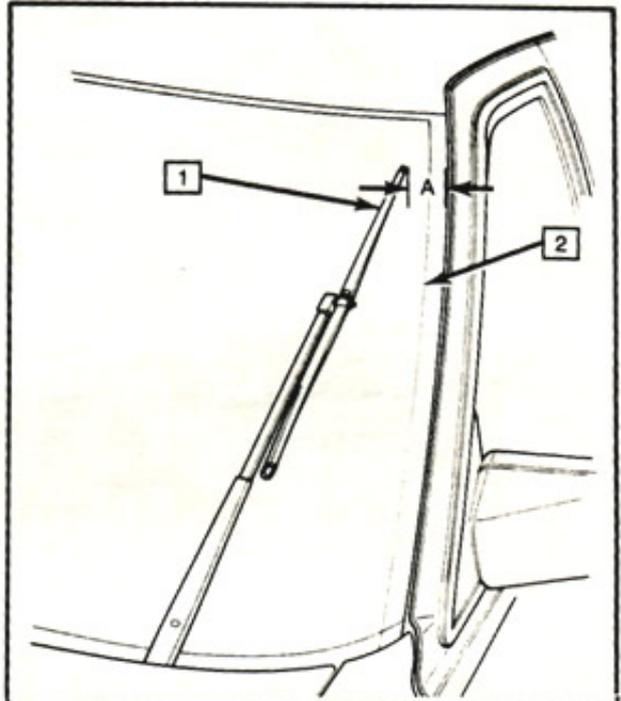
FIGURE 5

When the wipers are shut off after operation on wet glass, both wiper arm and blade assembly should be fully seated on the park ramps. In the full left stroke position, the tip of the blade element must be no more than 78mm (3 1/16 inches) from the pillar. if wipers require adjustment, refer to section 8E of the appropriate Service Manual.

• WITH LEFT HAND WIPER BLADE IN THE FULL OUTER WIPE POSITION, DIMENSION A SHOULD BE NO GREATER THAN 78mm (3-1/16 IN.)

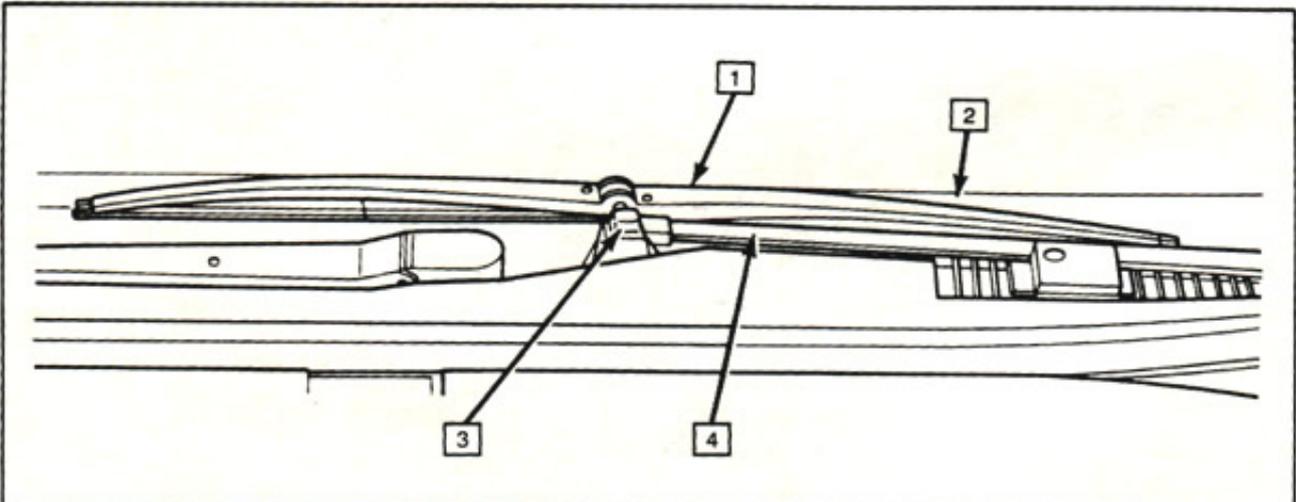
FIGURE 6

• WIPER ARM SHOULD BE FULLY SEATED ON PARK RAMP
