1984 - 1996 Corvette: Service Bulletin: Windshield Wipers Chatter and/or Wipe Unevenly

Subject: Windshield Wipers Chatter and/or Wipe Unevenly

Source: Chevrolet Dealer Service Bulletin

Bulletin No: 87-104

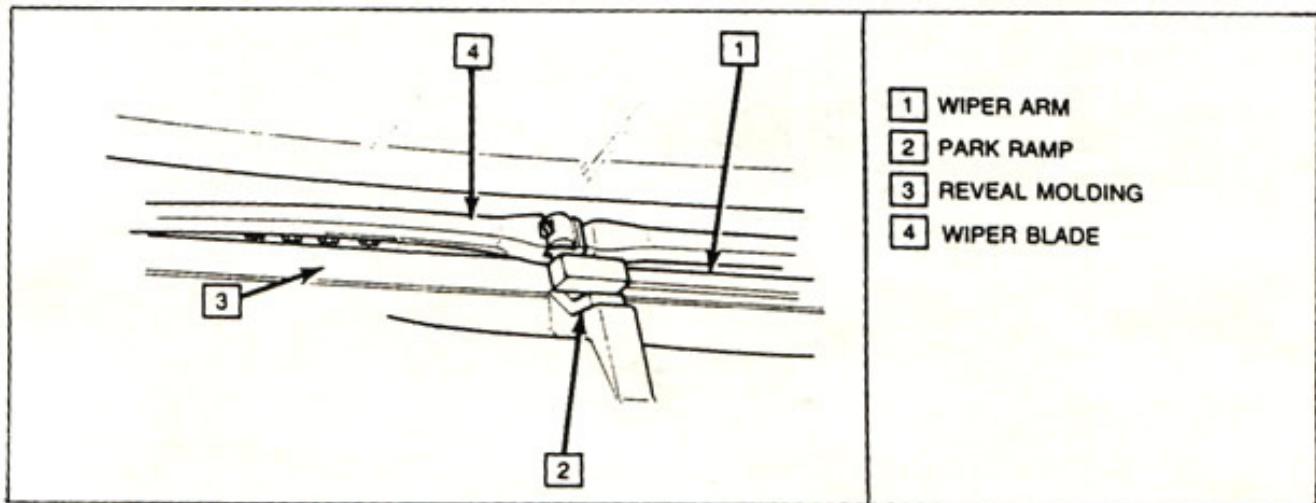
FIGURE 1

Check Fit of Windshield Reveal Molding (Figure 1)

On vehicles equipped with depressed park (hidden) wiper blades and windshield lower reveal molding, check the fit of the reveal molding across the base of the windshield. The lower reveal molding must fit uniformly along the glass surface to allow the wiper blades to move freely from the glass wiper area to the park position when the wipers are turned off. Gaps in excess of 1.0mm (.040 in.) should be corrected using the following procedure.

1. Remove both wiper arm assemblies.
2. Remove self drilling screws which retain the reveal molding.
3. Clean the underside of the lower reveal molding and the windshield glass. Remove any obstructions which prevent the reveal molding from matching the glass contour.
4. If necessary, the lower reveal molding should be reformed as required to improve the fit. Care should be used to prevent marring the molding surface.
5. Reinstall the lower reveal molding using new self-sealing screws (P/N 20564495) starting with the center screw and work outward. Use over sized screws if necessary.

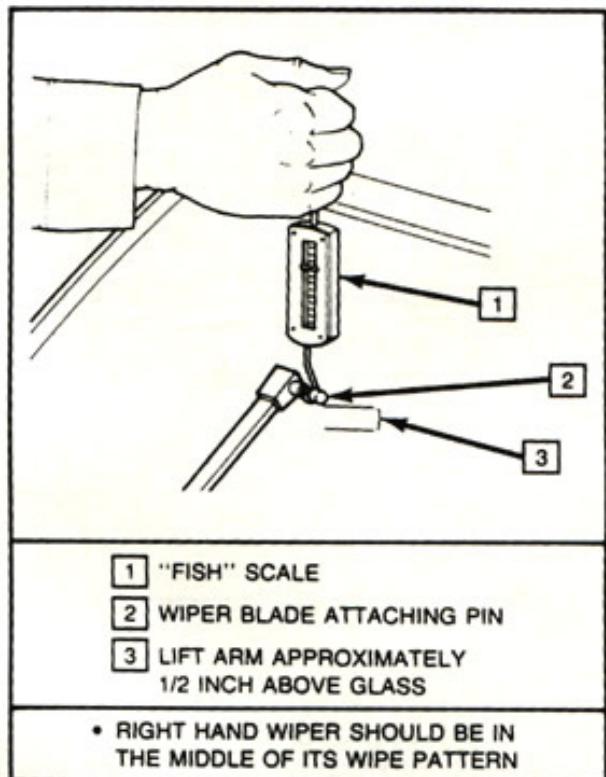
FIGURE 2

Check Windshield Wiper Arm Pressure (Figure 2)

1. Turn on ignition switch and wipers. When the right hand wiper is in the middle of a wipe stroke, stop the wiper system by turning off the ignition switch. Proceed with the following steps to measure the right hand arm pressure. prior to measuring the left hand arm pressure be sure the left hand arm is in the middle of the wipe stroke.
2. Remove the wiper blade assembly from the wiper arm.

3. Attach a scale to the wiper arm attaching pin and measure the force required to lift the wiper arm perpendicular to the windshield to the normal working height (i.e., the height of the blade attached).
4. if the force required is not within the specifications given below, the wiper arm assembly should be replaced.

<u>CARLINE</u>	<u>OUNCES</u>
All domestically produced passenger cars except Cavalier	29 +/- 3
Cavalier	24 +/- 3
<u>Check Wiper Blade Mounting Angle</u> (Figure 3)

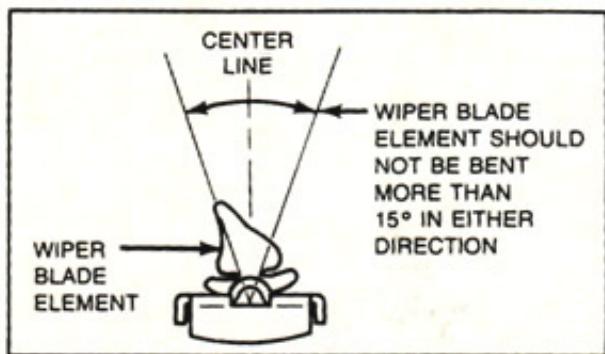
FIGURE 4

Check For Blade Set (Figure 4)

Remove the wiper blade assemblies from the wiper arms being careful to note orientation for reassembly. Look down the length of the blade element. The rubber element which contacts the glass must be on the center line of the blade assembly +/- 15 degrees. Replace the element if necessary.

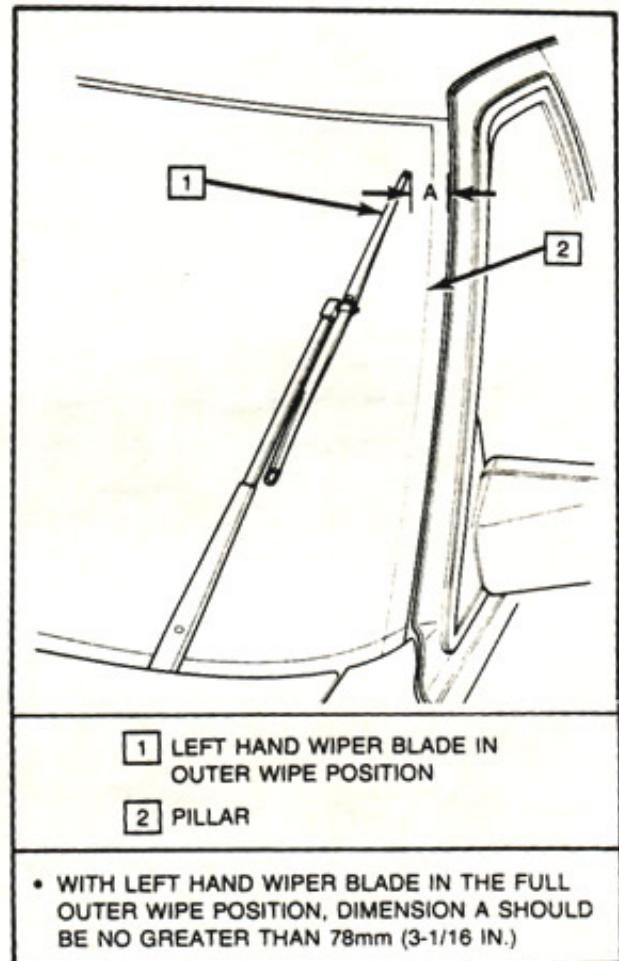
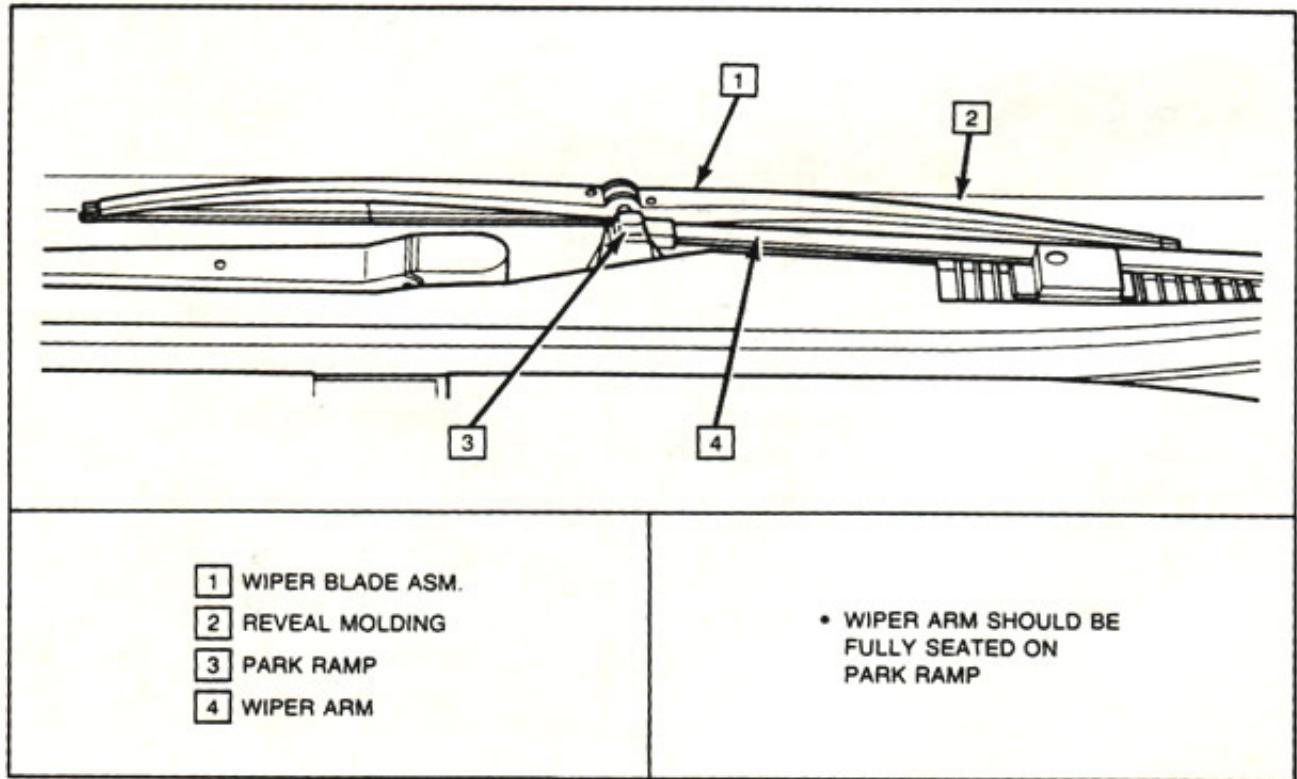
Check Wiper Arm & Park Position Adjustments (Figure 5 & 6)

When the wipers are shut off after operation on wet glass, both wiper arm and blade assembly should be fully seated on the park ramps. In the full left stroke position, the tip of the blade element must be no more than 78mm (3 1/16 inches) from the pillar. if wipers require adjustment, refer to section 8E of the appropriate Service Manual.
