1984 - 1996 Corvette: Service Bulletin: Windshield Wipers Chatter and/or Wipe Unevenly

Subject: Windshield Wipers Chatter and/or Wipe Unevenly

Source: Chevrolet Dealer Service Bulletin

Bulletin No: 87-104

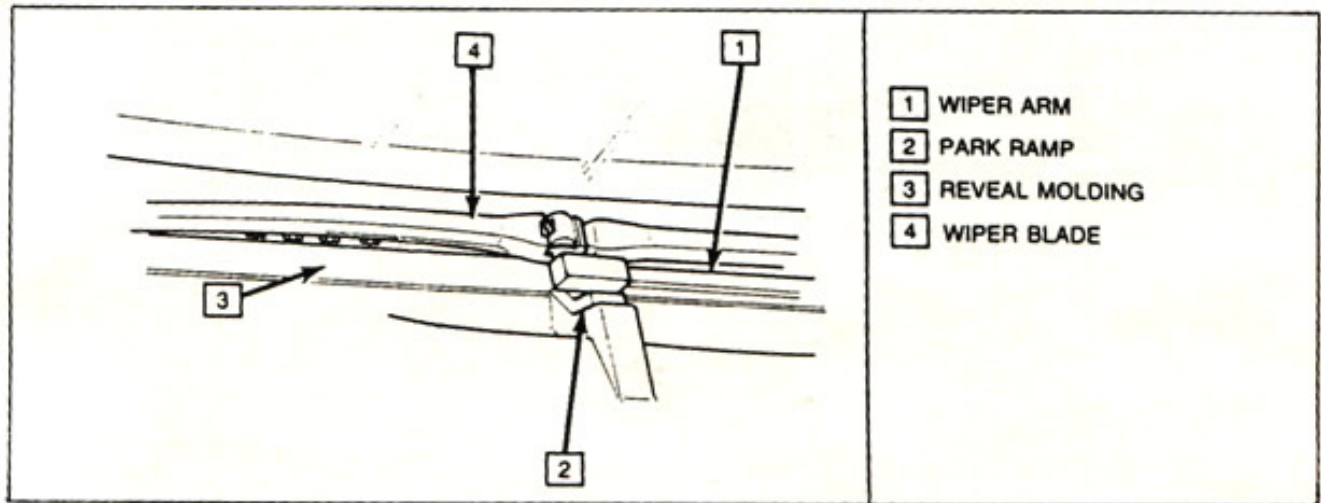
FIGURE 1

Check Fit of Windshield Reveal Molding (Figure 1)

On vehicles equipped with depressed park (hidden) wiper blades and windshield lower reveal molding, check the fit of the reveal molding across the base of the windshield. The lower reveal molding must fit uniformly along the glass surface to allow the wiper blades to move freely from the glass wiper area to the park position when the wipers are turned off. Gaps in excess of 1.0mm (.040 in.) should be corrected using the following procedure.

1. Remove both wiper arm assemblies.
2. Remove self drilling screws which retain the reveal molding.
3. Clean the underside of the lower reveal molding and the windshield glass. Remove any obstructions which prevent the reveal molding from matching the glass contour.
4. If necessary, the lower reveal molding should be reformed as required to improve the fit. Care should be used to prevent marring the molding surface.
5. Reinstall the lower reveal molding using new self-sealing screws (P/N 20564495) starting with the center screw and work outward. Use over sized screws if necessary.

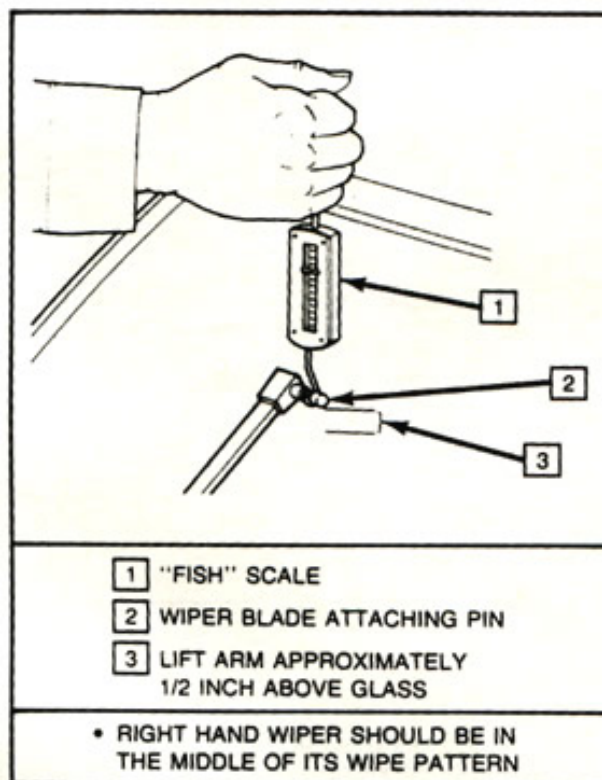
FIGURE 2

Check Windshield Wiper Arm Pressure (Figure 2)

1. Turn on ignition switch and wipers. When the right hand wiper is in the middle of a wipe stroke,, stop the wiper system by turning off the ignition switch. Proceed with the following steps to measure the right hand arm pressure. prior to measuring the left hand arm pressure be sure the left hand arm is in the middle of the wipe stroke.
2. Remove the wiper blade assembly from the wiper arm.

3. Attach a scale to the wiper arm attaching pin and measure the force required to lift the wiper arm perpendicular to the windshield to the normal working height (i.e., the height of the blade attached).
4. if the force required is not within the specifications given below, the wiper arm assembly should be replaced.

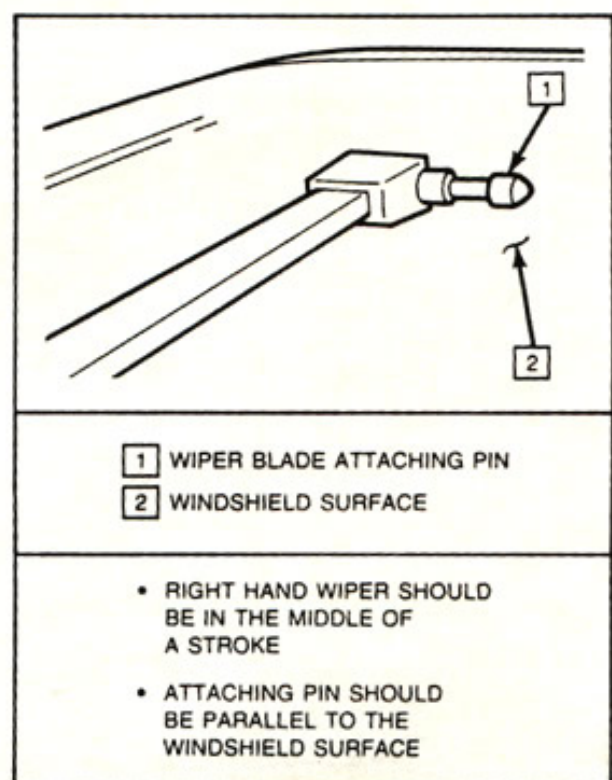
FIGURE 3

Check Wiper Blade Mounting Angle (Figure 3)

With the right hand wiper arm assembly in the middle of a wipestroke and the wiper blade assemblies removed, visually check that the blade assembly mounting pin on each wiper arm is parallel to the windshield. Replace the wiper arm if necessary.

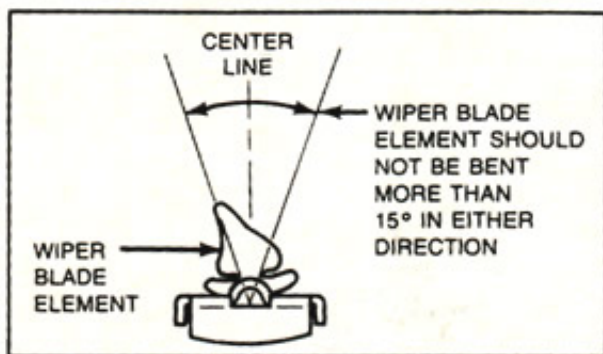
FIGURE 4

Check For Blade Set (Figure 4)

Remove the wiper blade assemblies from the wiper arms being careful to note orientation for reassembly. Look down the length of the blade element. The rubber element which contacts the glass must be on the center line of the blade assembly +/- 15 degrees. Replace the element if necessary.

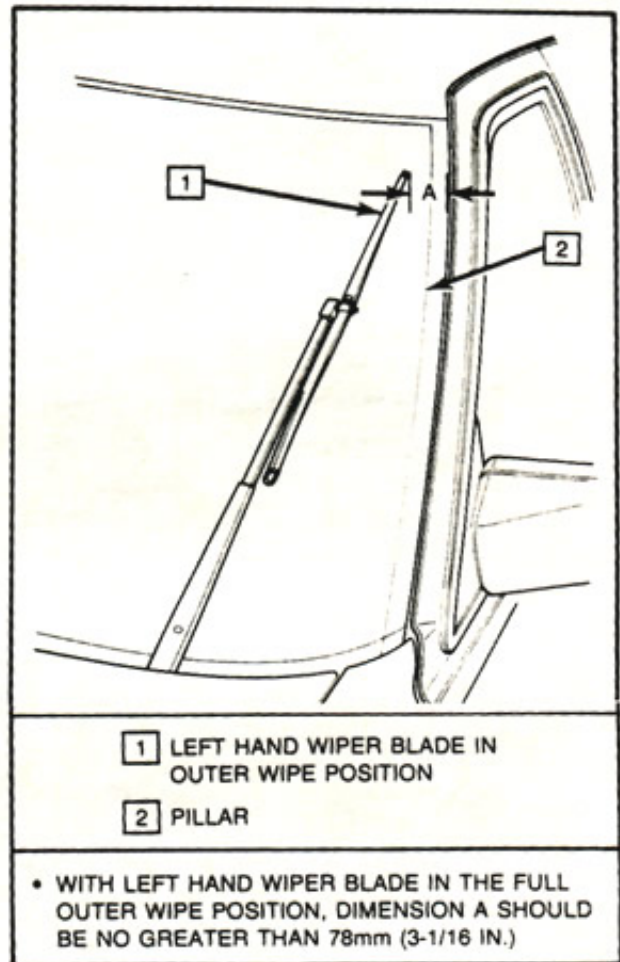
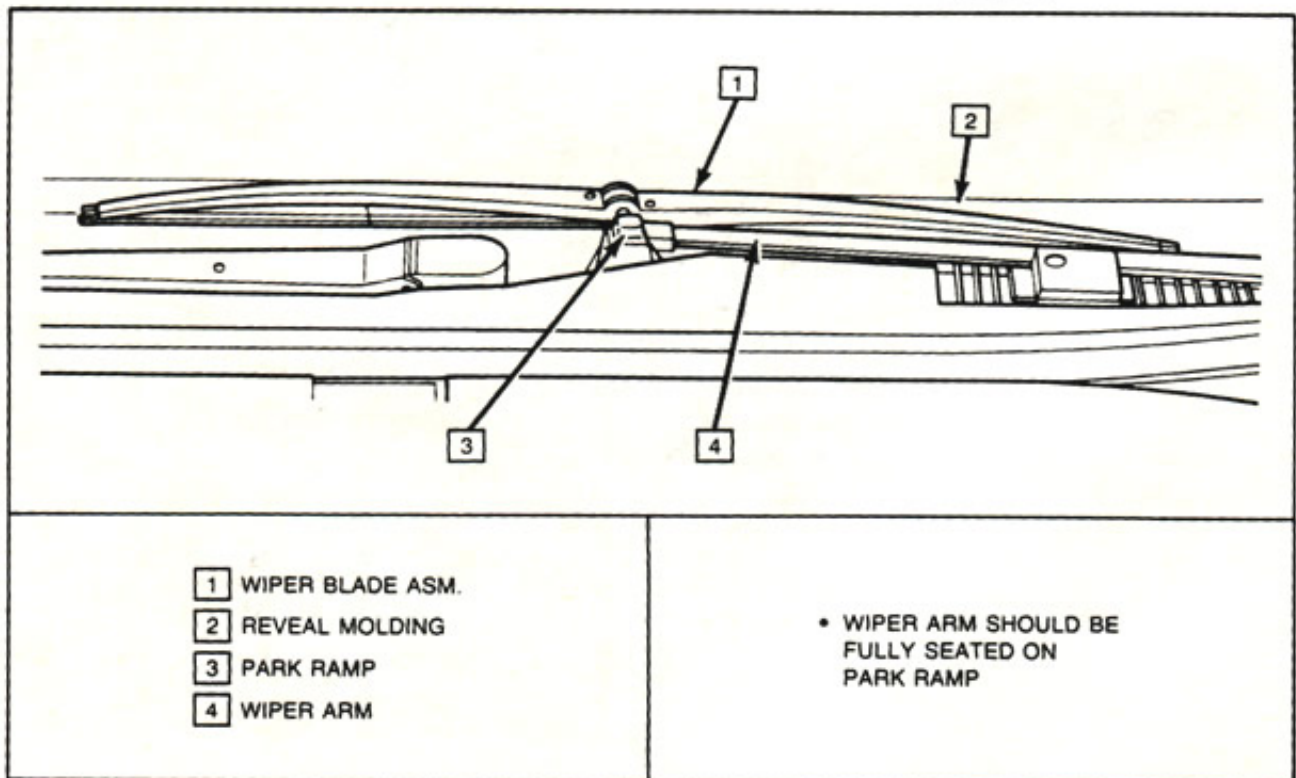
Check Wiper Arm & Park Position Adjustments (Figure 5 & 6)

When the wipers are shut off after operation on wet glass, both wiper arm and blade assembly should be fully seated on the park ramps. In the full left stroke position, the tip of the blade element must be no more than 78mm (3 1/16 inches) from the pillar. if wipers require adjustment, refer to section 8E of the appropriate Service Manual.
