1966 Corvette: Reliability Data Center Letter: Poor Release and High Pedal Effort - 1966 327 CID Corvette Engines

Your Reliability Data Center
Flint V-8 Engine Plant

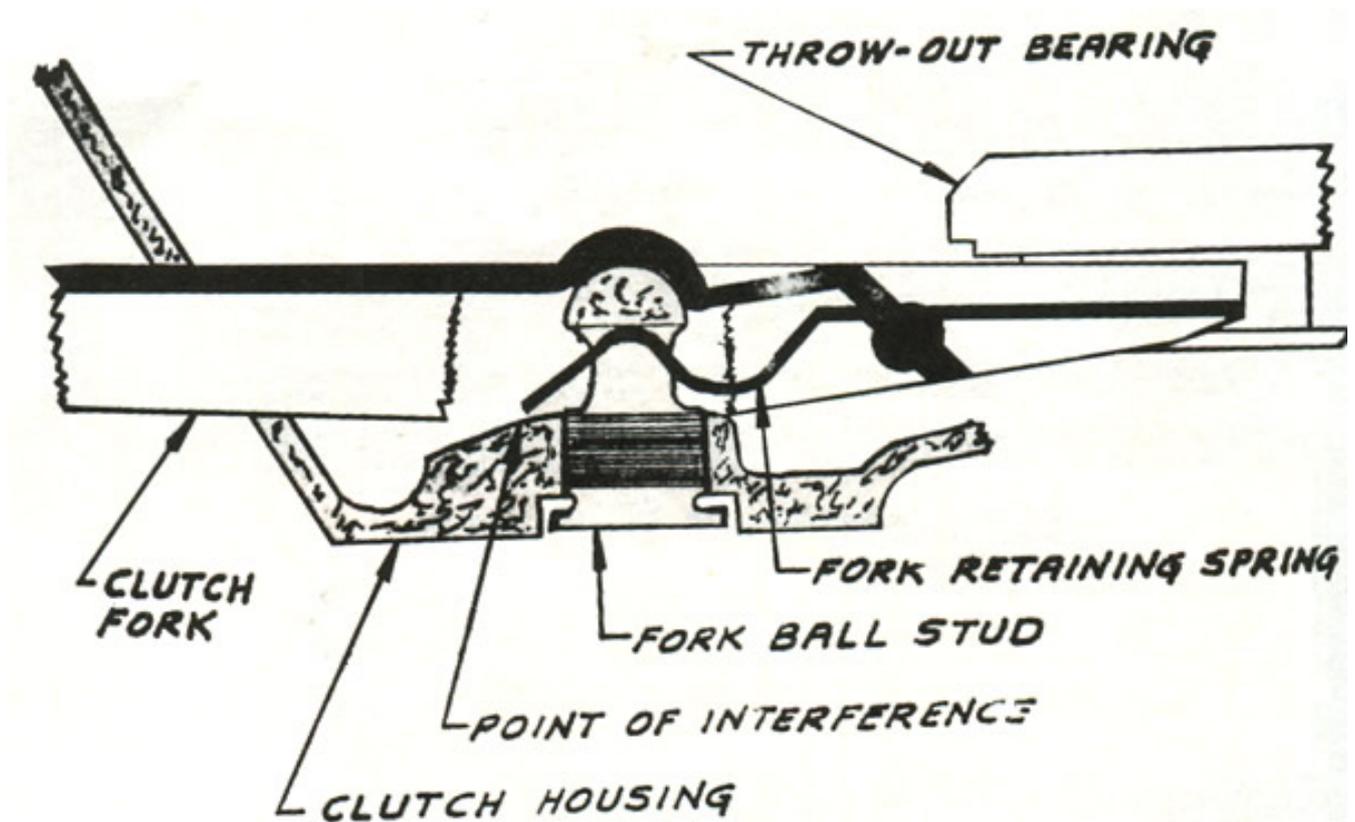
Recent investigation of poor release of clutch, high pedal effort and disc wear has isolated the condition to the clutch fork retainer tangs interfering with the clutch housing boss provided for the ball stud which causes a reduction in fork travel.

The above condition is caused by a short ball stud Part No. 3887159 which was used on 1966 327 CID Corvette engines until 4-4-66. At that time the past design ball stud part No. 3729000 was again installed and is currently being used.

The correct ball stud Part No. 372900 has an overall length of 1 1/2 inches, the shorter stud, Part No. 3887159 is approximately 1 3/8 inches long.

In the event a complaint of high pedal effort or poor release is encountered the unit should be inspected for the above mentioned condition. (see attached illustration).
