1966 Corvette: Reliability Data Center Letter: Poor Release and High Pedal Effort - 1966 327 CID Corvette Engines

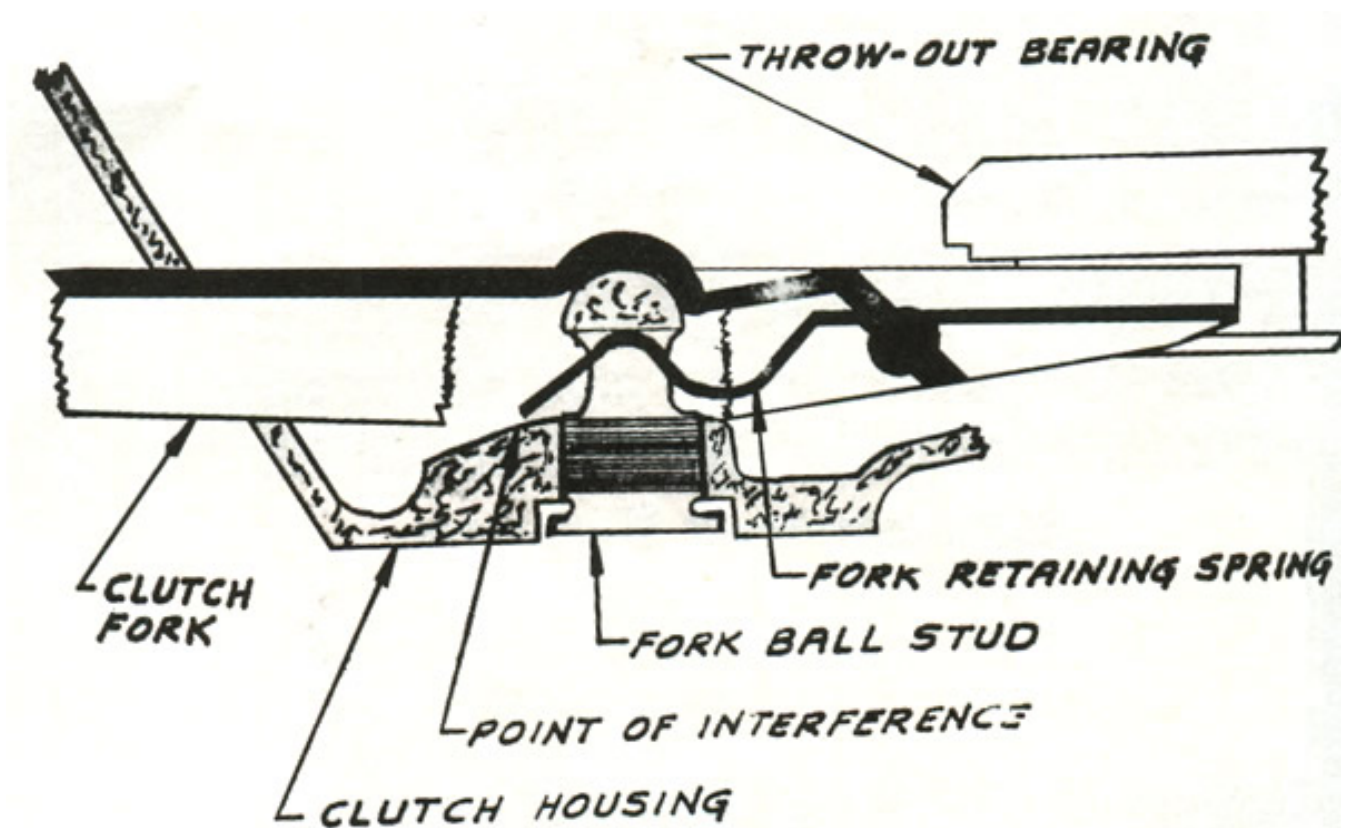
Recent investigation of poor release of clutch, high pedal effort and disc wear has isolated the condition to the clutch fork retainer tangs interfering with the clutch housing boss provided for the ball stud which causes a reduction in fork travel.

The above condition is caused by a short ball stud Part No. 3887159 which was used on 1966 327 CID Corvette engines until 4-4-66. At that time the past design ball stud part No. 3729000 was again installed and is currently being used.

The correct ball stud Part No. 372900 has an overall length of 1 1/2 inches, the shorter stud, Part No. 3887159 is approximately 1 3/8 inches long.

In the event a complaint of high pedal effort or poor release is encountered the unit should be inspected for the above mentioned condition. (see attached illustration).
