1966 Corvette: Reliability Data Center Letter: Poor Release and High Pedal Effort - 1966 327 CID Corvette Engines

Chevrolet - Flint V8 Engine Reliability Data Center

June 23, 1967

Poor Release and High Pedal Effort
1966 327 CID Corvette Engines

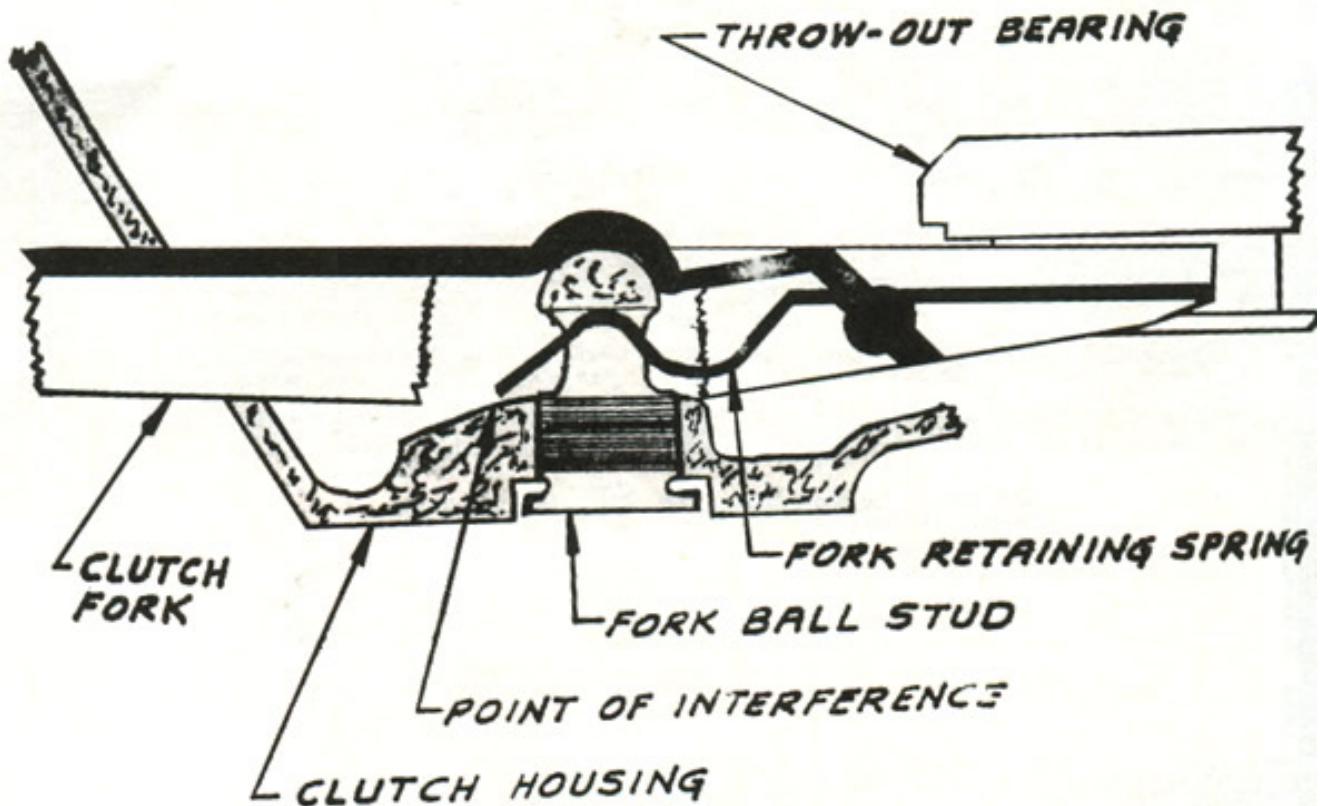
Recent investigation of poor release of clutch, high pedal effort and disc wear has isolated the condition to the clutch fork retainer tangs interfering with the clutch housing boss provided for the ball stud which causes a reduction in fork travel.

The above condition is caused by a short ball stud Part No. 3887159 which was used on 1966 327 CID Corvette engines until 4-4-66. At that time the past design ball stud part No. 3729000 was again installed and is currently being used.

In the event a complaint of high pedal effort or poor release is encountered the unit should be inspected for the above mentioned condition. (see attached illustration).

The correct ball stud Part No. 372900 has an overall length of 1 12 inches, the shorter stud, Part No. 3887159 is approximately 1 3/8 inches long.
