1968 Corvette: Inter-Organization Letter: Water Leaks - 1968 Corvette Aero-Coupe and Convertible Supplement to A.I. 68-11

To REGIONAL SERVICE ENGINEERS
From G. F. Jackson
Subject WATER LEAKS - 1968 CORVETTE
AERO COUPE AND CONVERTIBLE
SUPPLEMENT TO A.I. 68-11

Location
Location Central Office
Date October 16, 1968

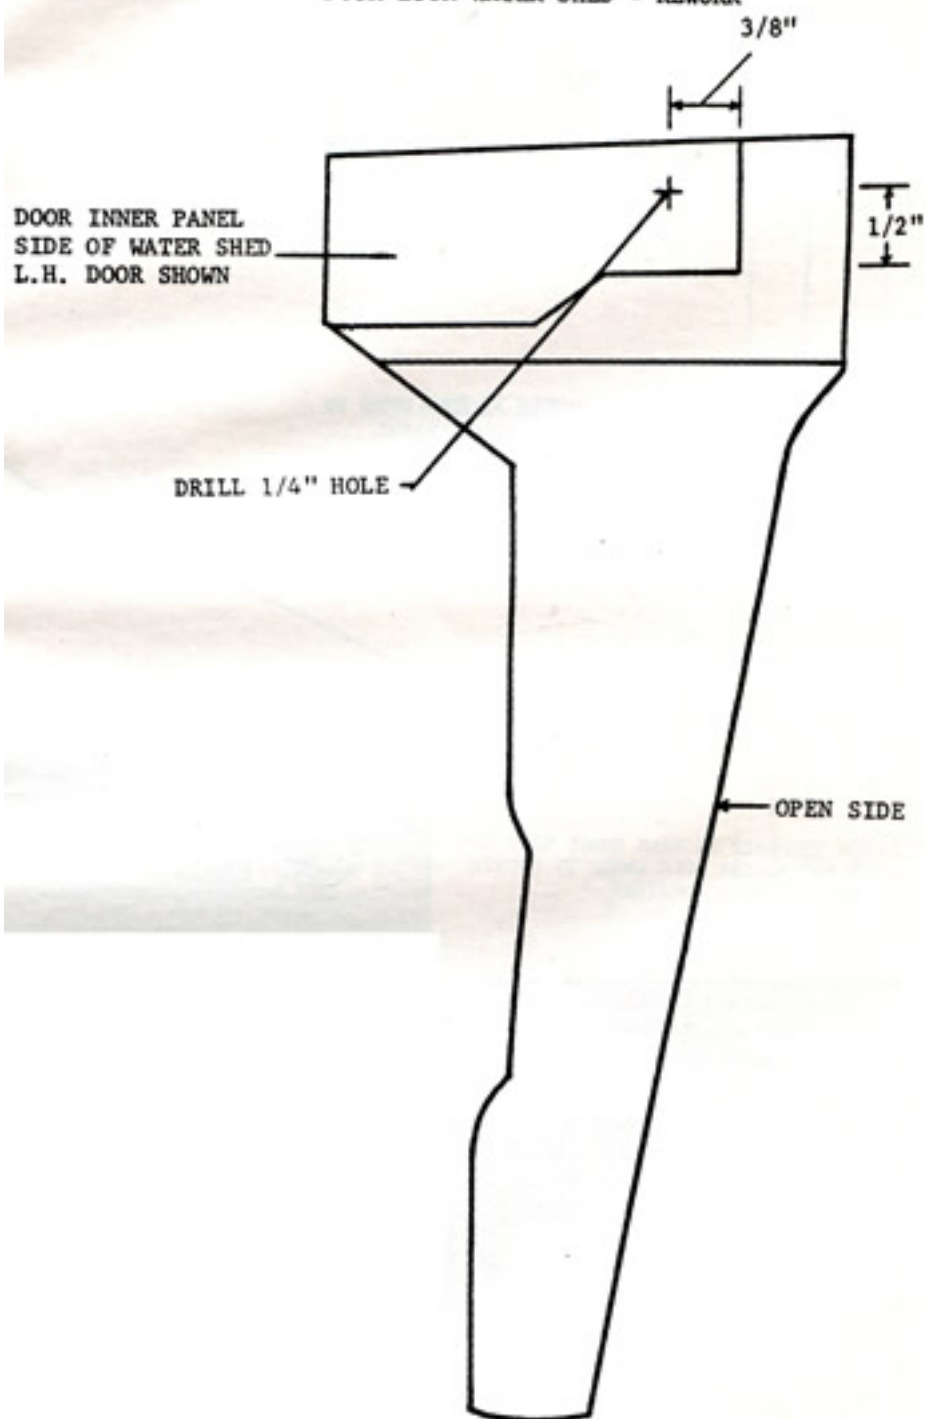
DOOR LOCK WATER SHED - REWORK

Some of the late style water sheds were manufactured with the inner attaching hole not drilled. This hole may be located by using the sketch on Page 3, of this supplement

DOOR INNER PANEL
SIDE OF WATER SHED.
L.H. DOOR SHOWN

1/2"

DRILL 1/4" HOLE
