# 1973 - 1974 Corvette: Service Bulletin: Engine Overheat Due to Blocked Coolant Passage in the Cylinder Head

**Source:** Chevrolet Dealer Service Technical Bulletin

**Bulletin No:** 74-T-6

**Date:** Dec. 5, 1973

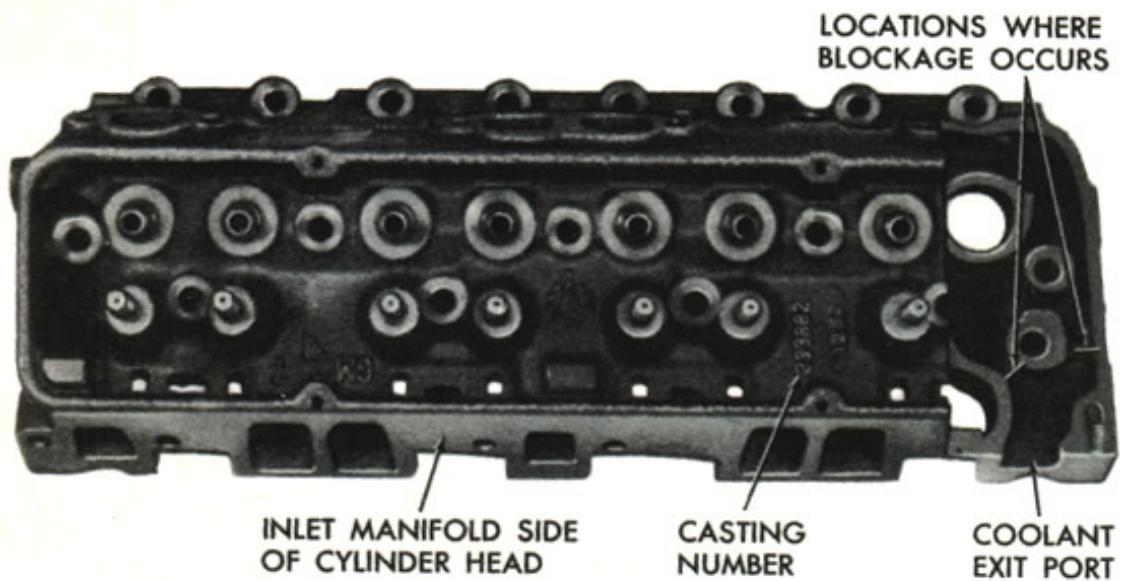
A small number of 350 and 400 cubic inch displacement V-8 engines were built before 9/24/73 (0924) with a coolant blockage in the cylinder head resulting in an overheat condition. A 1974 casting process change has resulted in a possible blockage of the coolant exit port in cylinder head casting No. 333882 (casting number appears on the top of the cylinder head beneath the rocker cover). This cylinder head is common to all 1974 small block V-8 engines, except for those used in C-K30 and 50 thru 60 series trucks.

6. If a blockage is present, it will occur at a depth of approximately five and one half (5-1/2) to six (6) inches from the edge of the thermostat port.

**TOP VIEW OF A CYLINDER HEAD PARTIALLY SECTIONED TO SHOW BLOCKED COOLANT PASSAGES**

7. The blocked coolant port can be repaired by removing the inlet manifold and knocking out the casting flash in the blocked water passage with a suitable tool. Take care not to damage the oil drain boss. The particles of flashing that fall into the water jacket do not have to be removed. If the blockage cannot be removed, the cylinder head should be replaced.

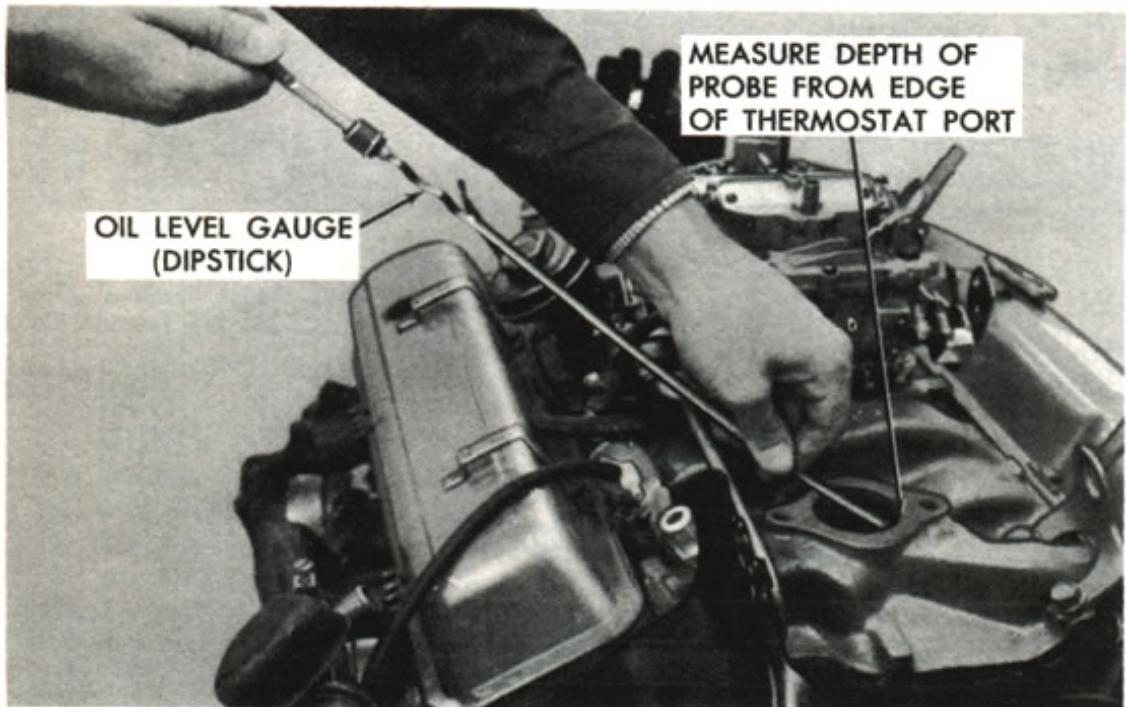
1. Remove the thermostat housing and thermostat.
2. Insert the oil level gauge (dipstick) into the thermostat port thru the inlet manifold coolant passage and into the cylinder head (refer to the illustration on page 3).

4. If at least seven (7) inches of the dipstick is inserted past the edge of the thermostat port, there is no blockage.
5. Remove the dipstick and repeat the test for the other cylinder head.

**INSPECTION PROBE OF COOLANT EXIT PORT**
