1973 - 1974 Corvette: Service Bulletin: Engine Overheat Due to Blocked Coolant Passage in the Cylinder Head

Source: Chevrolet Dealer Service Technical Bulletin

Bulletin No: 74-T-6

Date: Dec. 5, 1973

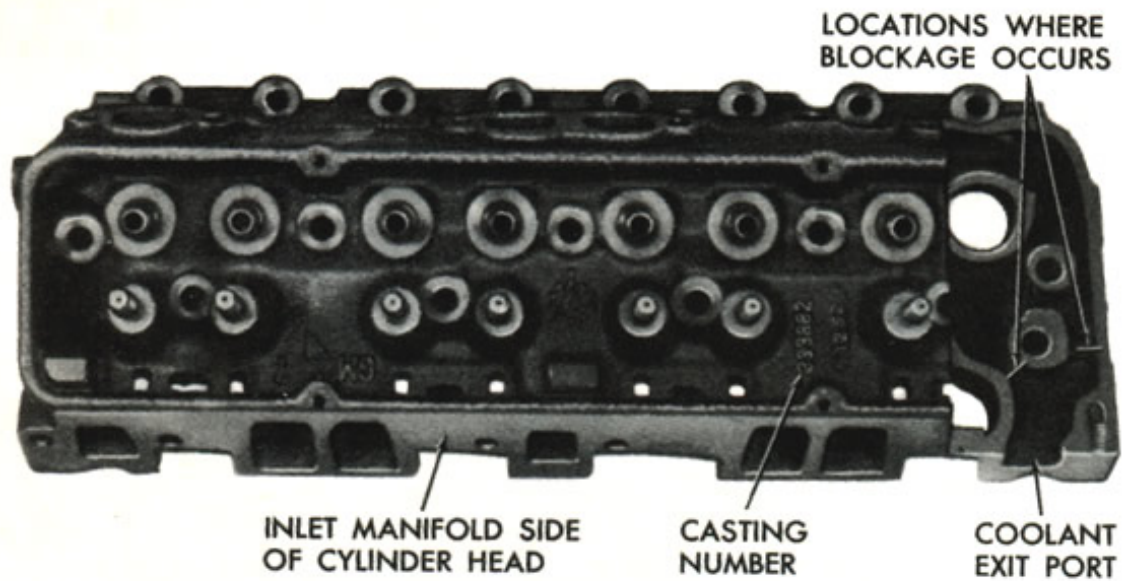
A small number of 350 and 400 cubic inch displacement V-8 engines were built before 9/24/73 (0924) with a coolant blockage in the cylinder head resulting in an overheat condition. A 1974 casting process change has resulted in a possible blockage of the coolant exit port in cylinder head casting No. 333882 (casting number appears on the top of the cylinder head beneath the rocker cover). This cylinder head is common to all 1974 small block V-8 engines, except for those used in C-K30 and 50 thru 60 series trucks.

6. If a blockage is present, it will occur at a depth of approximately five and one half (5-1/2) to six (6) inches from the edge of the thermostat port.

TOP VIEW OF A CYLINDER HEAD PARTIALLY SECTIONED TO SHOW BLOCKED COOLANT PASSAGES

7. The blocked coolant port can be repaired by removing the inlet manifold and knocking out the casting flash in the blocked water passage with a suitable tool. Take care not to damage the oil drain boss. The particles of flashing that fall into the water jacket do not have to be removed. If the blockage cannot be removed, the cylinder head should be replaced.

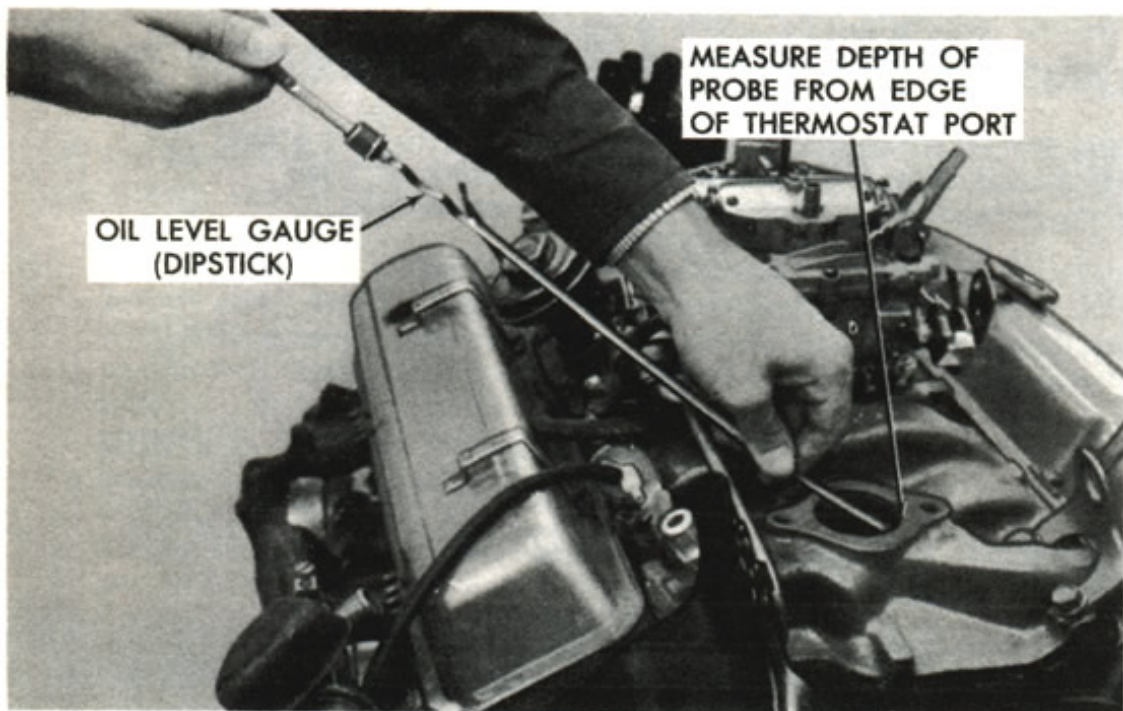
4. If at least seven (7) inches of the dipstick is inserted past the edge of the thermostat port, there is no blockage.
5. Remove the dipstick and repeat the test for the other cylinder head.

INSPECTION PROBE OF COOLANT EXIT PORT

1. Remove the thermostat housing and thermostat.
2. Insert the oil level gauge (dipstick) into the thermostat port thru the inlet manifold coolant passage and into the cylinder head (refer to the illustration on page 3).

3. Work the dipstick into the cylinder head as far as possible by carefully rotating and pushing the handle with one hand while guiding the blade with the other hand.
