1984 Corvette: Recall: Product Safety Campaign 84C25 Rear Axle Differential Cross Shaft

Subject: Product Safety Campaign 84C25 Rear Axle Differential Cross Shaft

Model and Year: 1984 Chevrolet Corvette Models

Bulletin No: 84C25

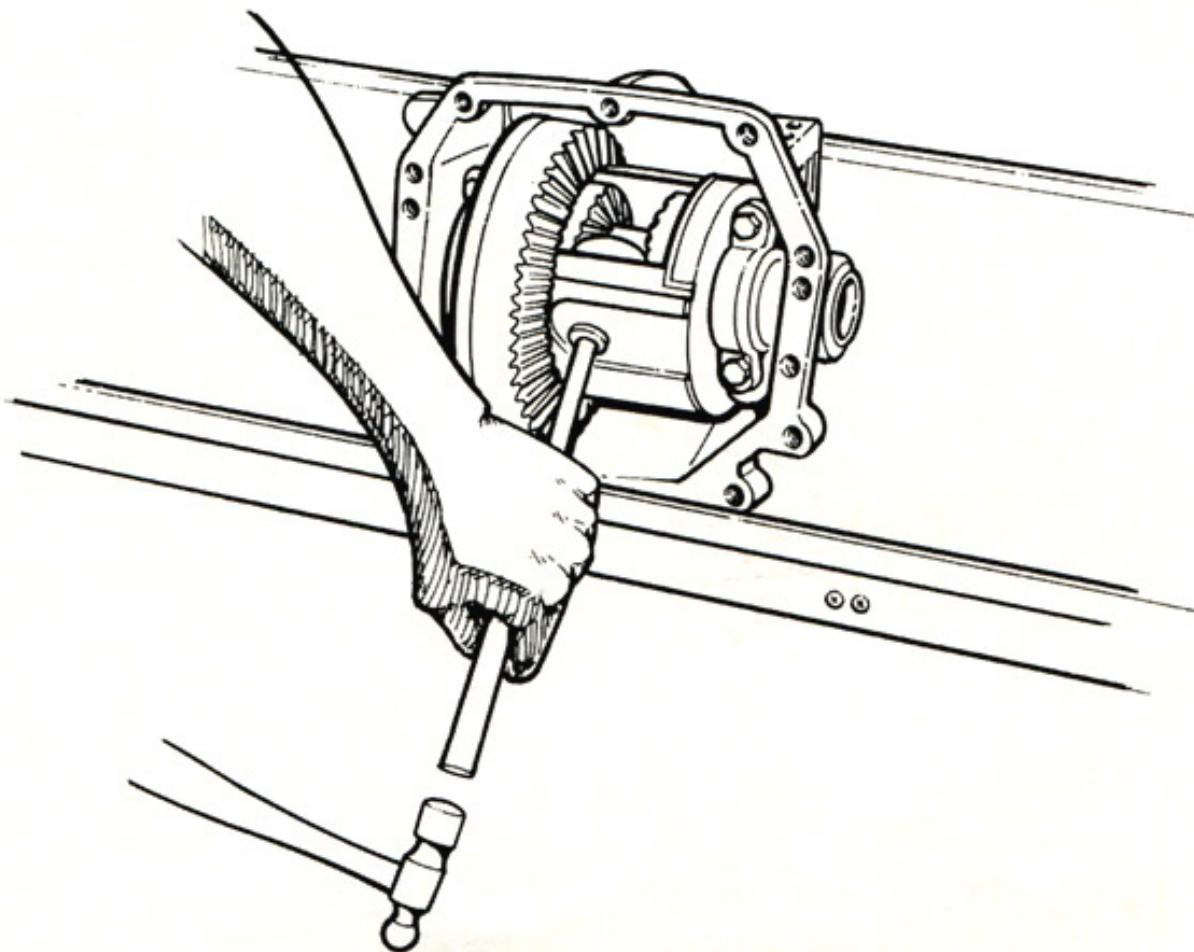
5. Rotate case assembly to position illustrated in Figure 1. With appropriate size drift and small mallet, lightly tap on cross shaft to determine if movement of shaft can be achieved.
