1967 - 1975 Corvette: Service Bulletin: Fabric Roof Cover Repairs

Subject: Fabric Roof Cover Repairs

Source: Chevrolet Dealer Service Information Bulletin

Bulletin No: 69-I-2 (Supplement)

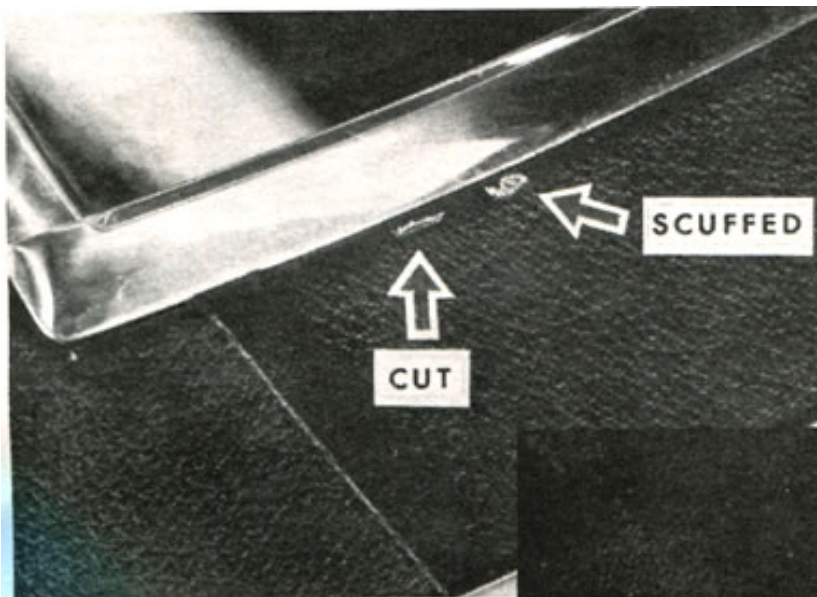
TYPICAL FABRIC
ROOF COVER DIS-
CREPANCIES
FIGURE 1

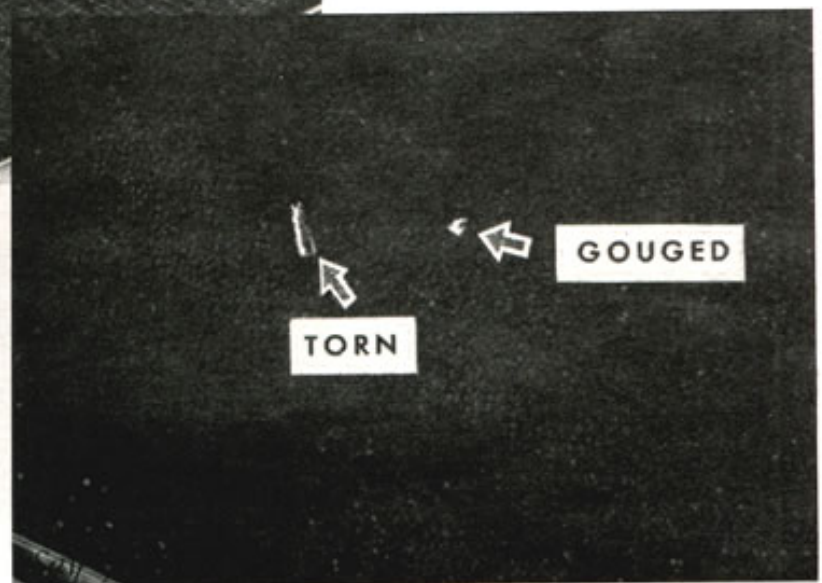
TYPICAL FABRIC ROOF
COVER DISCREPANCIES
FIGURE 2

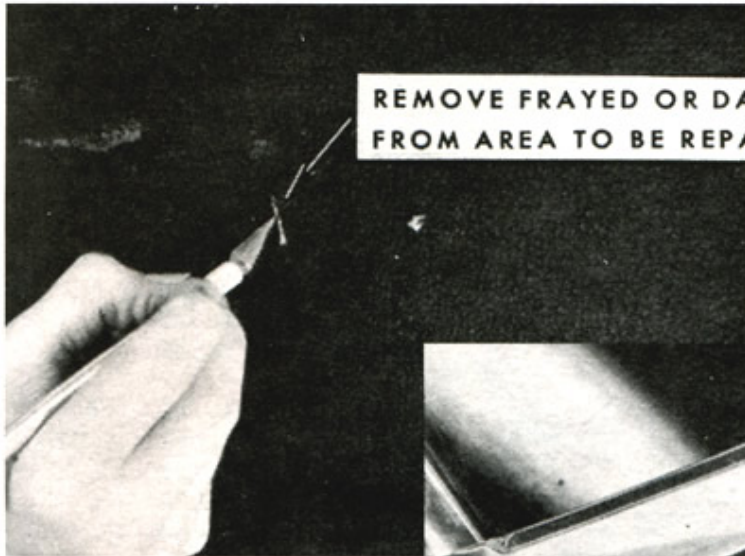
TRIMMING
FIGURE 5

REMOVE FRAYED OR DAMAGED EDGES
FROM AREA TO BE REPAIRED

- a. On extremely dirty fabric roof covers, pre-clean entire roof cover with a detergent type all purpose vinyl cleaner.
- b. Mask-off areas adjacent to repair area (body panels, moldings, glass, etc.).
- c. Using a razor sharp knife, trim the damaged area to remove all frayed or damaged edges as shown in Figure 5.

NOTE : Trimming of vinyl from the edge of the damaged area should be kept to a minimum. On cuts, scuffs and gouges with clean, unfrayed edges, no trimming is necessary.

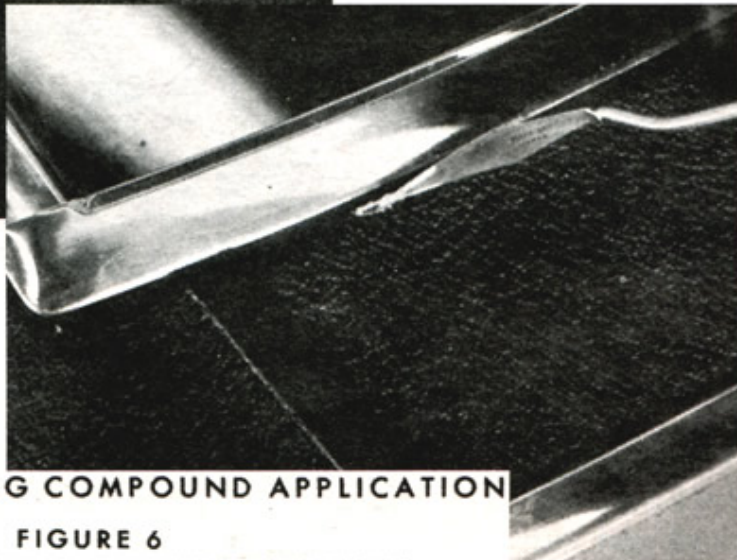
FIGURE 6

VINYL REPAIR PATCHING COMPOUND APPLICATION

- a. On damaged areas where no trimming was necessary, apply vinyl patching compound to edges of damaged area as shown in Figure 6. Remove excess compound from adjacent vinyl.
- b. On damaged areas where trimming was necessary, apply compound to area being repaired and trowel flush with adjacent surface as shown in Figure 7. Remove any excess material.

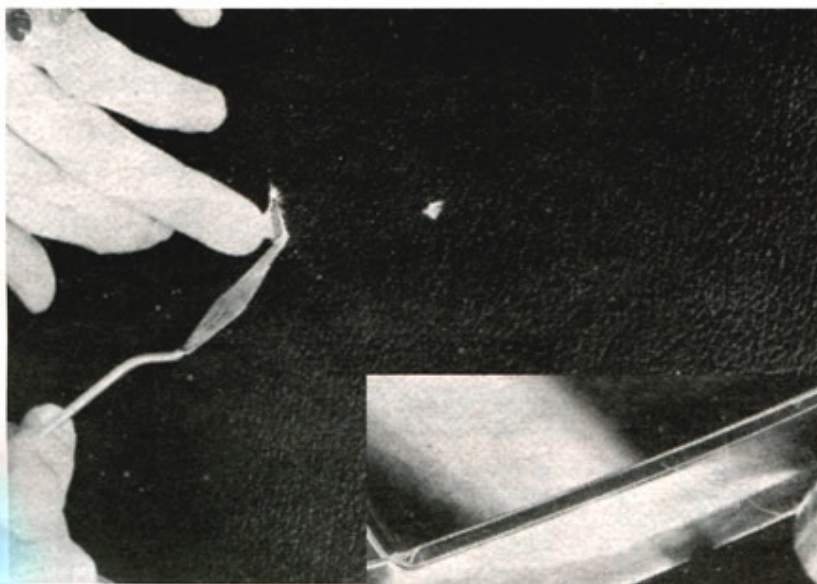
VINYL REPAIR
PATCHING COM-
POUND APPLICA-
TION
FIGURE 7

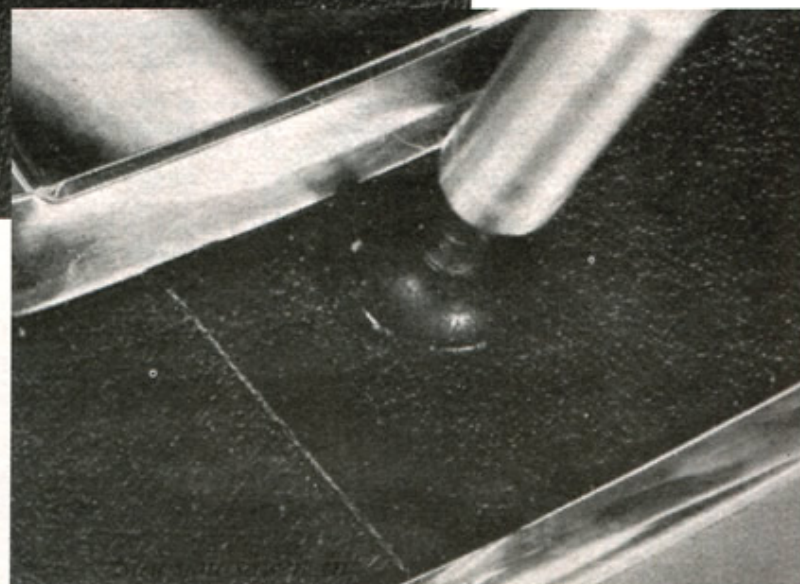
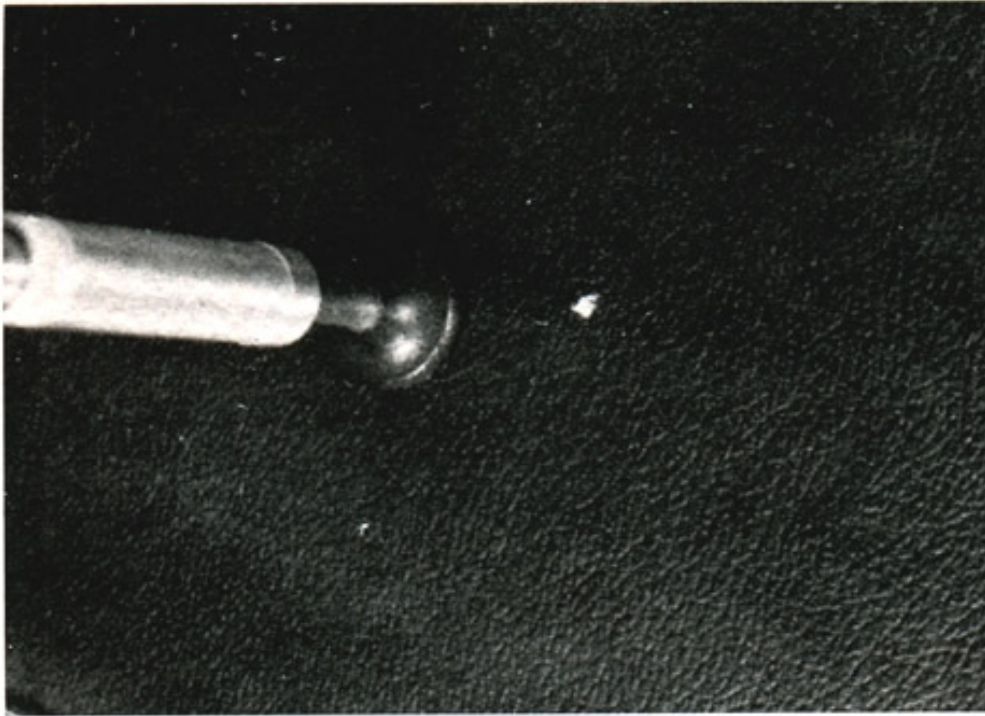
VINYL REPAIR
PATCHING COM-
POUND CURING
AND GRAINING
OPERATION
FIGURE 8

VINYL REPAIR
PATCHING
COMPOUND
CURING AND
GRAINING
OPERATION
FIGURE 9

4. Graining Operation - Exerting light hand pressure, apply pre-heated graining iron to damaged area filled with patching compound for

approximately one and one-half (1-1/2) minutes as shown in Figures 8 and 9. Curing and graining time can be increased slightly depending on the size of the repair.

IMPORTANT : During this operation, it is important the graining iron be held in a stable, perpendicular position.

NOTE: Use the surface of the tool most compatible to the damaged area contours (round edge in drip rail areas; tapered edge adjacent to reveal moldings; crown surface for relatively flat areas). For large damaged areas, repeat curing and graining, using an over-lapping technique.
