1967 - 1975 Corvette: Service Bulletin: Fabric Roof Cover Repairs

Subject: Fabric Roof Cover Repairs

Source: Chevrolet Dealer Service Information Bulletin

Bulletin No: 69-I-2 (Supplement)

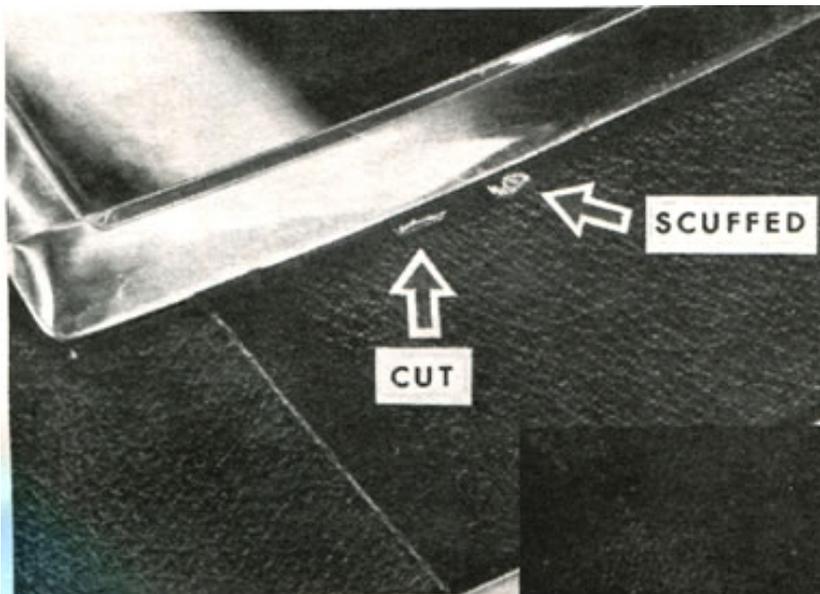
TYPICAL FABRIC
ROOF COVER DIS-
CREPANCIES
FIGURE 1

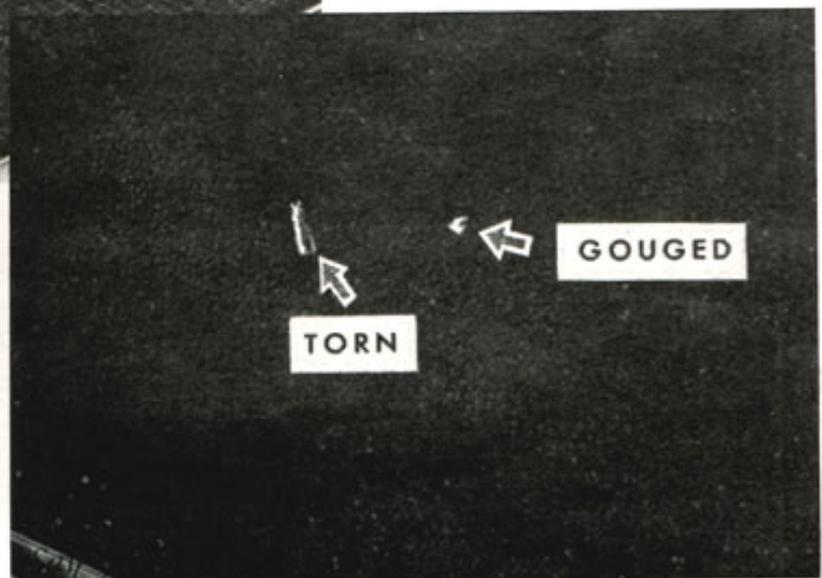
TYPICAL FABRIC ROOF
COVER DISCREPANCIES
FIGURE 2

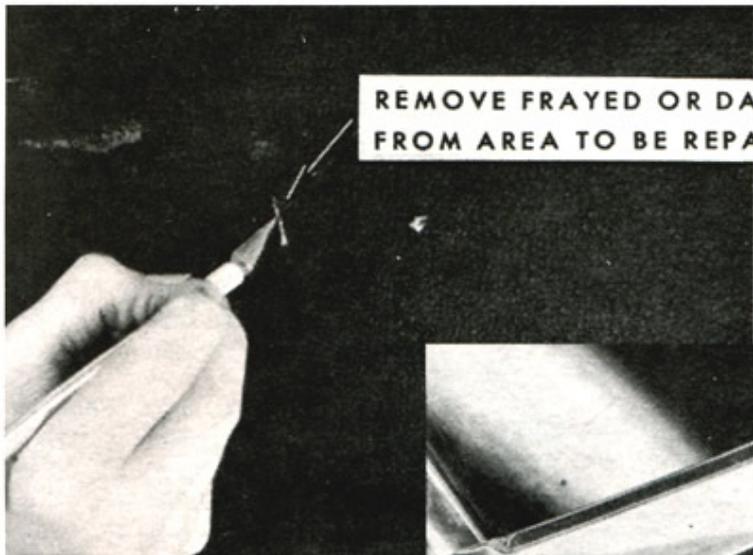
TRIMMING
FIGURE 5

REMOVE FRAYED OR DAMAGED EDGES
FROM AREA TO BE REPAIRED

- a. On extremely dirty fabric roof covers, pre-clean entire roof cover with a detergent type all purpose vinyl cleaner.
- b. Mask-off areas adjacent to repair area (body panels, moldings, glass, etc.).
- c. Using a razor sharp knife, trim the damaged area to remove all frayed or damaged edges as shown in Figure 5.

NOTE : Trimming of vinyl from the edge of the damaged area should be kept to a minimum. On cuts, scuffs and gouges with clean, unfrayed edges, no trimming is necessary.

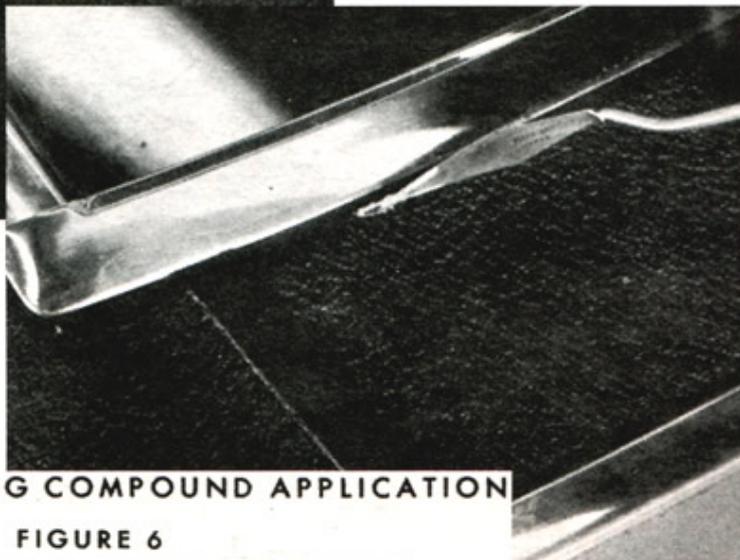
FIGURE 6

VINYL REPAIR PATCHING COMPOUND APPLICATION

- a. On damaged areas where no trimming was necessary, apply vinyl patching compound to edges of damaged area as shown in Figure 6. Remove excess compound from adjacent vinyl.
- b. On damaged areas where trimming was necessary, apply compound to area being repaired and trowel flush with adjacent surface as shown in Figure 7. Remove any excess material.

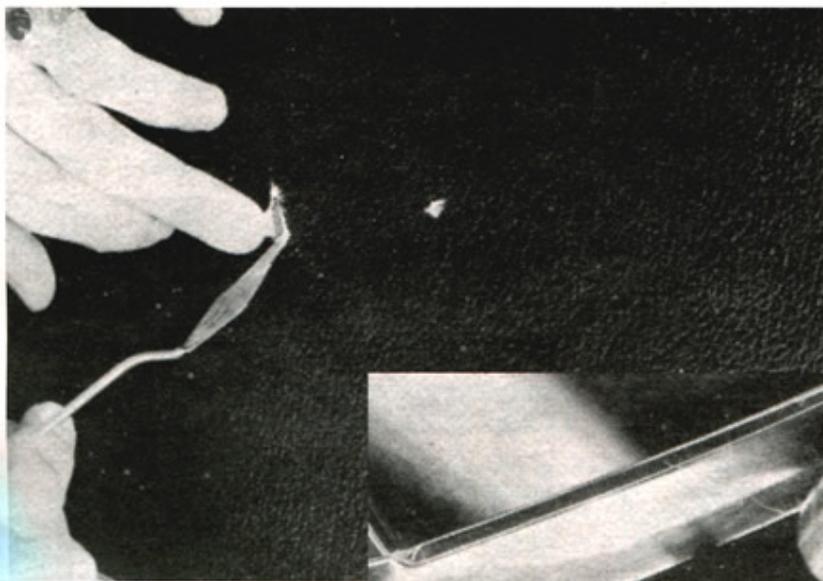
VINYL REPAIR
PATCHING COM-
POUND APPLICA-
TION
FIGURE 7

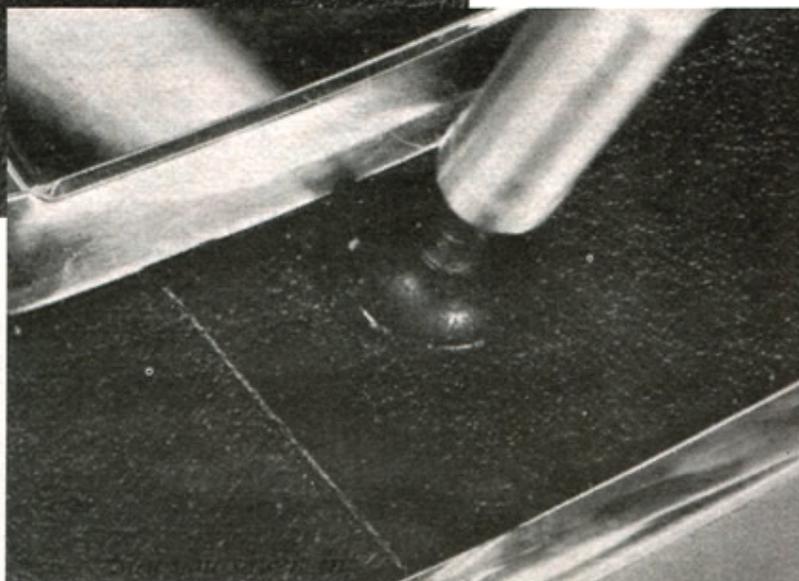
VINYL REPAIR
PATCHING COM-
POUND CURING
AND GRAINING
OPERATION
FIGURE 8

4. Graining Operation - Exerting light hand pressure, apply pre-heated graining iron to damaged area filled with patching compound for

approximately one and one-half (1-1/2) minutes as shown in Figures 8 and 9. Curing and graining time can be increased slightly depending on the size of the repair.

IMPORTANT : During this operation, it is important the graining iron be held in a stable, perpendicular position.

NOTE: Use the surface of the tool most compatible to the damaged area contours (round edge in drip rail areas; tapered edge adjacent to reveal moldings; crown surface for relatively flat areas). For large damaged areas, repeat curing and graining, using an over-lapping technique.

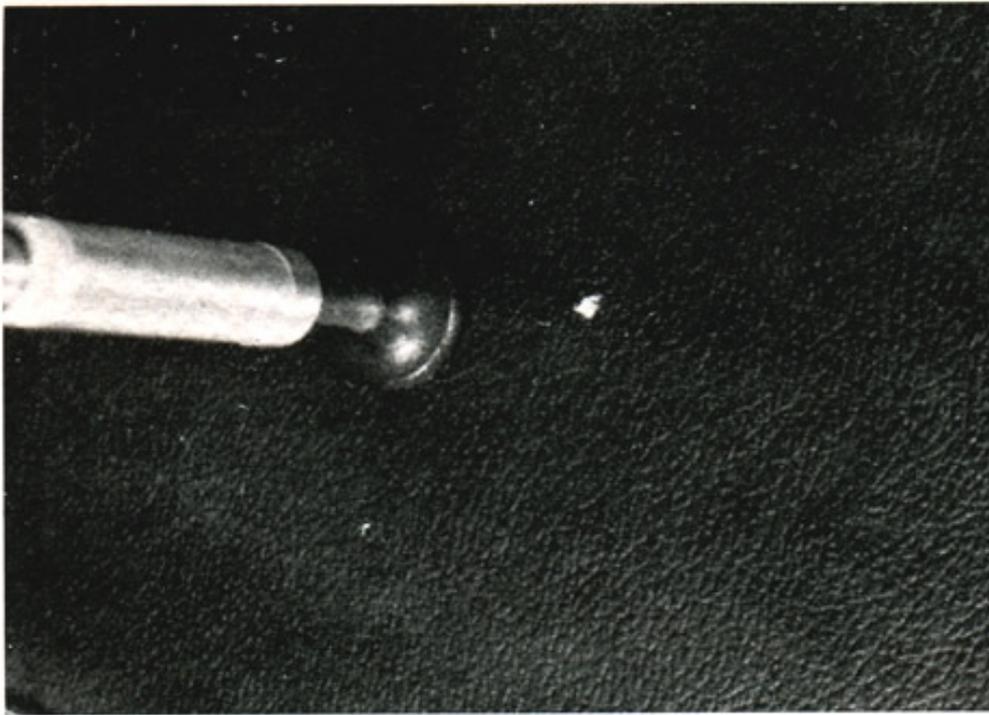
VINYL REPAIR
PATCHING
COMPOUND
CURING AND
GRAINING
OPERATION
FIGURE 9
