# 1967 - 1975 Corvette: Service Bulletin: Fabric Roof Cover Repairs

**Subject:** Fabric Roof Cover Repairs  
**Model and Year:** NA  
**Source:** Chevrolet Dealer Service Information Bulletin  
**Bulletin No:** 69-I-2 (Supplement)  
**Section:** I  
**Date:** July 18, 1969

This supplement describes an improved procedure for the repair of fabric roof covers. Certain types of damage that previously required replacing the fabric roof cover may now be repaired by using the methods and tools described in this bulletin.

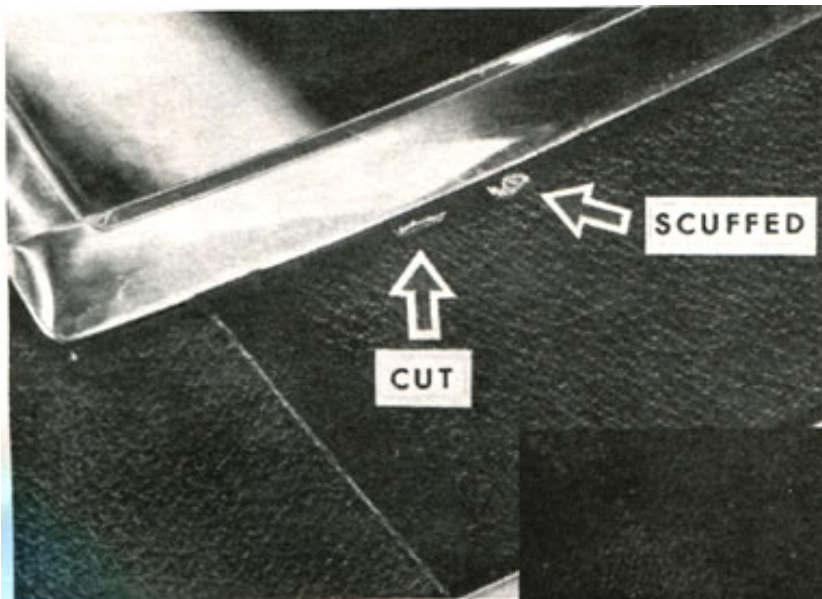
TYPICAL FABRIC  
ROOF COVER DIS-  
CREPANCIES  
FIGURE 1

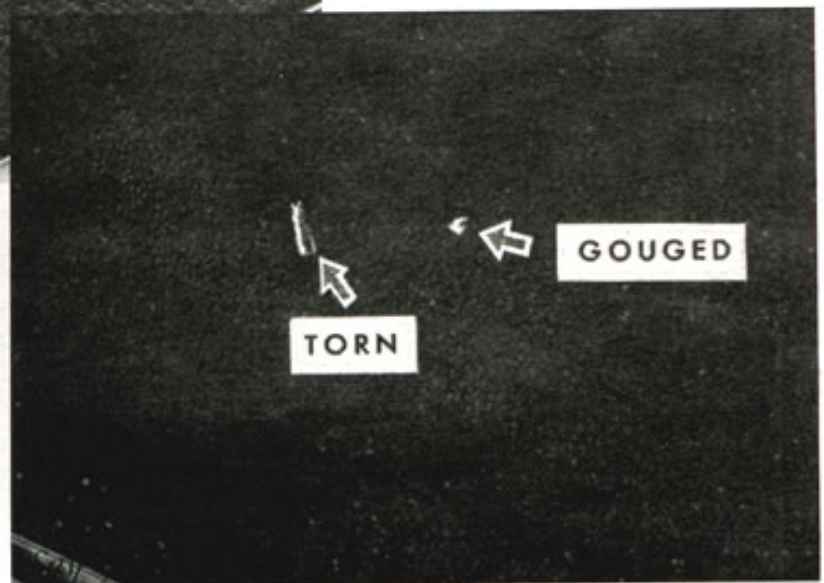
TYPICAL FABRIC ROOF  
COVER DISCREPANCIES  
FIGURE 2

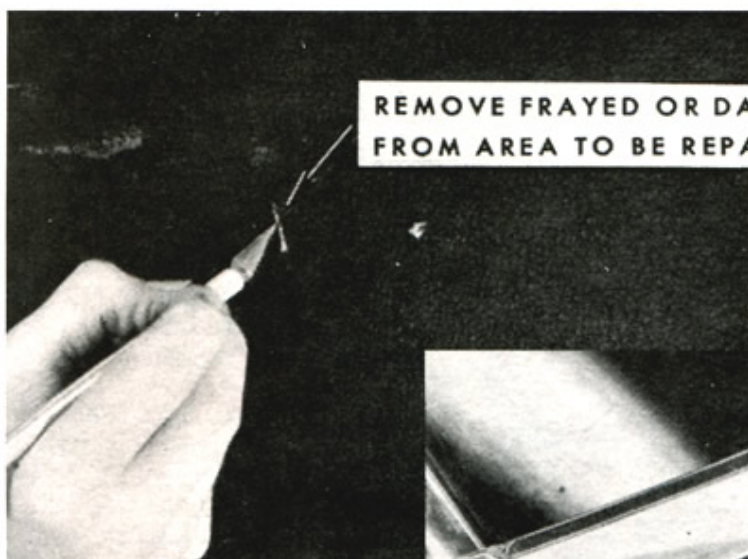
FIGURE 5

REMOVE FRAYED OR DAMAGED EDGES  
FROM AREA TO BE REPAIRED

- On extremely dirty fabric roof covers, pre-clean entire roof cover with a detergent type all purpose vinyl cleaner.
- Mask-off areas adjacent to repair area (body panels, moldings, glass, etc.).
- Using a razor sharp knife, trim the damaged area to remove all frayed or damaged edges as shown in Figure 5.

NOTE : Trimming of vinyl from the edge of the damaged area should be kept to a minimum. On cuts, scuffs and gouges with clean, unfrayed edges, no trimming is necessary.
