1967 - 1975 Corvette: Service Bulletin: Fabric Roof Cover Repairs

Subject: Fabric Roof Cover Repairs

Source: Chevrolet Dealer Service Information Bulletin

Bulletin No: 69-I-2 (Supplement)

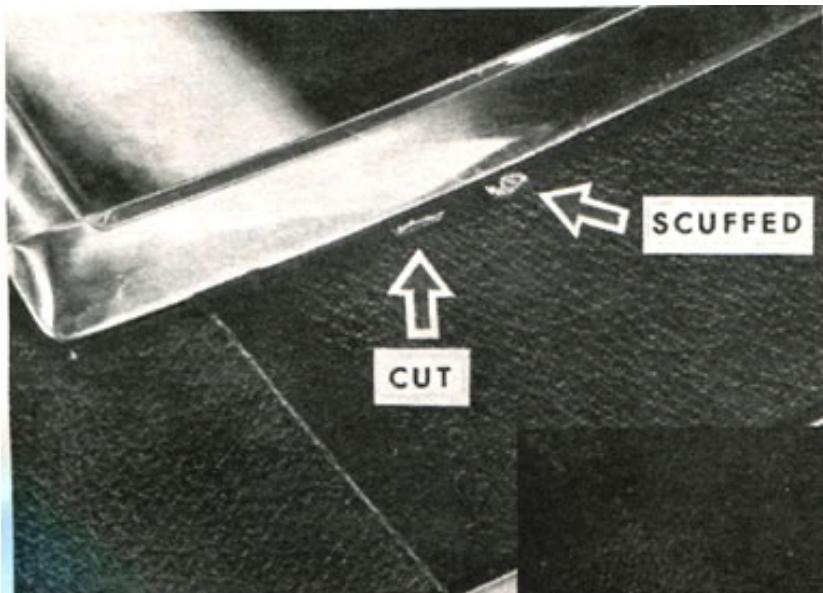
TYPICAL FABRIC
ROOF COVER DIS-
CREPANCIES
FIGURE 1

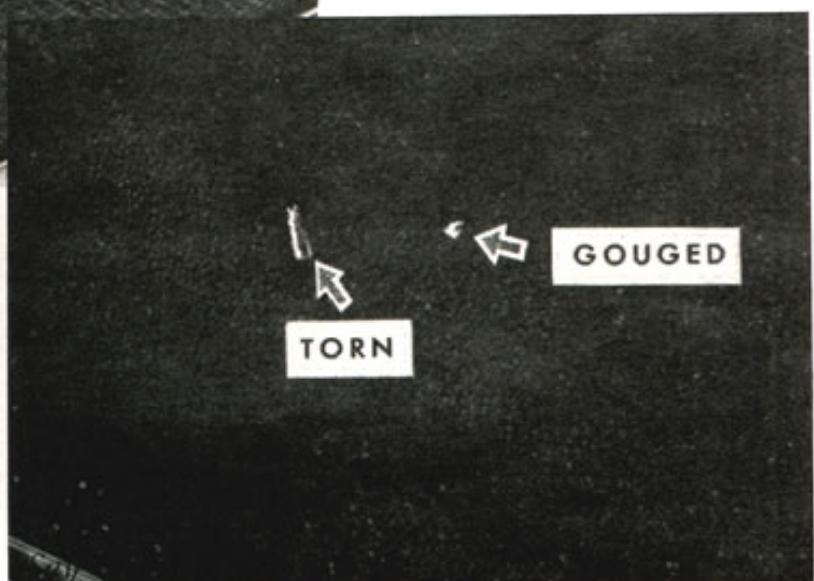
TYPICAL FABRIC ROOF
COVER DISCREPANCIES
FIGURE 2

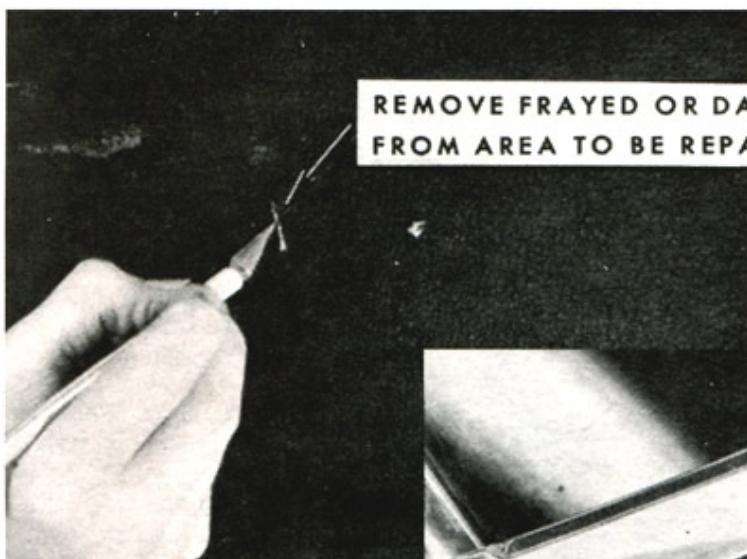
FIGURE 5

REMOVE FRAYED OR DAMAGED EDGES
FROM AREA TO BE REPAIRED

- a. On extremely dirty fabric roof covers, pre-clean entire roof cover with a detergent type all purpose vinyl cleaner.
- b. Mask-off areas adjacent to repair area (body panels, moldings, glass, etc.).
- c. Using a razor sharp knife, trim the damaged area to remove all frayed or damaged edges as shown in Figure 5.

NOTE : Trimming of vinyl from the edge of the damaged area should be kept to a minimum. On cuts, scuffs and gouges with clean, unfrayed edges, no trimming is necessary.

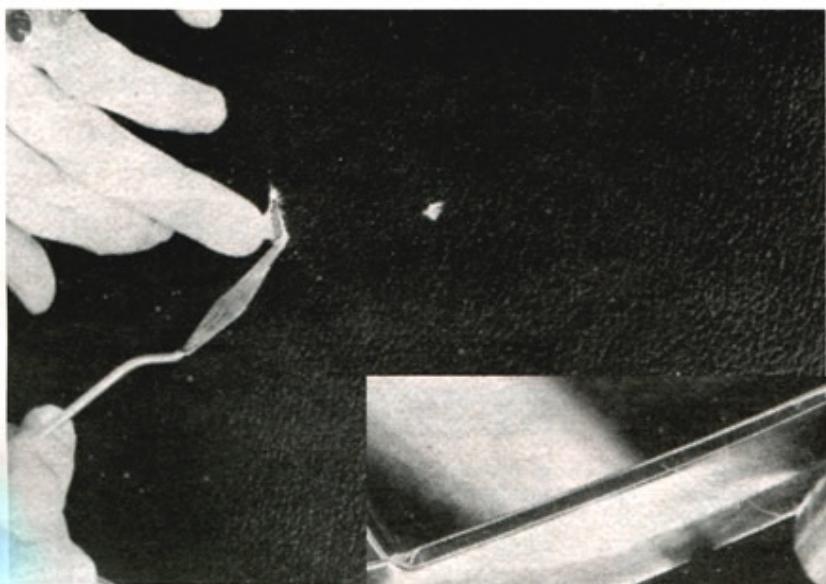
VINYL REPAIR
PATCHING COM-
POUND APPLICA-
TION
FIGURE 7

- a. On damaged areas where no trimming was necessary, apply vinyl patching compound to edges of damaged area as shown in Figure 6. Remove excess compound from adjacent vinyl.
- b. On damaged areas where trimming was necessary, apply compound to area being repaired and trowel flush with adjacent surface as shown in Figure 7. Remove any excess material.

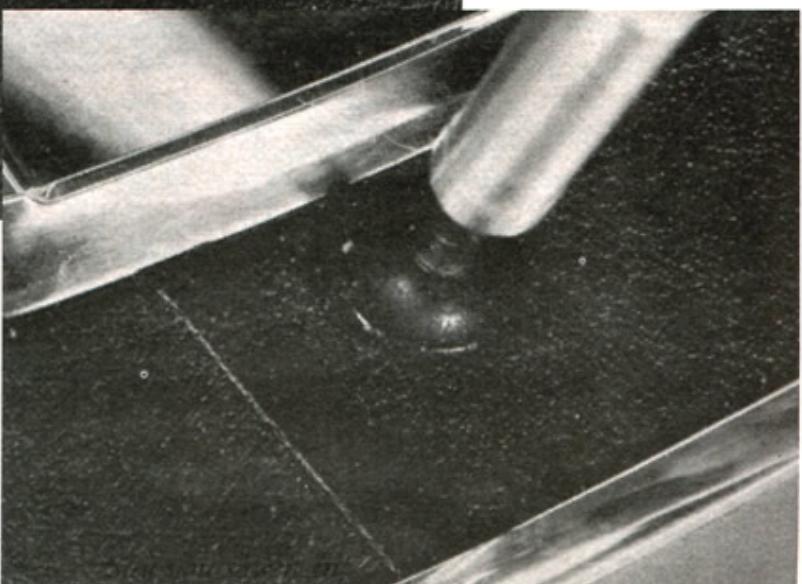
VINYL REPAIR
PATCHING COM-
POUND CURING
AND GRAINING
OPERATION
FIGURE 8

4. Graining Operation - Exerting light hand pressure, apply pre-heated graining iron to damaged area filled with patching compound for

approximately one and one-half (1-1/2) minutes as shown in Figures 8 and 9. Curing and graining time can be increased slightly depending on the size of the repair.

IMPORTANT : During this operation, it is important the graining iron be held in a stable, perpendicular position.

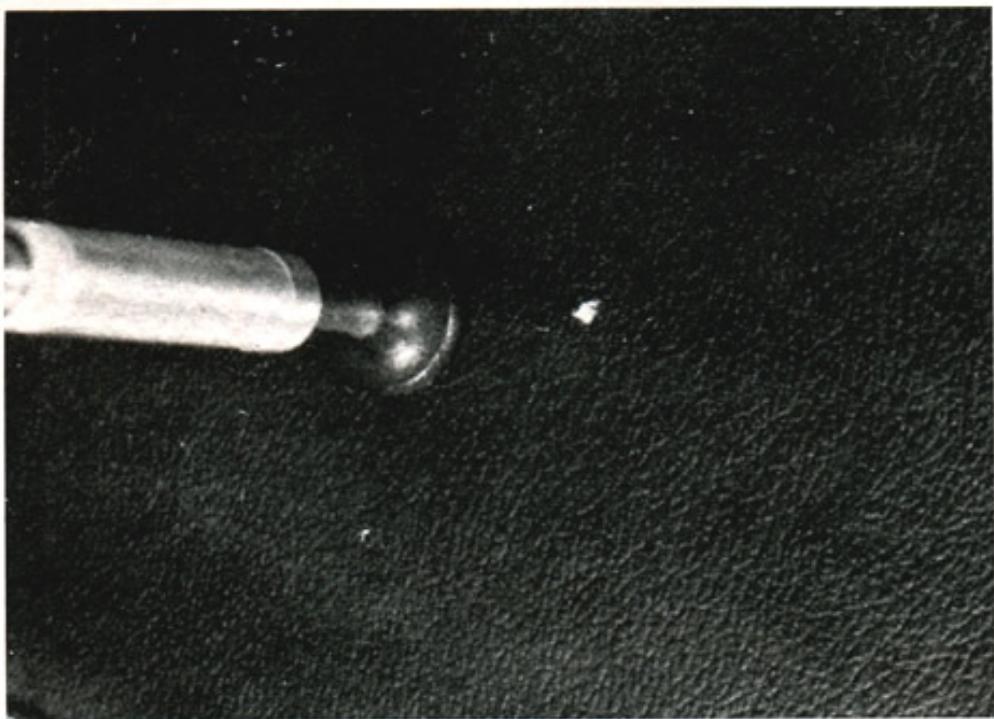
VINYL REPAIR
PATCHING
COMPOUND
CURING AND
GRAINING
OPERATION
FIGURE 9
