1968 Corvette: Service Bulletin: Refrigerant Leak

Source: Chevrolet Dealer Service Technical Bulletin

Bulletin No: 68-T-56

Date: July 12, 1968

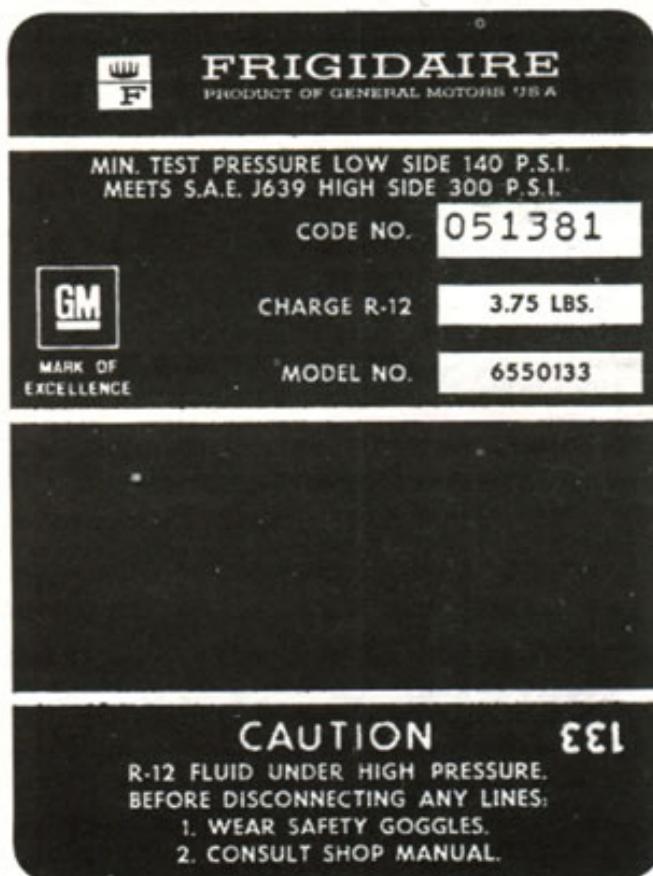
(FIGURE 1)

In production, the suspected seals were used between September 1, 1967 and March 18, 1968 and again between April 22, 1968 and April 29, 1968. Compressors built within these dates may be identified by noting the date stamped on the identification tag (See Fig. 1) located on top of the compressor.

Build date code should be within the following series of numbers:

090171 - 031881

and

042281 - 042981

4. Add a dab of white paint after the shift digit on identification tag.
