1959 - 1960 Corvette: Service Bulletin: Front and Rear Door Glass Loose in Run Channels

Source: Chevrolet Technical Service Bulletin

Bulletin No: DR #651

Date: April 7, 1960

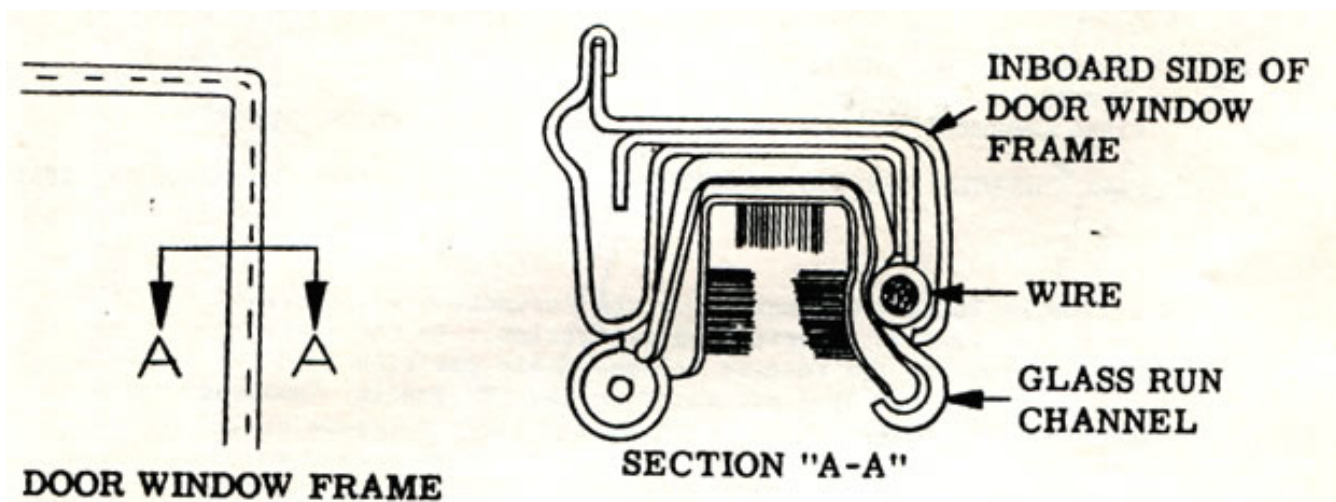
FIGURE #1

If front or rear door window glasses are excessively loose in the glass run channels, causing rattles or air leaks, the condition may be corrected as follows:

The condition of "in and out" looseness may be corrected by installing black insulated wire or similar material between the glass run channel and the inboard side of door window frame as shown in Section "A-A", figure #1. Wire should be approximately 15" long. Insert wire from belt line to top of window frame. Trim off excess wire as required.

The degree of "in and out" movement of the door window will determine the gauge of wire necessary to correct this discrepancy; however, a #14 gauge wire will normally correct the condition. On doors where the "in and out" movement of the window is very small, #20 gauge wire may be adequate.

If glass is still loose, a second piece of wire may be inserted between the channel and outboard side of window frame.

On front doors, the repair may be performed along the door lock pillar section only. However, on rear doors, the repair may be performed along either lock pillar or hinge pillar sections, or both, depending upon severity of condition.
