1959 - 1960 Corvette: Service Bulletin: Front and Rear Door Glass Loose in Run Channels

Source: Chevrolet Technical Service Bulletin

Bulletin No: DR #651

Date: April 7, 1960

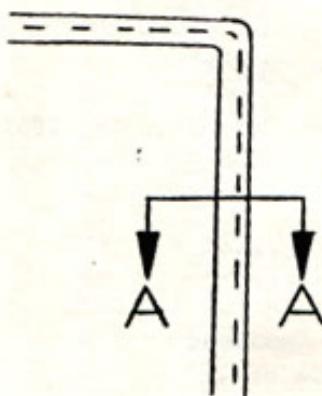
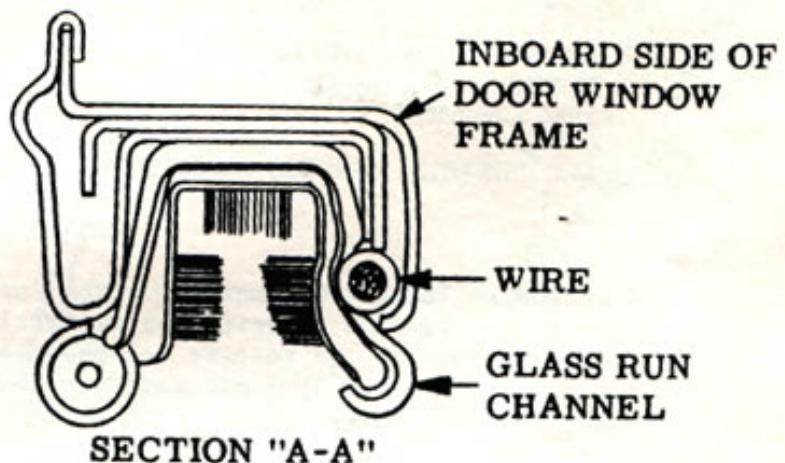
FIGURE #1

If front or rear door widow glasses are excessively loose in the glass run channels, causing rattles or air leaks, the condition may be corrected as follows:

"IN AND OUT" LOOSENESS

The condition of "in and out" looseness may be corrected by installing black insulated wire or similar material between the glass run channel and the inboard side of door window frame as shown in Section "A-A", figure #1. Wire should be approximately 15" long. Insert wire from belt line to top of window frame. Trim off excess wire as required.

The degree of "in and out" movement of the door window will determine the gauge of wire necessary to correct this discrepancy; however, a #14 gauge wire will normally correct the condition. On doors where the "in and out" movement of the window is very small, #20 gauge wire may be adequate.

If glass is still loose, a second piece of wire may be inserted between the channel and outboard side of window frame.

On front doors, the repair may be performed along the door lock pillar section only. However, on rear doors, the repair may be performed along either lock pillar or hinge pillar sections, or both, depending upon severity of condition.
