1959 - 1960 Corvette: Service Bulletin: Front and Rear Door Glass Loose in Run Channels

Source: Chevrolet Technical Service Bulletin

Bulletin No: DR #651

Date: April 7, 1960

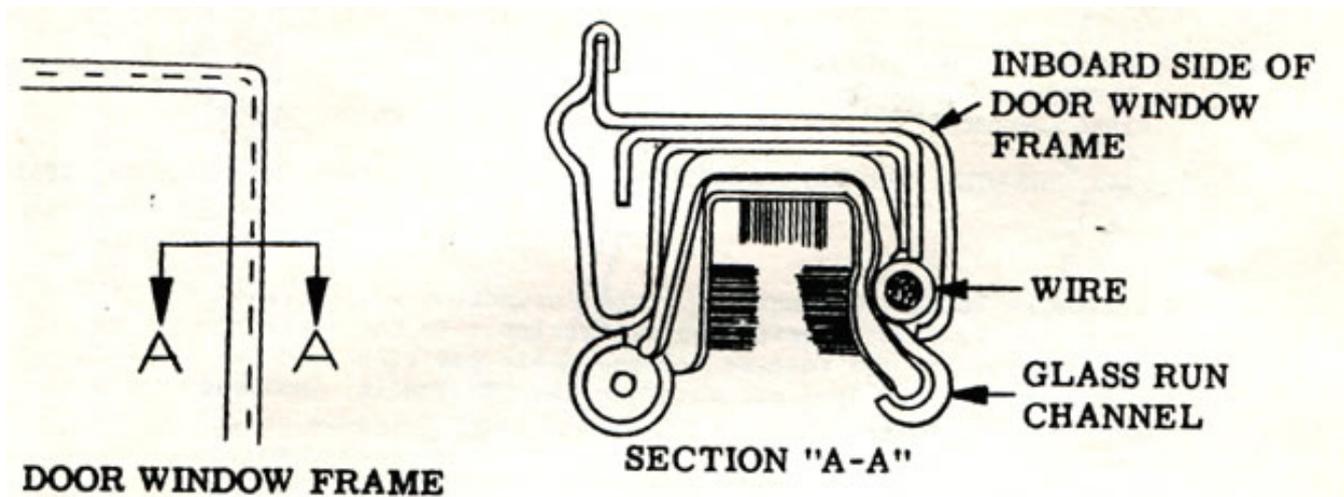
FIGURE #1

If front or rear door window glasses are excessively loose in the glass run channels, causing rattles or air leaks, the condition may be corrected as follows:

"IN AND OUT" LOOSENESS

The condition of "in and out" looseness may be corrected by installing black insulated wire or similar material between the glass run channel and the inboard side of door window frame as shown in Section "A-A", figure #1. Wire should be approximately 15" long. Insert wire from belt line to top of window frame. Trim off excess wire as required.

The degree of "in and out" movement of the door window will determine the gauge of wire necessary to correct this discrepancy; however, a #14 gauge wire will normally correct the condition. On doors where the "in and out" movement of the window is very small, #20 gauge wire may be adequate.

If glass is still loose, a second piece of wire may be inserted between the channel and outboard side of window frame.

On front doors, the repair may be performed along the door lock pillar section only. However, on rear doors, the repair may be performed along either lock pillar or hinge pillar sections, or both, depending upon severity of condition.

After repair has been performed, operate window assembly several times to insure proper operation.
