2014 Corvette: GM TechLink: Techline Infotainment DVD Software Update

Subject: Techline Infotainment DVD Software Update

Date: February 5, 2015

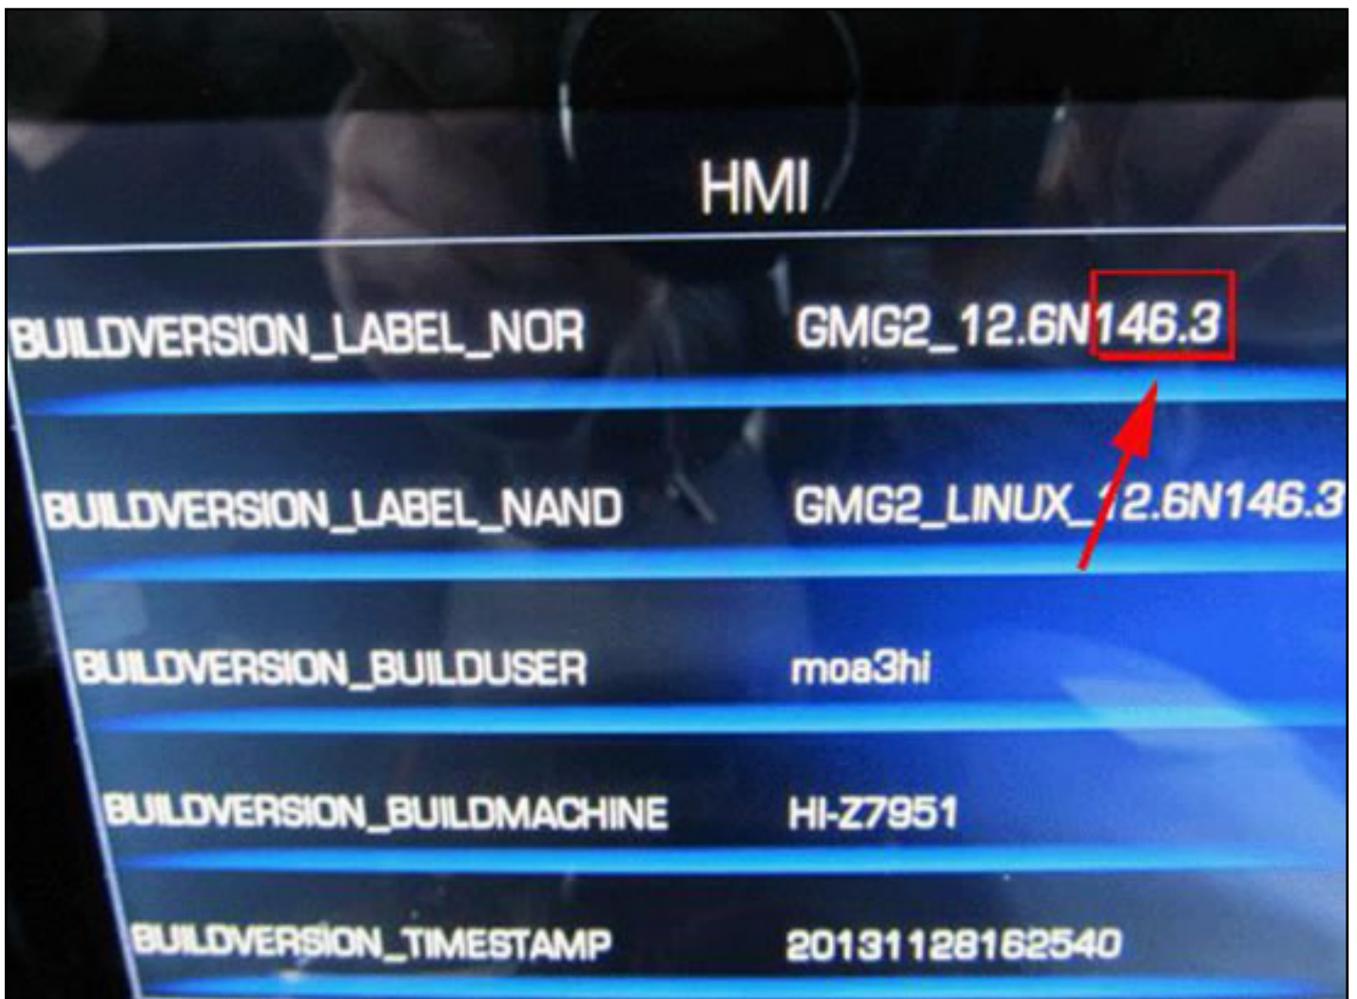
Fig. 9

Before updating the infotainment system software, check the Human Machine Interface (HMI) build version. The HMI build version label should be GMG2.12.6N146.4 or lower. (Fig. 9)

If the software version is higher than GMG2.12.6N146.4, damage to the HMI module may occur. Do not update the infotainment system software if the software version is higher than GMG2.12.6N146.4.

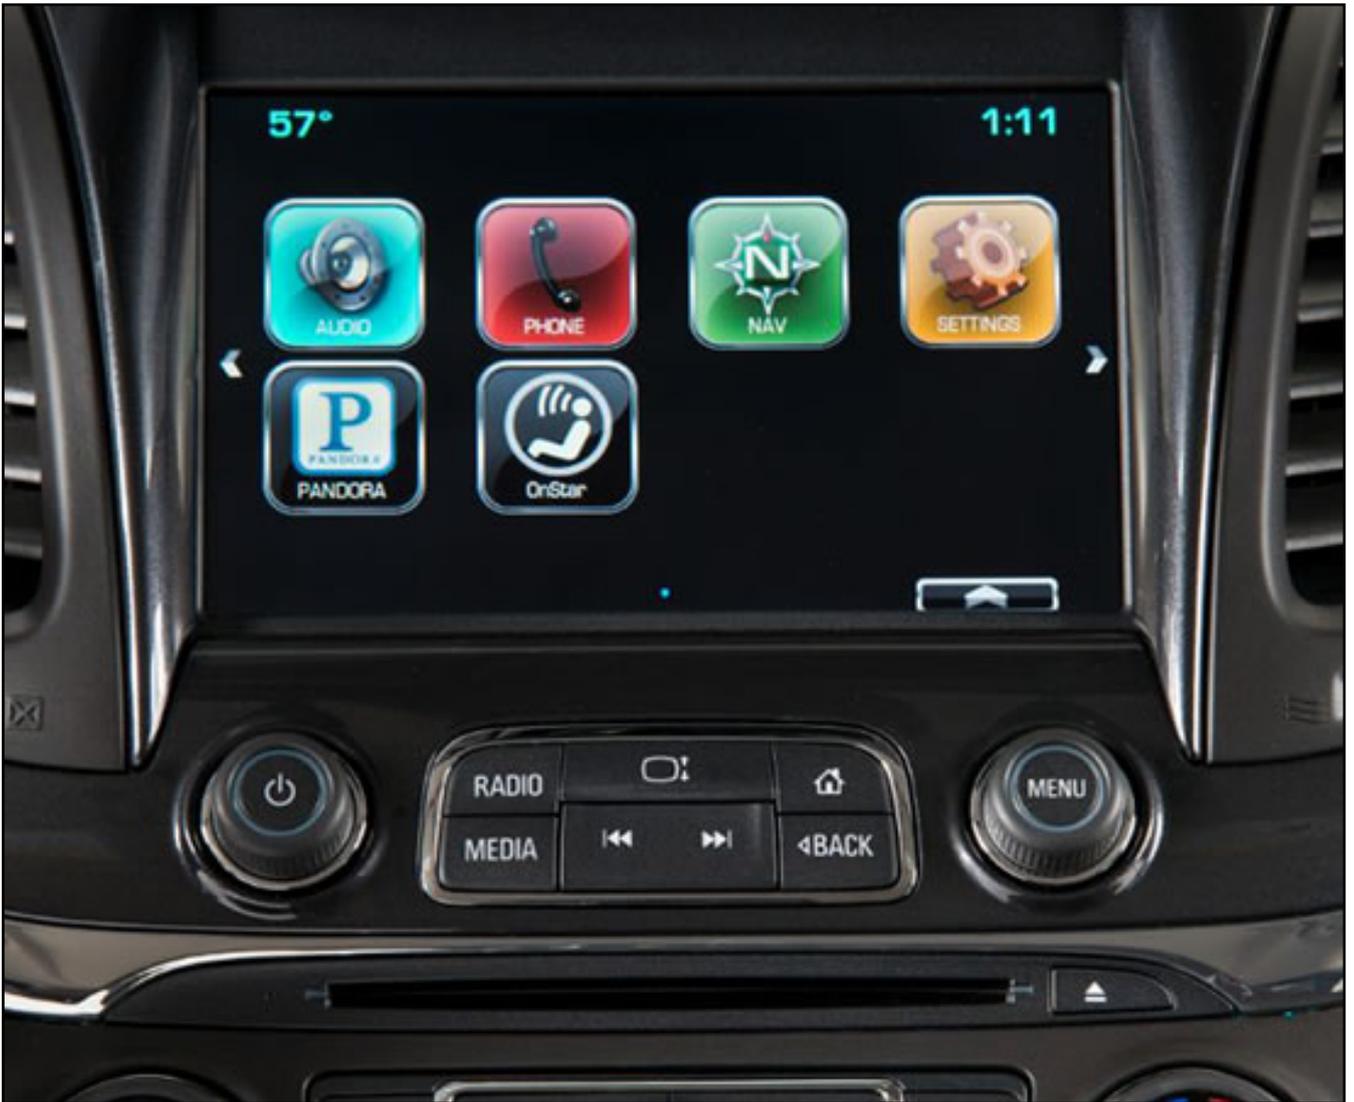
Fig. 10

To verify the HMI build version on Buick, Chevrolet and GMC models, press the Power, Menu and Home buttons at the same time on the infotainment system, and then select HMI from the onboard development screen. (Fig. 10)

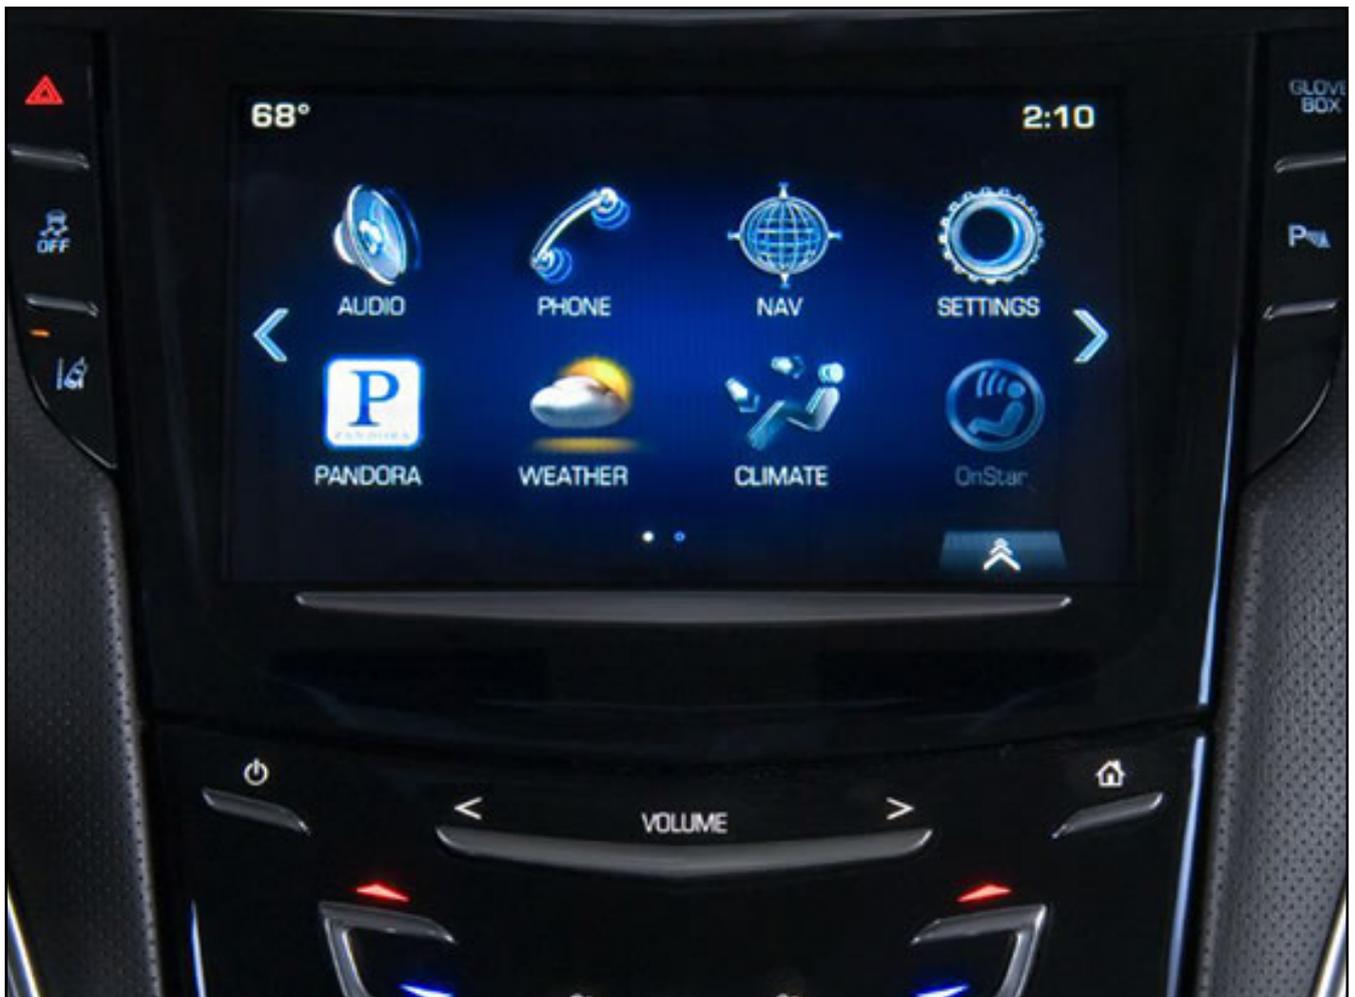
Fig. 11

For Cadillac models, press the Home and Volume Down buttons at the same time, and then select HMI from the onboard development screen. (Fig. 11)
