# 2014 Corvette: GM TechLink: Techline Infotainment DVD Software Update

**Subject:** Techline Infotainment DVD Software Update

**Date:** February 5, 2015

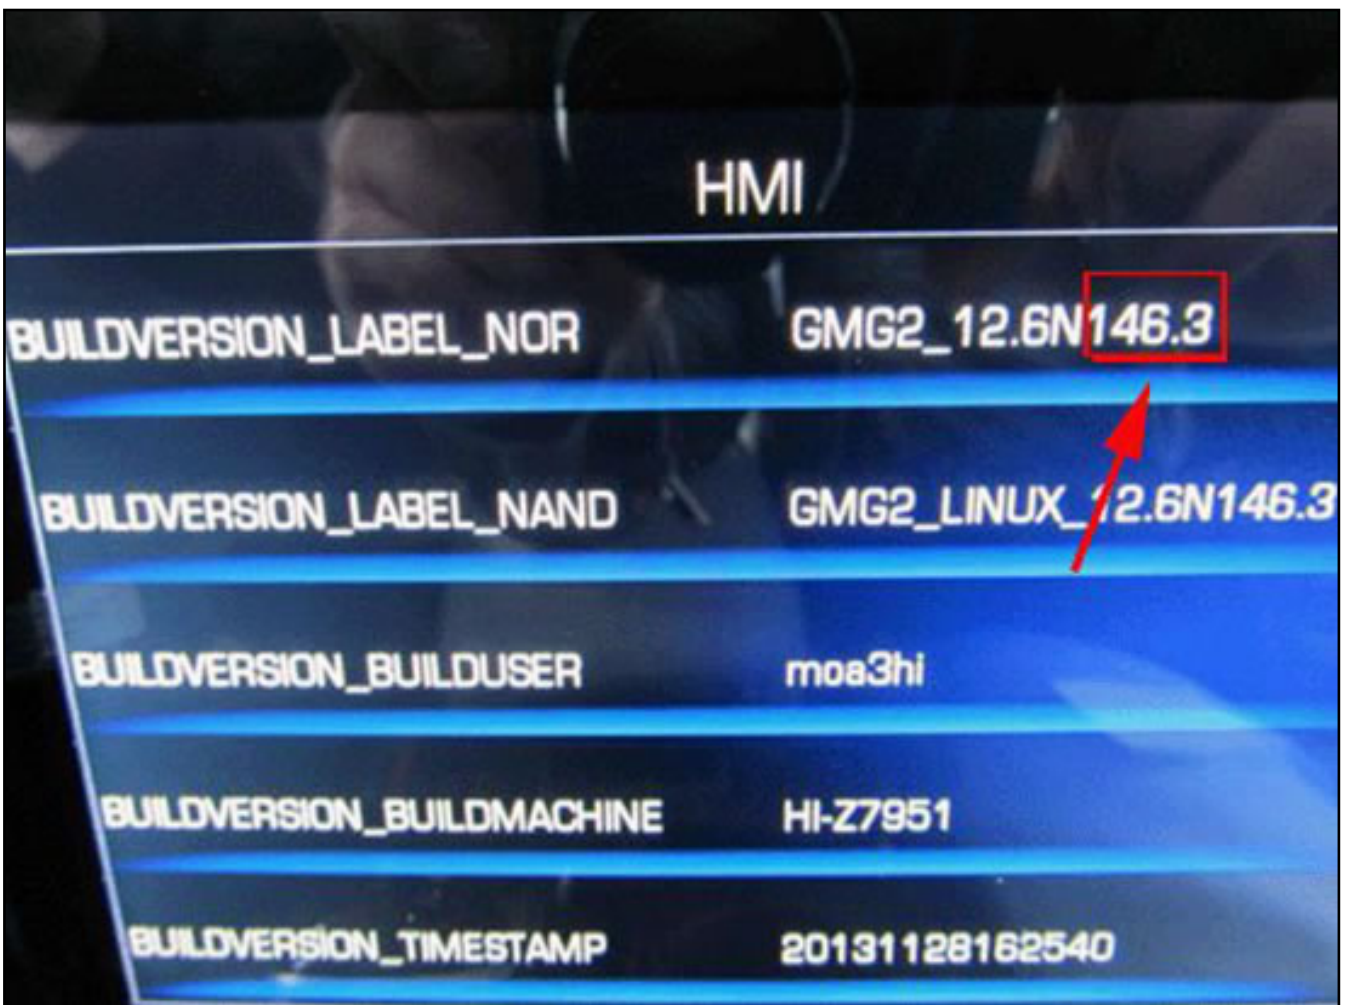
**Fig. 9**

Before updating the infotainment system software, check the Human Machine Interface (HMI) build version. The HMI build version label should be GMG2.12.6N146.4 or lower. (Fig. 9)

If the software version is higher than GMG2.12.6N146.4, damage to the HMI module may occur. Do not update the infotainment system software if the software version is higher than GMG2.12.6N146.4.

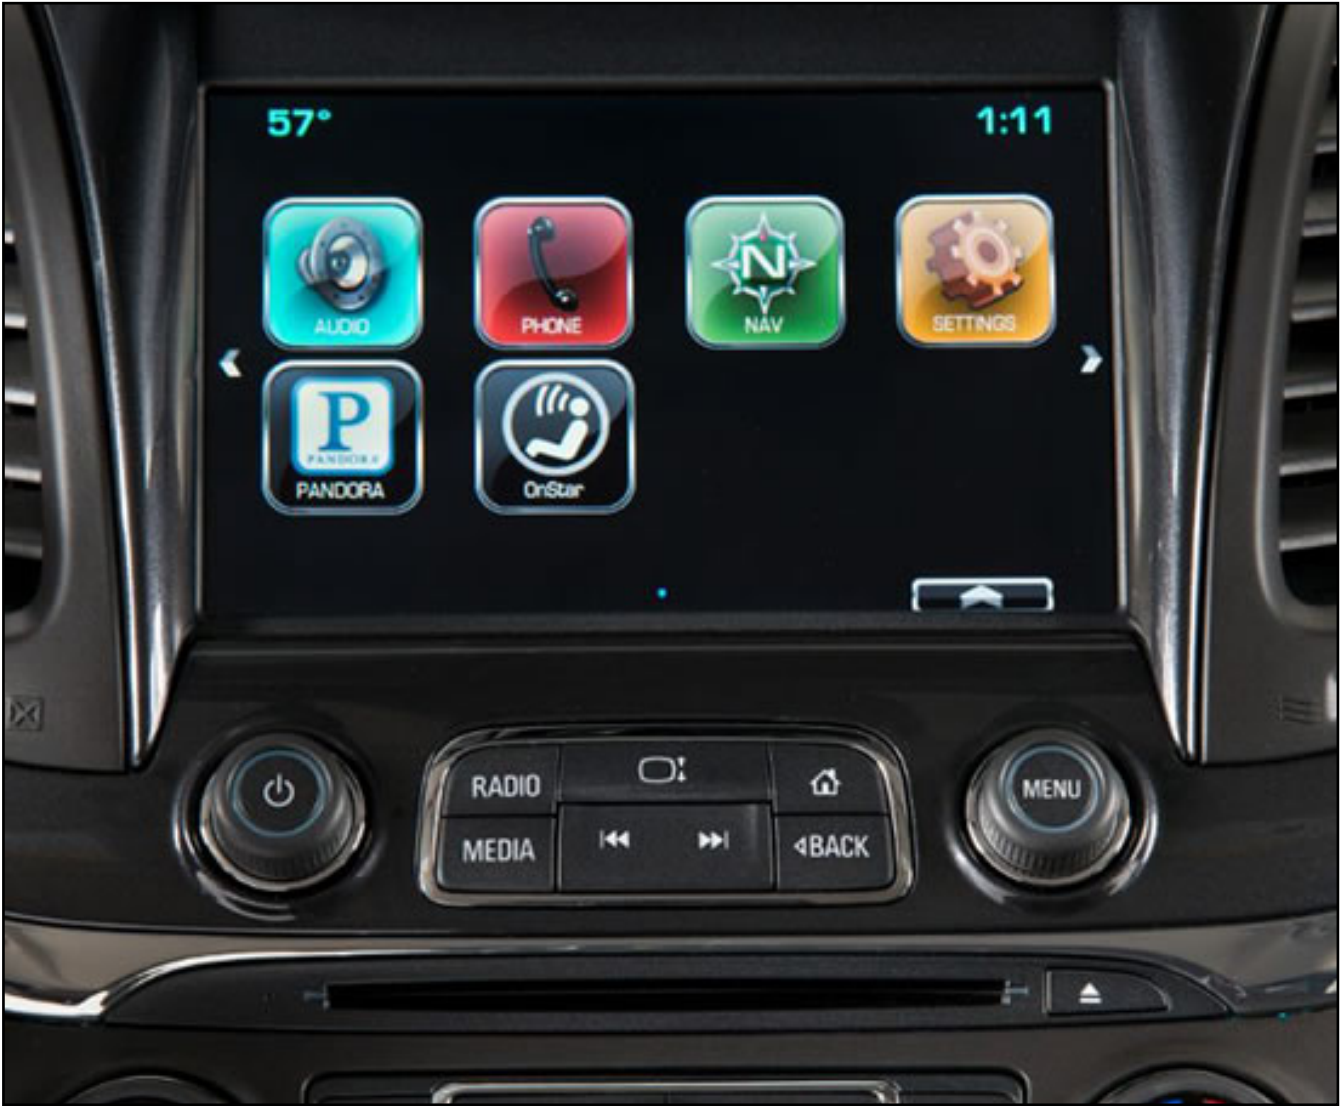
**Fig. 10**

To verify the HMI build version on Buick, Chevrolet and GMC models, press the Power, Menu and Home buttons at the same time on the infotainment system, and then select HMI from the onboard development screen. (Fig. 10)

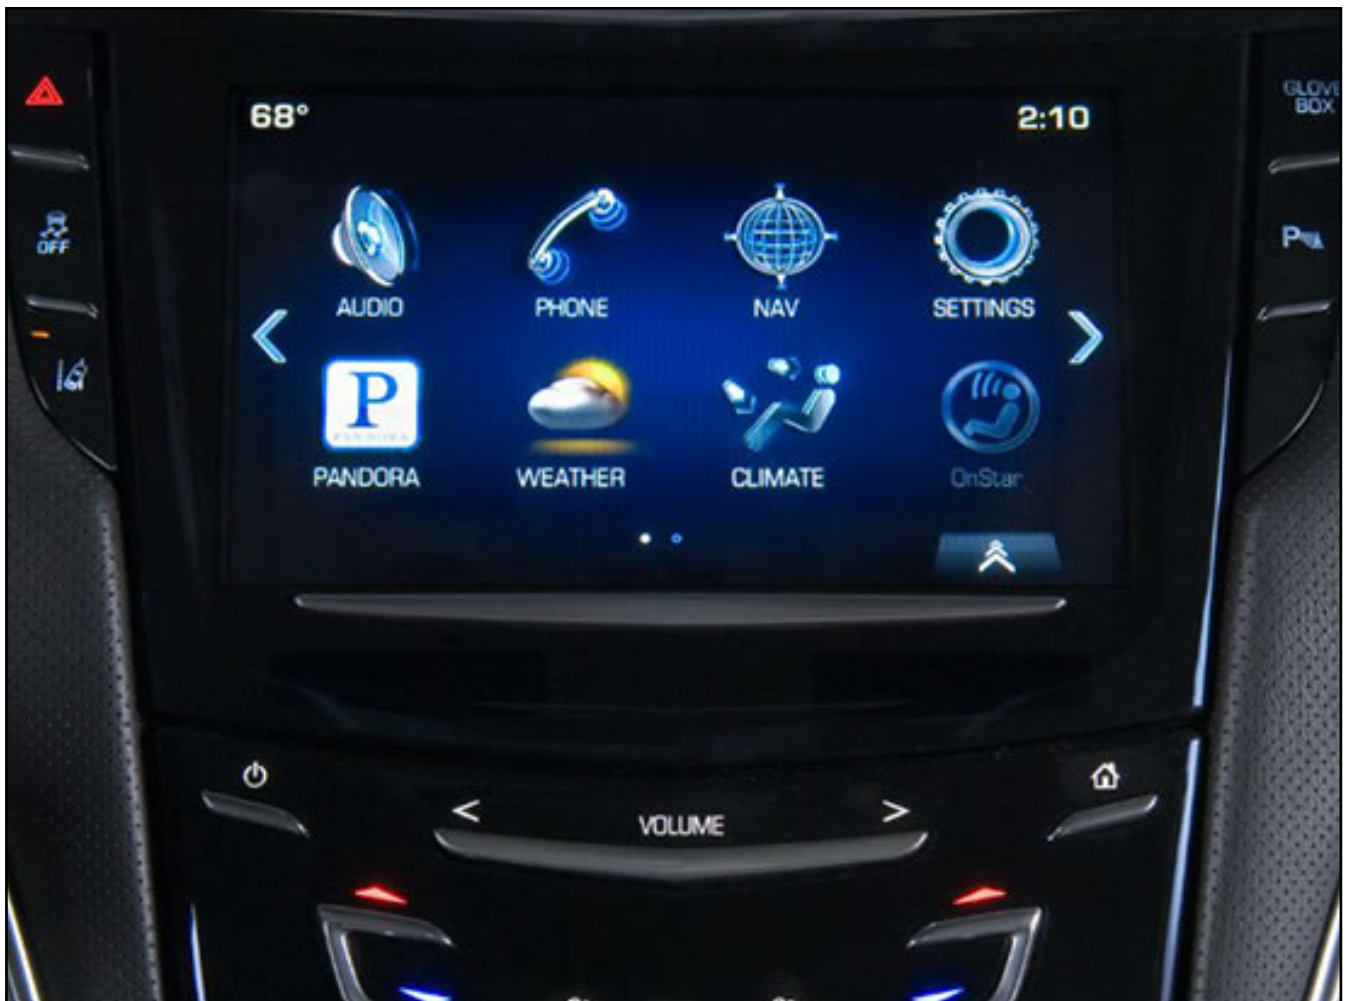
**Fig. 11**

For Cadillac models, press the Home and Volume Down buttons at the same time, and then select HMI from the onboard development screen. (Fig. 11)
