2014 Corvette: GM TechLink: Techline Infotainment DVD Software Update

Subject: Techline Infotainment DVD Software Update

Source: GM TechLink

Date: February 5, 2015

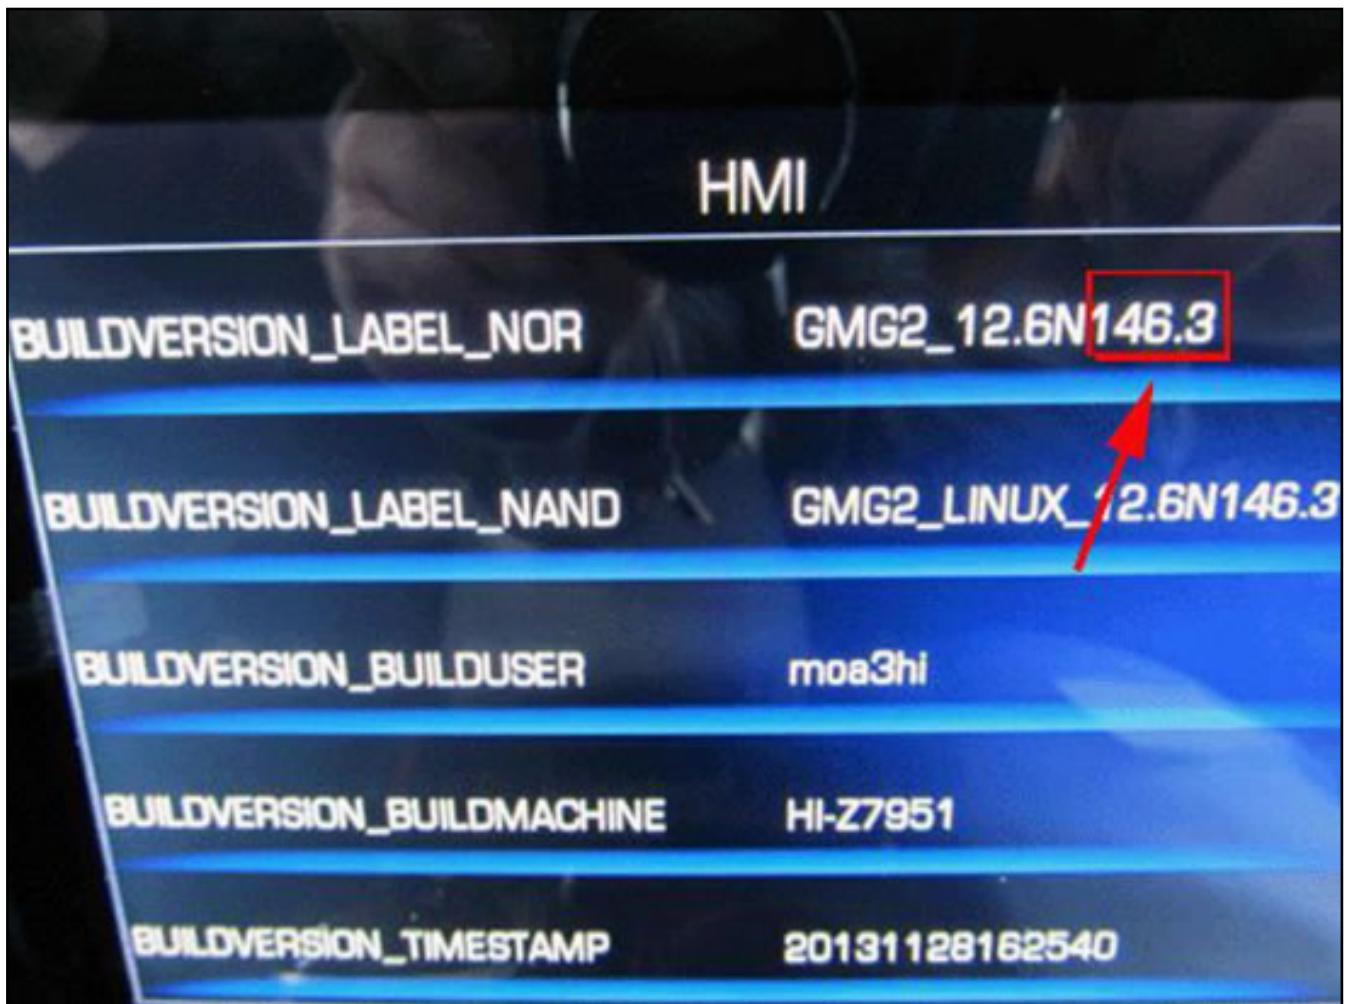
Fig. 9

Before updating the infotainment system software, check the Human Machine Interface (HMI) build version. The HMI build version label should be GMG2.12.6N146.4 or lower. (Fig. 9)

If the software version is higher than GMG2.12.6N146.4, damage to the HMI module may occur. Do not update the infotainment system software if the software version is higher than GMG2.12.6N146.4.

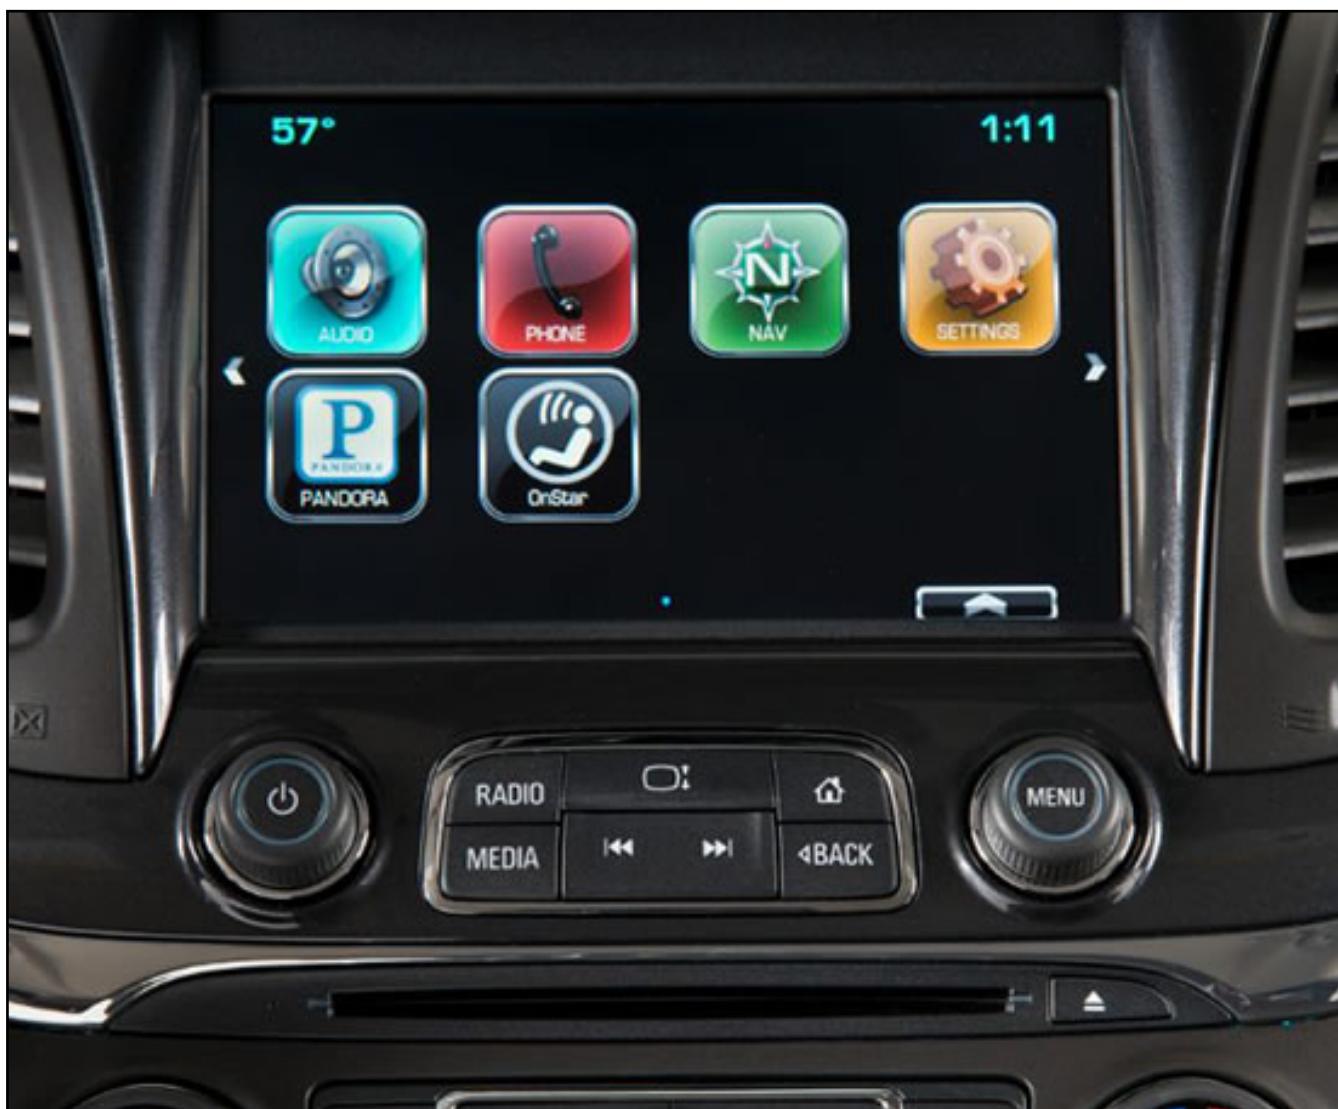
Fig. 10

To verify the HMI build version on Buick, Chevrolet and GMC models, press the Power, Menu and Home buttons at the same time on the infotainment system, and then select HMI from the onboard development screen. (Fig. 10)

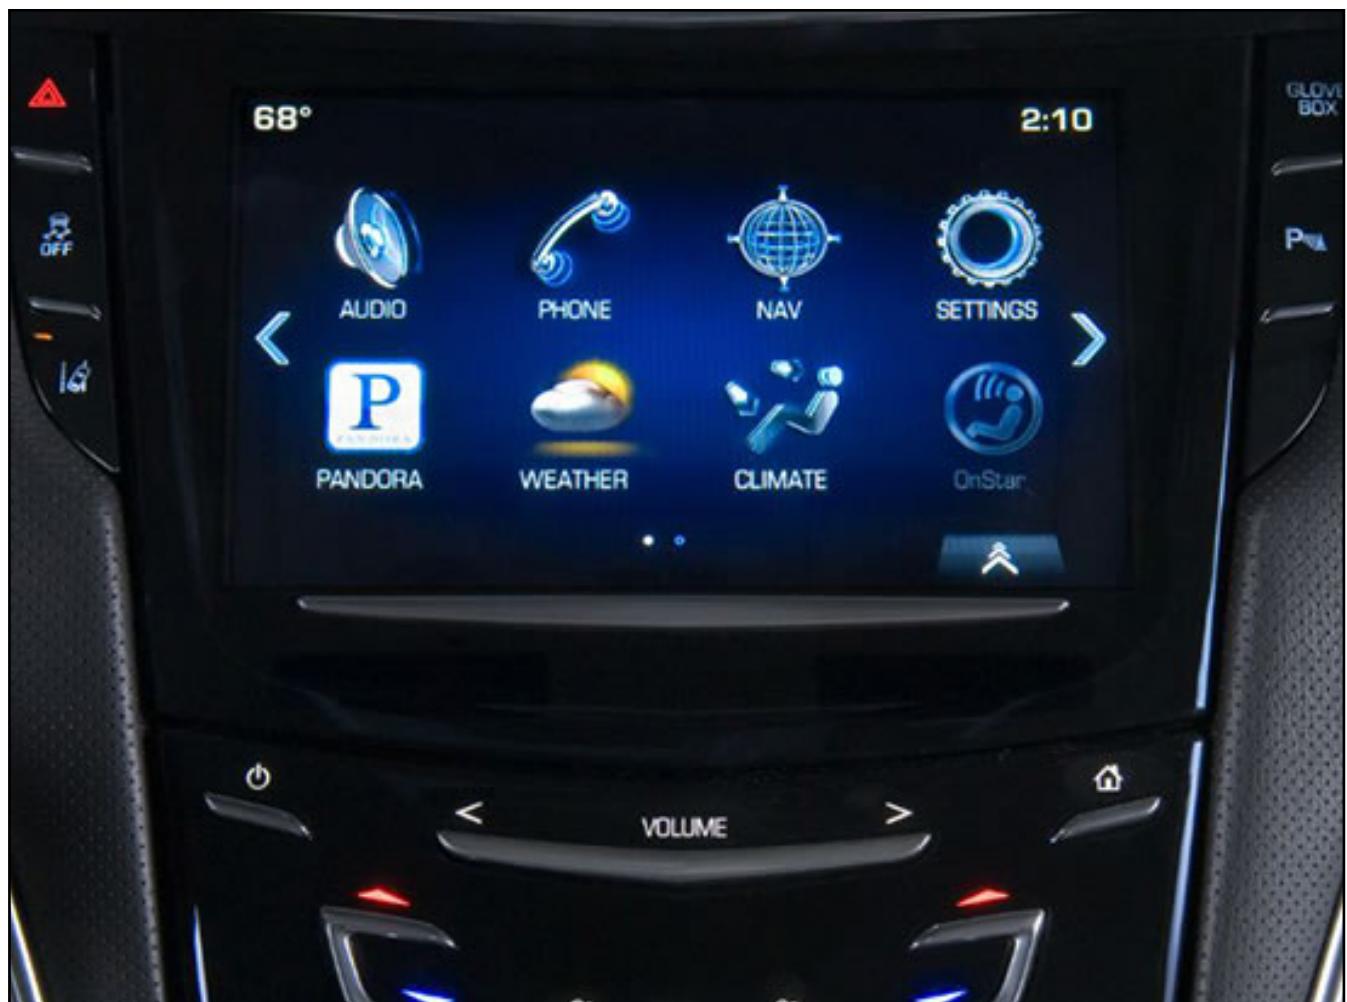
Fig. 11

For Cadillac models, press the Home and Volume Down buttons at the same time, and then select HMI from the onboard development screen. (Fig. 11)
