1988 - 1989 Corvette: Recall Notice: Rear Wheel Tie Rod

Bulletin No: 89C17

Subject: PRODUCT SAFETY CAMPAIGN 89C17
REAR WHEEL TIE ROD

Model and Year: 1988-89 CHEVROLET CORVETTE

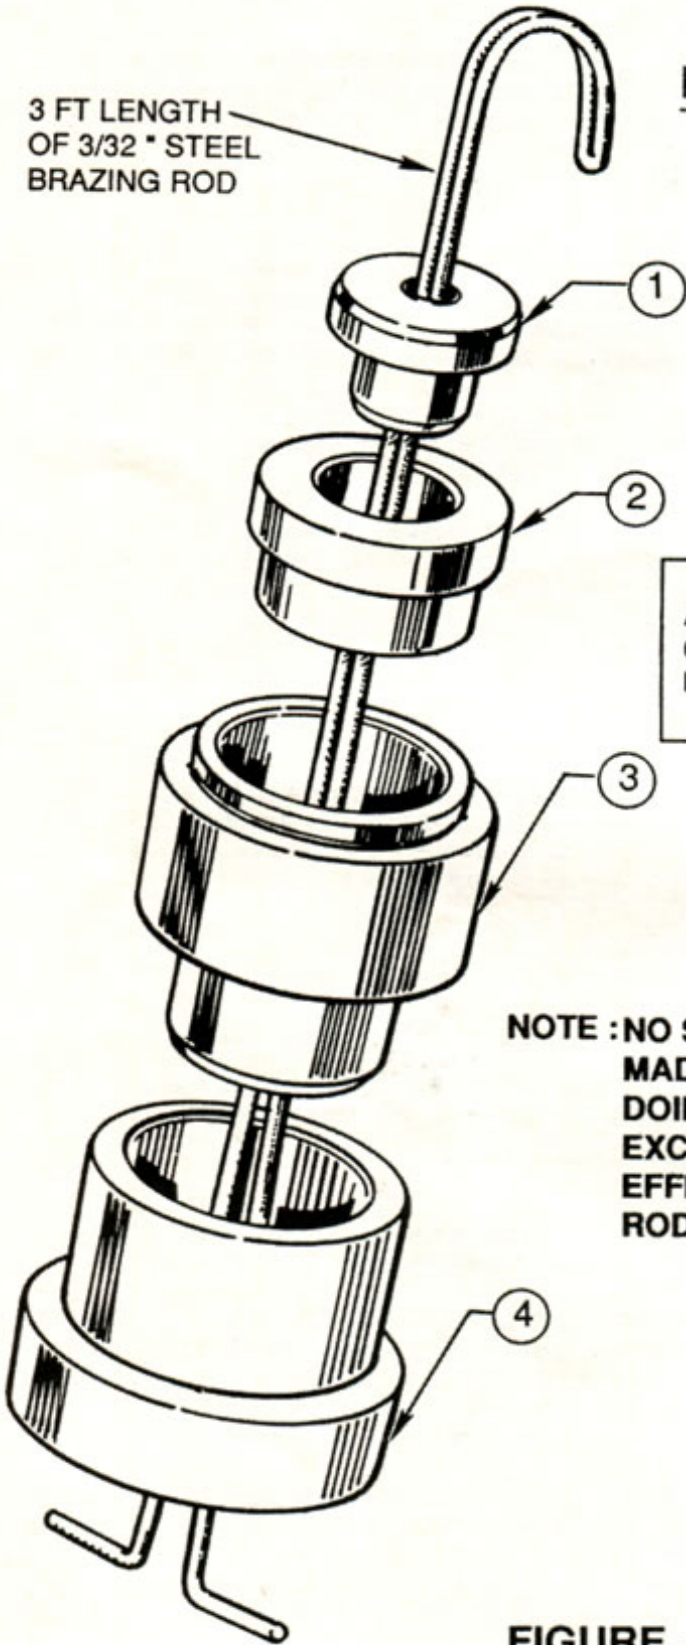
FIGURE 1

3 FT LENGTH
OF 3/32 " STEEL
BRAZING ROD

- ① J - 24895
- ② J - 9398 - A
- ③ J - 9481 - A
- ④ J - 26271 - A

ABOVE TOOLS ARE PART OF GM 4
CYLINDER (R - 4) COMPRESSOR TOOL
KIT J - 29892 -A

**NOTE : NO SUBSTITUTIONS SHOULD BE
MADE FOR THE TOOLS INDICATED.
DOING SO, MAY RESULT IN AN
EXCESSIVE WEIGHT WHICH COULD
EFFECT THE ACCURACY OF TIE
ROD INSPECTION.**

1. Fabricate/Assemble weight from materials indicated and as illustrated in Figure 1.
2. Raise Vehicle.
3. Remove cotter pins, nuts and washers from both outer rear tie rod ends and disconnect from knuckle assemblies utilizing tool J-24319-01.
