1988 - 1989 Corvette: Recall Notice: Rear Wheel Tie Rod

Bulletin No: 89C17

Subject: PRODUCT SAFETY CAMPAIGN 89C17
REAR WHEEL TIE ROD

Model and Year: 1988-89 CHEVROLET CORVETTE

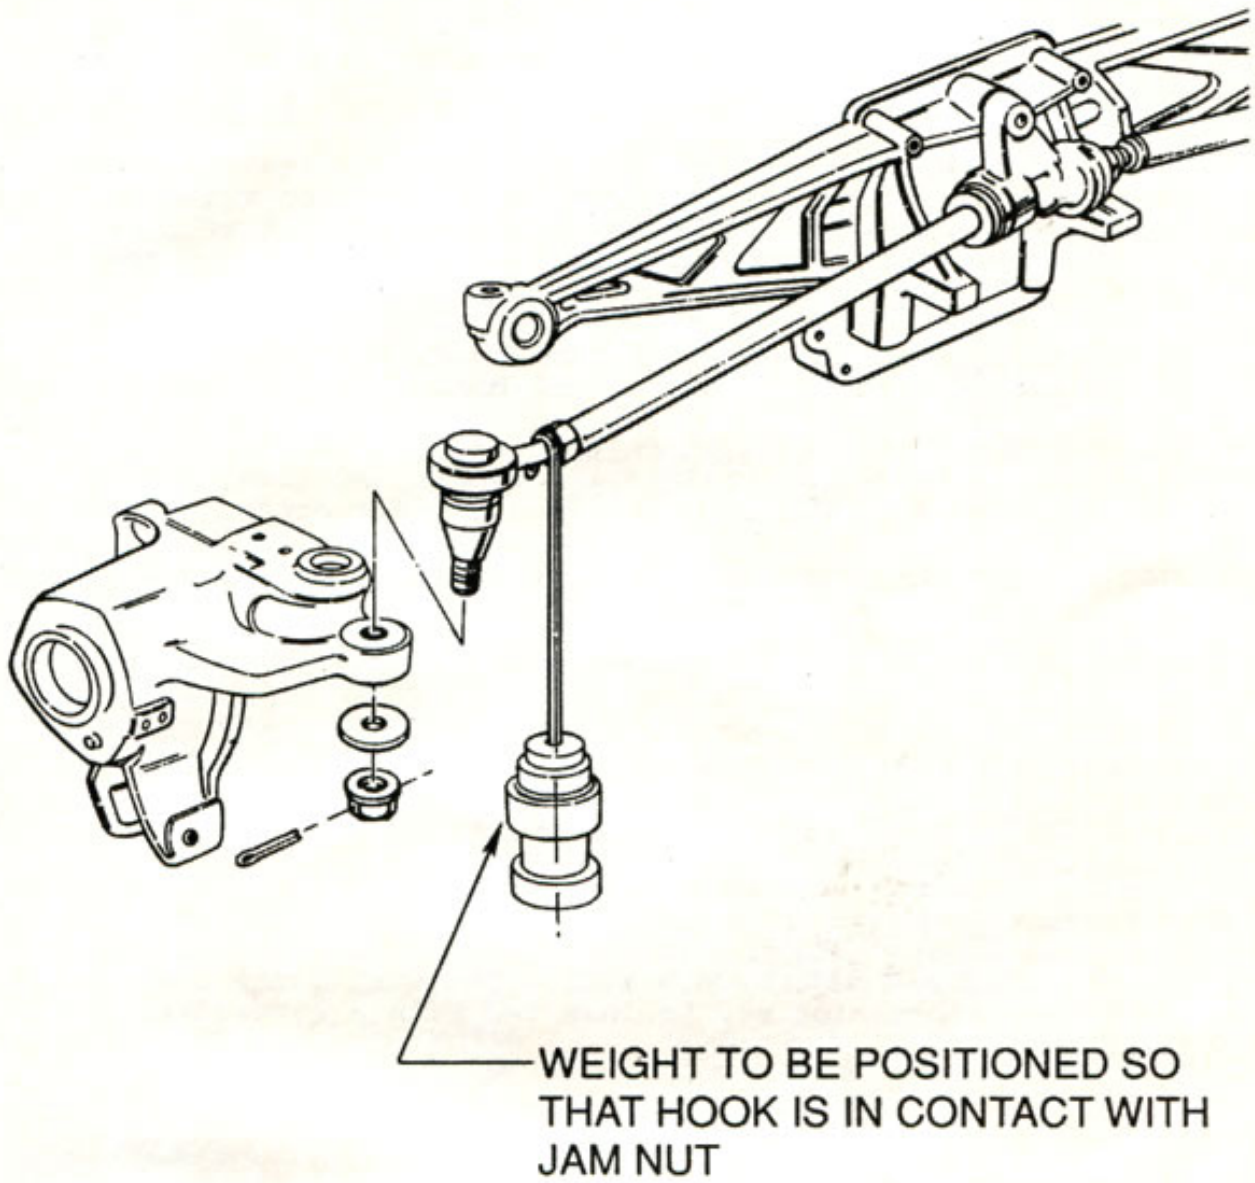
FIGURE 2

To prevent this condition from occurring, involved vehicles will be inspected to determine the amount of rocking torque on each tie rod. Tie rod assemblies above 12Nm rocking torque on either side will be replaced.

4. Raise and hold outer end of left hand tie rod linkage in its upper most position, insuring rod is not rotated while being raised. Attach weight as shown in Figure 2, release linkage and note results. Repeat procedure on right hand tie rod linkage.
5. Based on observations noted in performing step 4, select appropriate action from those noted below:
 - A. Linkage moves downward on both sides - Reconnect tie rod sockets to knuckles, install washers and nuts, torque nuts to 45 Nm (33 lbs. ft.) and install cotter pins.
 - B. Linkage on either or both sides doesn't move downward - Replace tie rod assembly, transferring existing tie rod ends to new assembly and following Section 3D in the Chevrolet Corvette Service Manual of the appropriate year.
6. Install Campaign Identification Label.
