1988 - 1989 Corvette: Recall Notice: Rear Wheel Tie Rod

Bulletin No: 89C17

Subject: PRODUCT SAFETY CAMPAIGN 89C17
REAR WHEEL TIE ROD

Model and Year: 1988-89 CHEVROLET CORVETTE

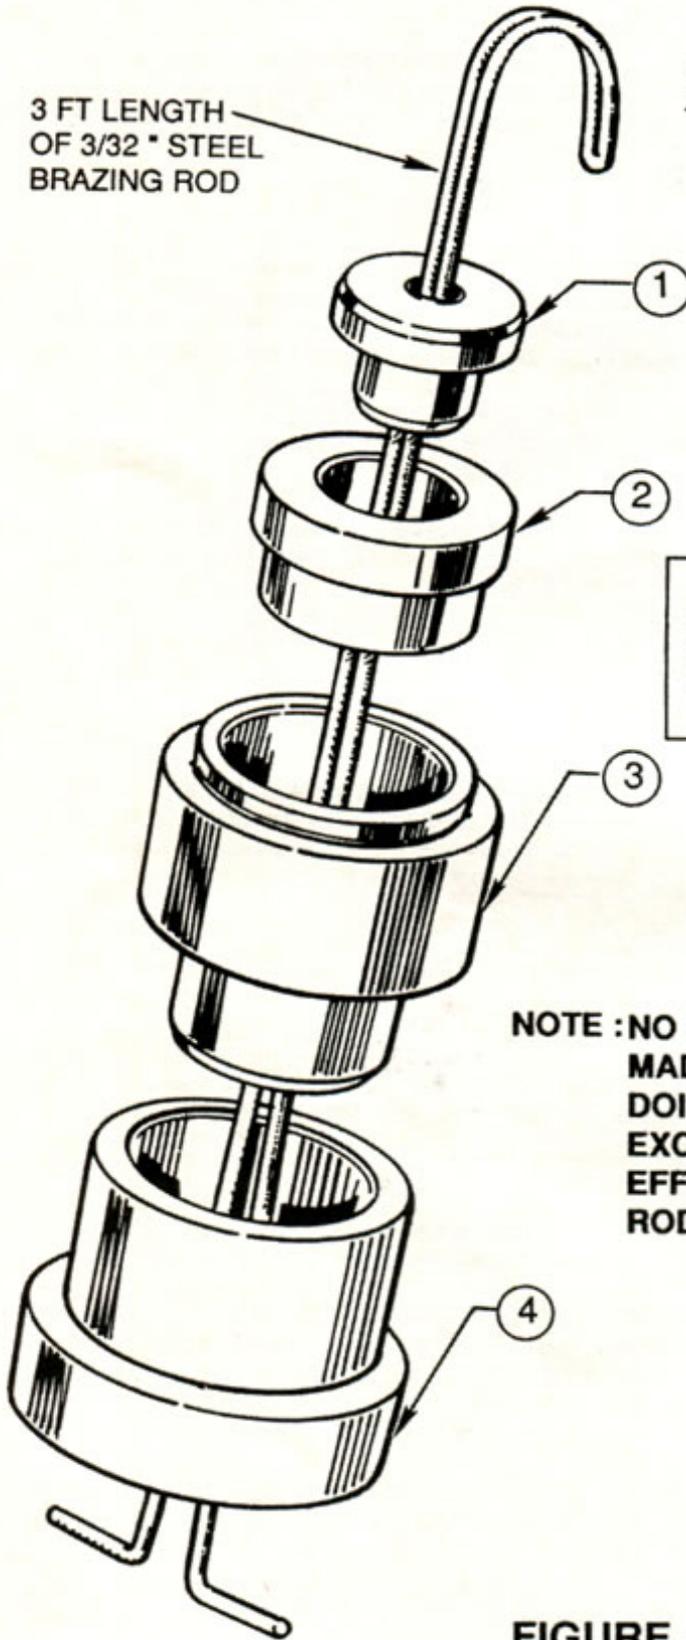
FIGURE 1

3 FT LENGTH
OF 3/32 " STEEL
BRAZING ROD

- ① J - 24895
- ② J - 9398 - A
- ③ J - 9481 - A
- ④ J - 26271 - A

ABOVE TOOLS ARE PART OF GM 4
CYLINDER (R - 4) COMPRESSOR TOOL
KIT J - 29892 -A

**NOTE : NO SUBSTITUTIONS SHOULD BE
MADE FOR THE TOOLS INDICATED.
DOING SO, MAY RESULT IN AN
EXCESSIVE WEIGHT WHICH COULD
EFFECT THE ACCURACY OF TIE
ROD INSPECTION.**

1. Fabricate/Assemble weight from materials indicated and as illustrated in Figure 1.
2. Raise Vehicle.
3. Remove cotter pins, nuts and washers from both outer rear tie rod ends and disconnect from knuckle assemblies utilizing tool J-24319-01.

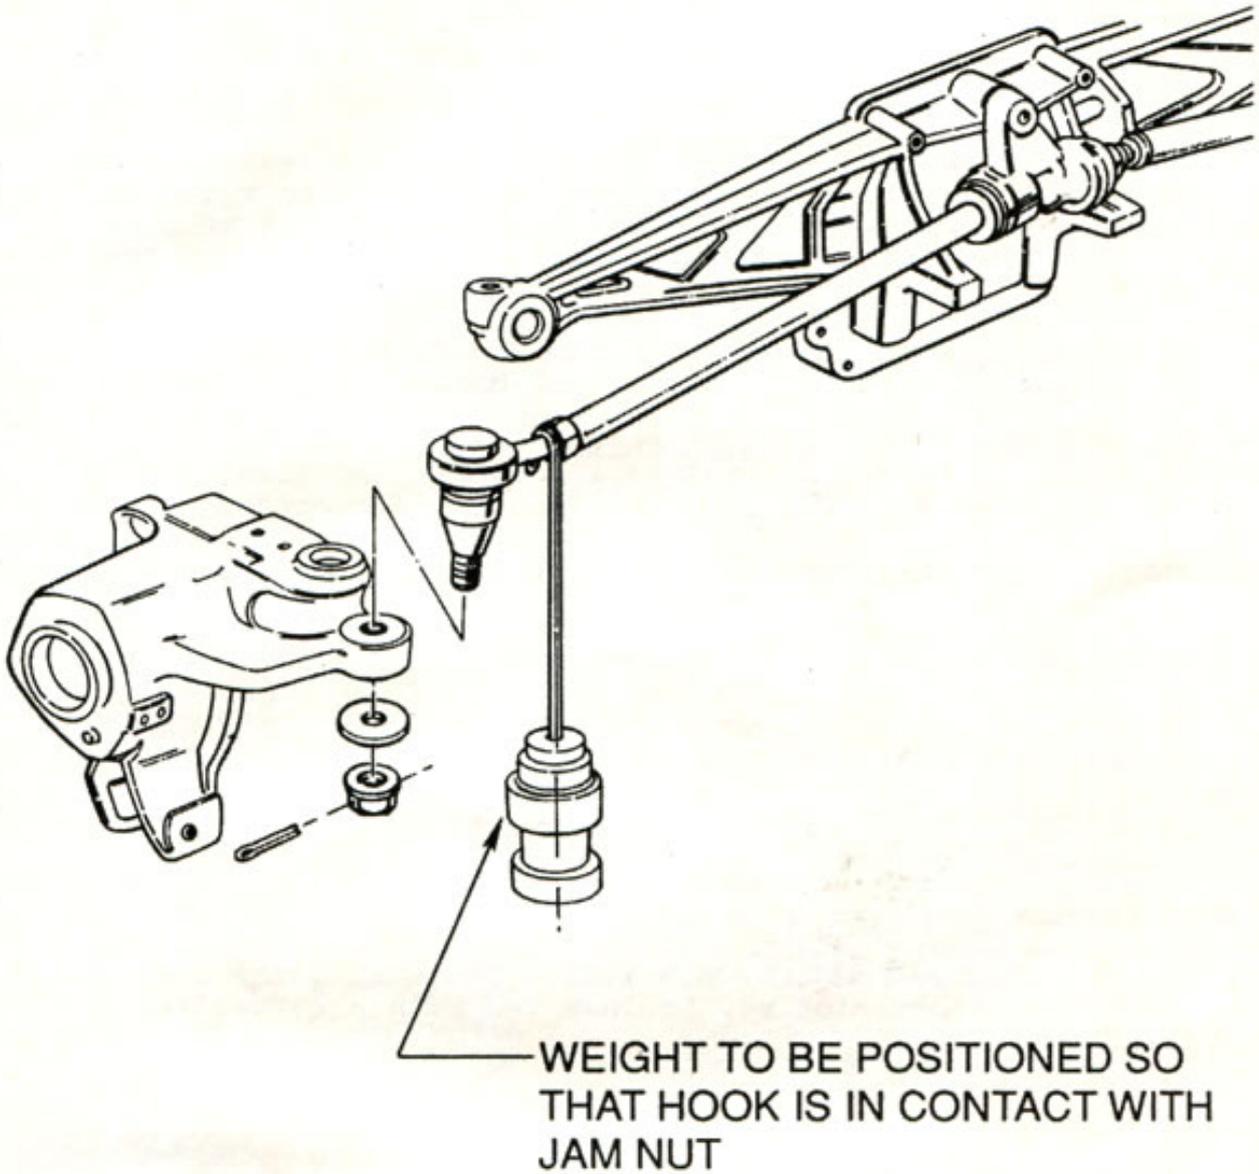
FIGURE 2

General Motors has determined that a defect which relates to motor vehicle safety exists in certain 1988-89 Chevrolet Corvette model vehicles. The rear wheel tie rod assembly of these vehicles may fatigue and could fracture at the inboard bearing due to high inner-joint rocking torque. Fracture in this assembly could result in a loss of vehicle control and a vehicle crash could occur without prior warning.

To prevent this condition from occurring, involved vehicles will be inspected to determine the amount of rocking torque on each tie rod. Tie rod assemblies above 12Nm rocking torque on either side will be replaced.

4. Raise and hold outer end of left hand tie rod linkage in its upper most position, insuring rod is not rotated while being raised. Attach weight as shown in Figure 2, release linkage and note results. Repeat procedure on right hand tie rod linkage.
5. Based on observations noted in performing step 4, select appropriate action from those noted below:
 - A. Linkage moves downward on both sides - Reconnect tie rod sockets to knuckles, install washers and nuts, torque nuts to 45 Nm (33 lbs. ft.) and install cotter pins.
 - B. Linkage on either or both sides doesn't move downward - Replace tie rod assembly, transferring existing tie rod ends to new assembly and following Section 3D in the Chevrolet Corvette Service Manual of the appropriate year.
6. Install Campaign Identification Label.
