# 1953 - 1954 Corvette: Service News: Powerglide Clutch Interference

**Subject:** Powerglide Clutch

**Model and Year:** 1953 - 1954 Corvette

**Source:** Chevrolet Service News

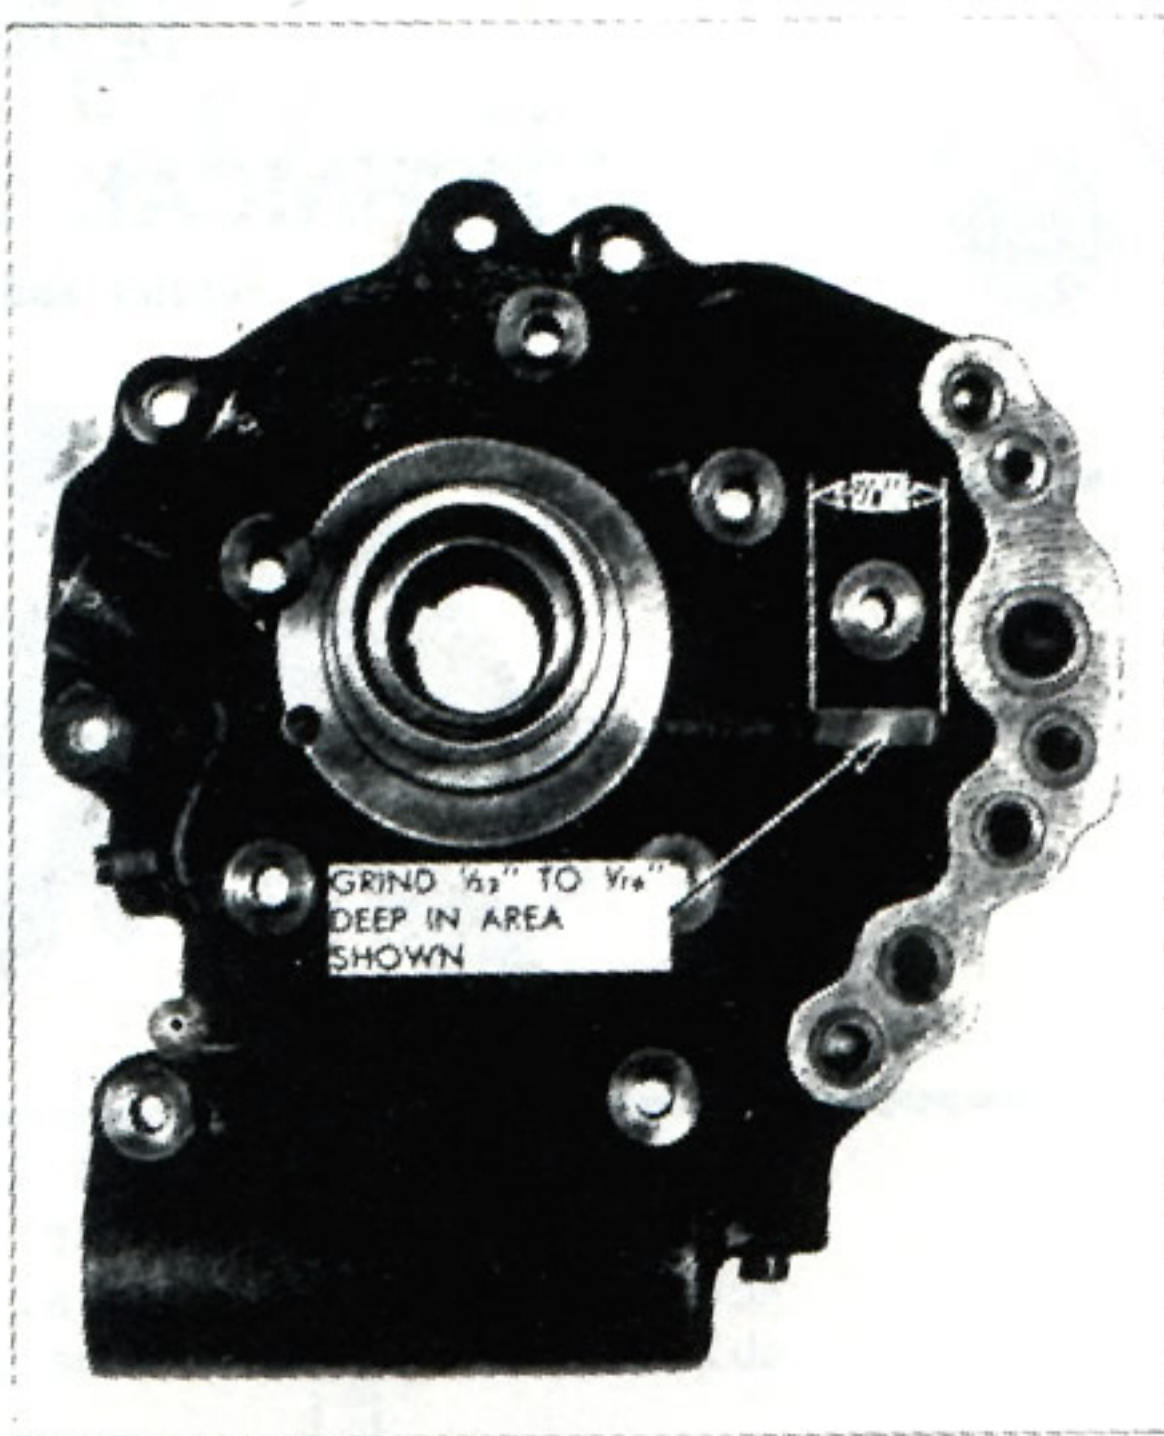
Due to limit stack conditions, a point of interference is possible when using a service replacement clutch drum or clutch assembly in 1953-54 Powerglide transmissions. The difficulty is caused by a ledge incorporated on the front face of a service replacement clutch drum, which can contact an embossed area on the valve body casting.

*Fig. 2—Powerglide Valve Body Re-worked.*

Where clutch drum-valve body interference is noted when installing one of the above assemblies the valve body must be reworked to obtain drum operating clearance, as shown in Figure 2.
