# 1953 - 1954 Corvette: Service News: Powerglide Clutch Interference

**Subject:** Powerglide Clutch

**Model and Year:** 1953 - 1954 Corvette

**Date:** October, 1957 - Volume 29- Number 10

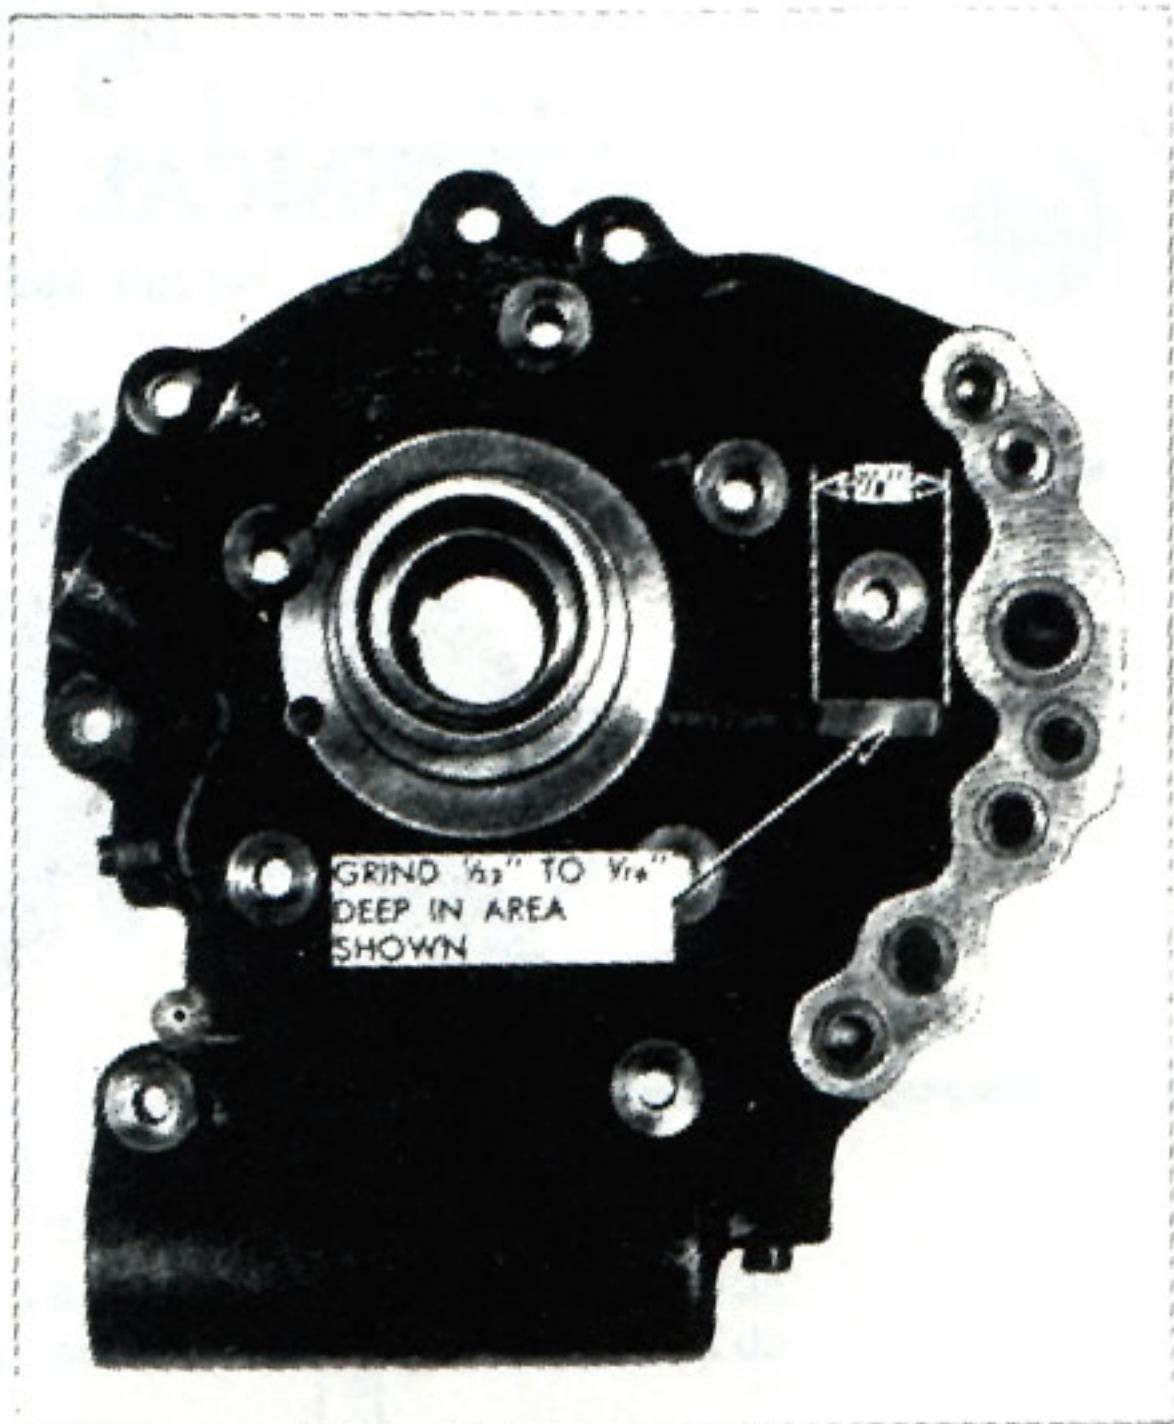
Due to limit stack conditions, a point of interference is possible when using a service replacement clutch drum or clutch assembly in 1953-54 Powerglide transmissions. The difficulty is caused by a ledge incorporated on the front face of a service replacement clutch drum, which can contact an embossed area on the valve body casting.

*Fig. 2—Powerglide Valve Body Re-worked.*

Where clutch drum-valve body interference is noted when installing one of the above assemblies the valve body must be reworked to obtain drum operating clearance, as shown in Figure 2.
