1953 - 1954 Corvette: Service News: Powerglide Clutch Interference

Subject: Powerglide Clutch

Model and Year: 1953 - 1954 Corvette

Date: October, 1957 - Volume 29- Number 10

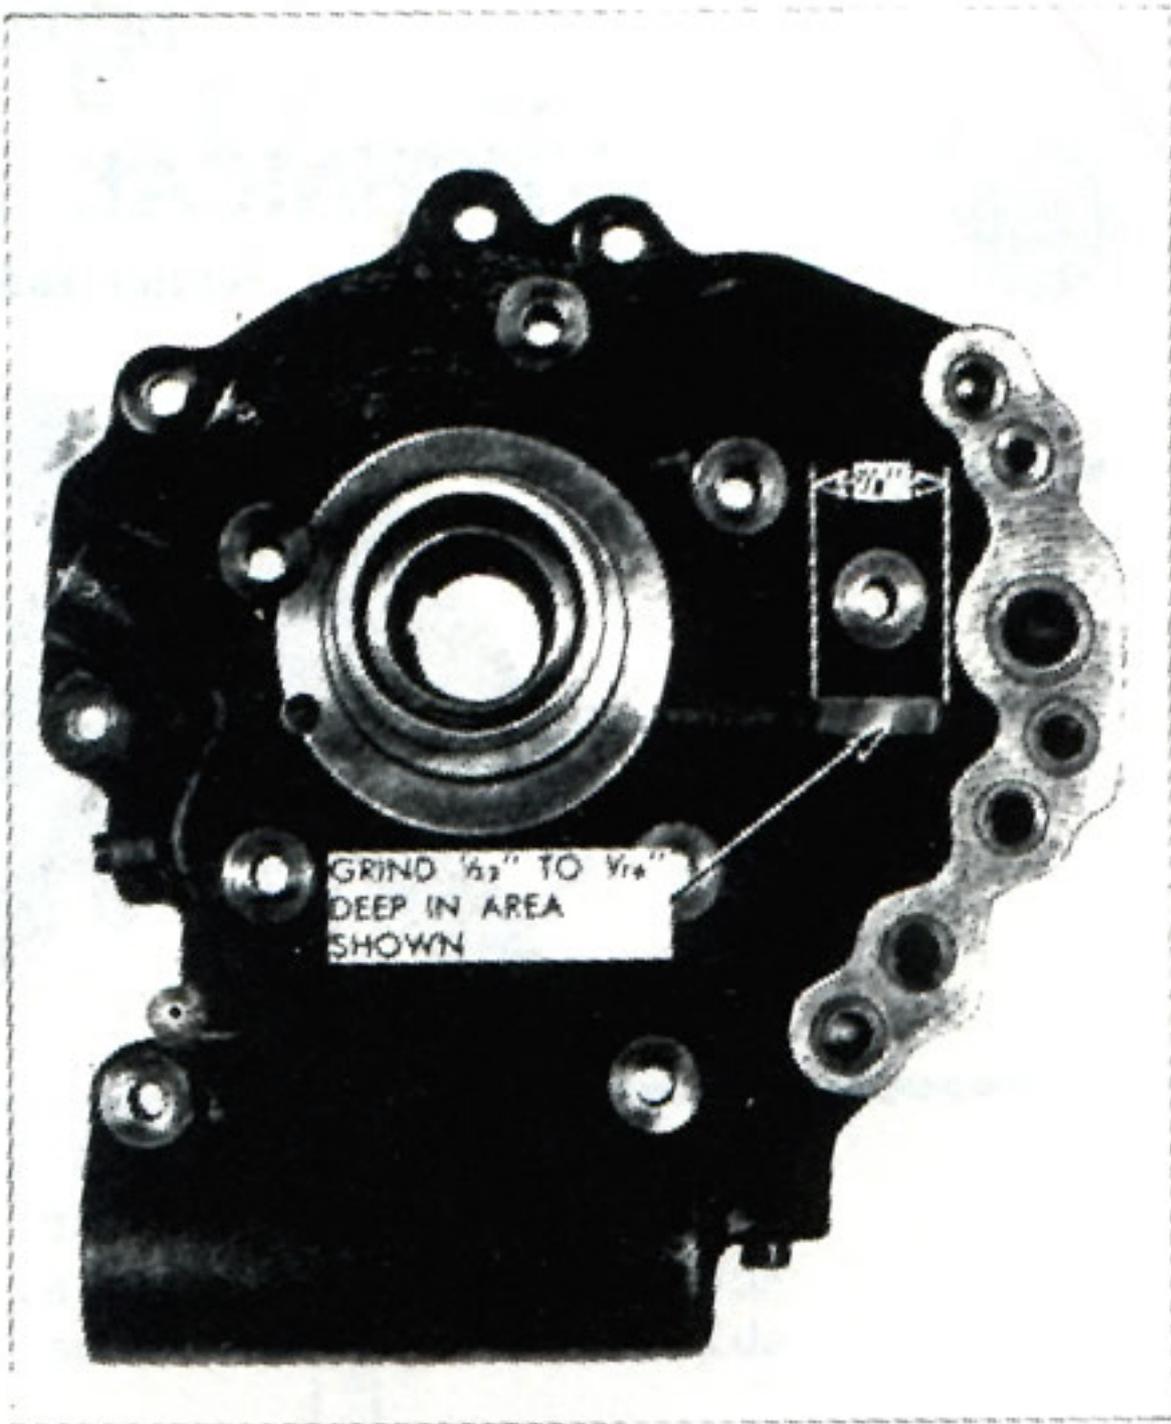
Due to limit stack conditions, a point of interference is possible when using a service replacement clutch drum or clutch assembly in 1953-54 Powerglide transmissions. The difficulty is caused by a ledge incorporated on the front face of a service replacement clutch drum, which can contact an embossed area on the valve body casting.

Fig. 2—Powerglide Valve Body Re-worked.

Where clutch drum-valve body interference is noted when installing one of the above assemblies the valve body must be reworked to obtain drum operating clearance, as shown in Figure 2.
