# 1959 Corvette: Service Bulletin: Windshield Washers

SUBJECT: 1959 PASSENGER CAR  
WINDSHIELD WASHERS

BULLETIN No. DR #405

March 18, 1959

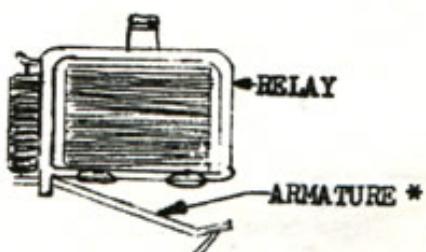
RELAY & ARMATURE WITH  
TERMINAL BOARD REMOVED  
(FOR ILLUSTRATION)  
FIG. #3

A few very early units may have a relay armature with a small opening or window which may contact the drive pawl. This could allow the drive pawl to push the armature up out of the park position and allow unit to recycle. Later armatures had a wider window and also a notch at end that contacts nylon gear. This notch prevented the drive pawl from catching top of ratchet tooth which also may cause unit to recycle. Later armatures incorporated additional features to maintain free movement and assume proper stop.

ARMATURE - EARLY DESIGN

CORRECTION: Replace Relay and Terminal Board Assembly, #4906055 (late type armature is part of this assembly).

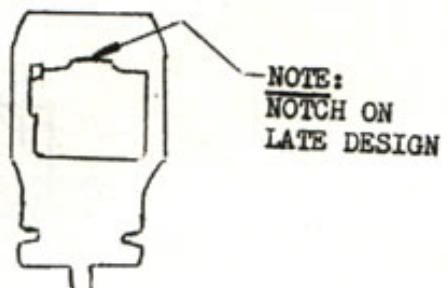
ARMATURE - LATE DESIGN  
FIG. #4

NOTE: See Figure #4, examples of early and late armature.
