1959 Corvette: Service Bulletin: Windshield Washers

SUBJECT: 1959 PASSENGER CAR
WINDSHIELD WASHERS

BULLETIN No. DR #405

March 18, 1959

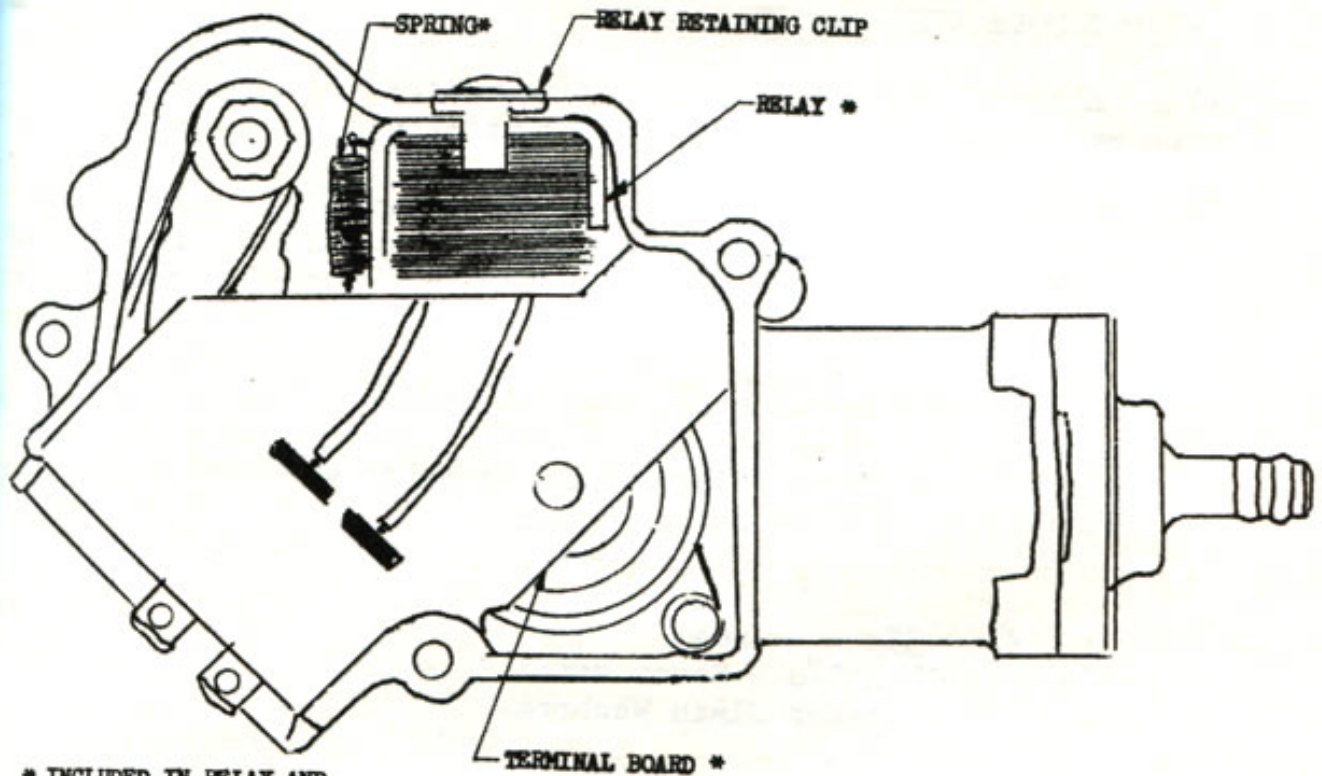
FIG. #2

* INCLUDED IN RELAY AND
TERMINAL BOARD ASSY.,
#A906055

CORRECTION: Replace Relay and Terminal Board Assembly, #4906055 (late type armature is part of this assembly).

1. Remove pump cover. Cover is retained by three (3) screws. See Figure #1.
2. Lift terminal board up.
3. Pull relay out of pump body. Relay is retained by clip. Relay, armature and terminal board will come out together. See Figure #2.
4. Reinstall new Relay and Terminal Board Assembly, #4906055.
