# 1959 Corvette: Service Bulletin: Windshield Washers

**SUBJECT:** 1959 PASSENGER CAR  
WINDSHIELD WASHERS

**BULLETIN No.** DR #405

March 18, 1959

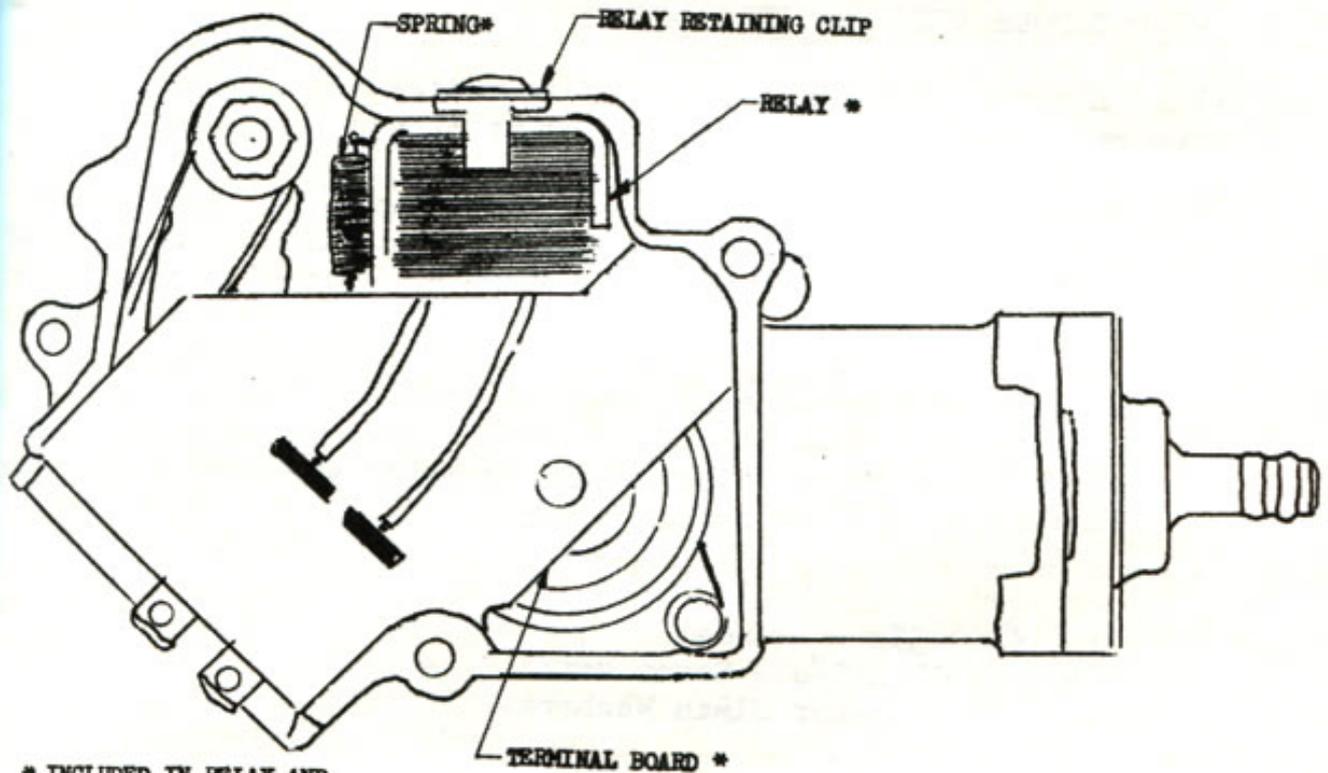
FIG. #2

\* INCLUDED IN RELAY AND  
TERMINAL BOARD ASSY.,  
#A906055

**CORRECTION:** Replace Relay and Terminal Board Assembly, #4906055 (late type armature is part of this assembly).

1. Remove pump cover. Cover is retained by three (3) screws. See Figure #1.
2. Lift terminal board up.
3. Pull relay out of pump body. Relay is retained by clip. Relay, armature and terminal board will come out together. See Figure #2.
4. Reinstall new Relay and Terminal Board Assembly, #4906055.

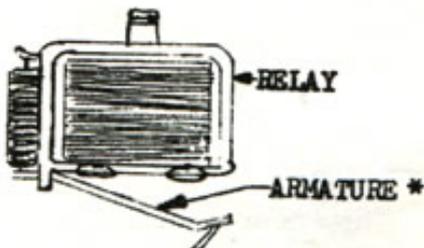
FIG. #3

RELAY & ARMATURE WITH  
TERMINAL BOARD REMOVED  
(FOR ILLUSTRATION)

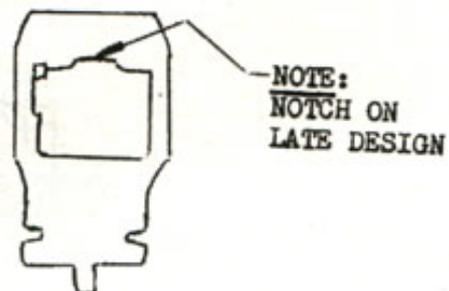
ARMATURE - LATE DESIGN  
FIG. #4

A few very early units may have a relay armature with a small opening or window which may contact the drive pawl. This could allow the drive pawl to push the armature up out of the park position and allow unit to recycle. Later armatures had a wider window and also a notch at end that contacts nylon gear. This notch prevented the drive pawl from catching top of ratchet tooth which also may cause unit to recycle. Later armatures incorporated additional features to maintain free movement and assume proper stop.

NOTE: See Figure #4, examples of early and late armature.
