1959 Corvette: Service Bulletin: Windshield Washers

SUBJECT: 1959 PASSENGER CAR
WINDSHIELD WASHERS

BULLETIN No. DR #405

March 18, 1959

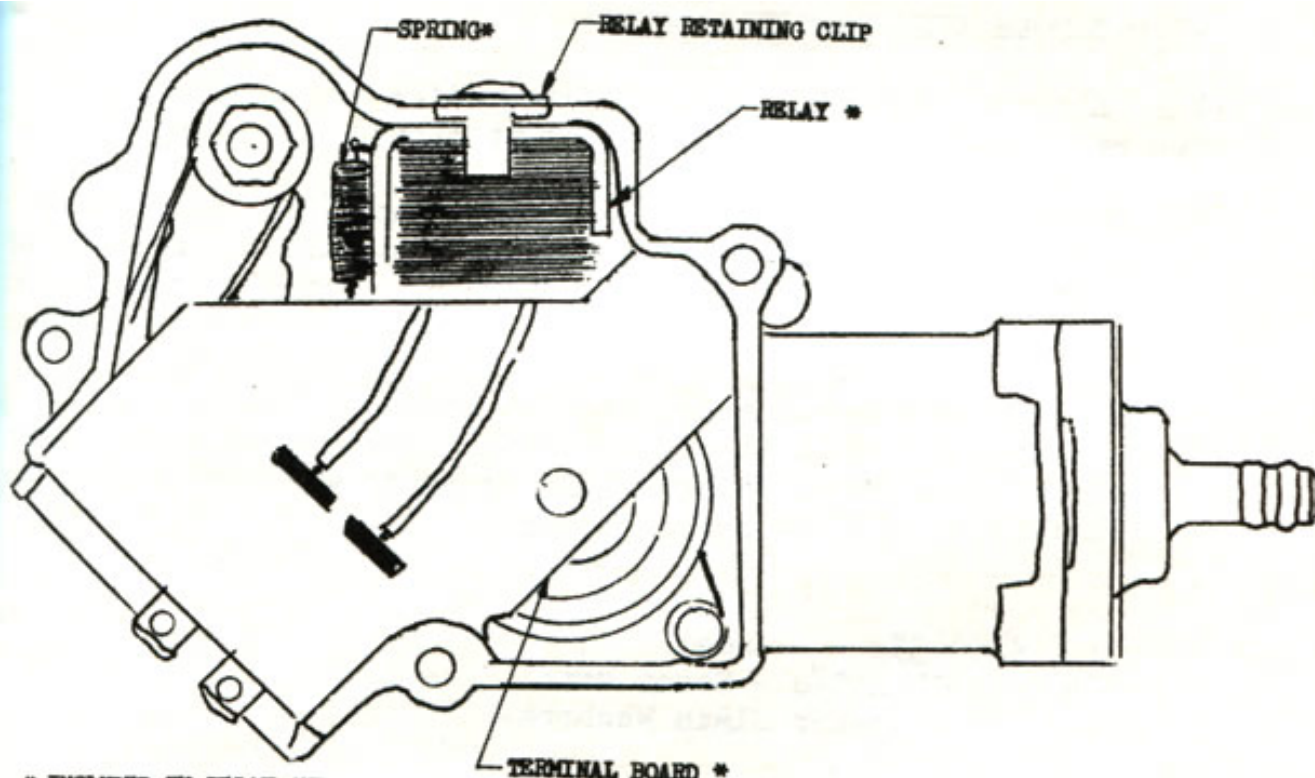
FIG. #2

* INCLUDED IN RELAY AND
TERMINAL BOARD ASSY.,
#906055

1. Remove pump cover. Cover is retained by three (3) screws. See Figure #1.
2. Lift terminal board up.
3. Pull relay out of pump body. Relay is retained by clip. Relay, armature and terminal board will come out together. See Figure #2.
4. Reinstall new Relay and Terminal Board Assembly, #4906055.

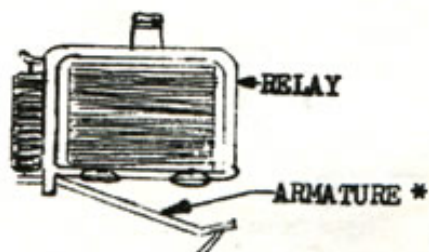
FIG. #3

RELAY & ARMATURE WITH
TERMINAL BOARD REMOVED
(FOR ILLUSTRATION)
