1964 Corvette: Service Bulletin: 4-Speed Shift Lever Revision

Source: Chevrolet Technical Service Bulletin

Bulletin No: DR #691

Date: September 8, 1964

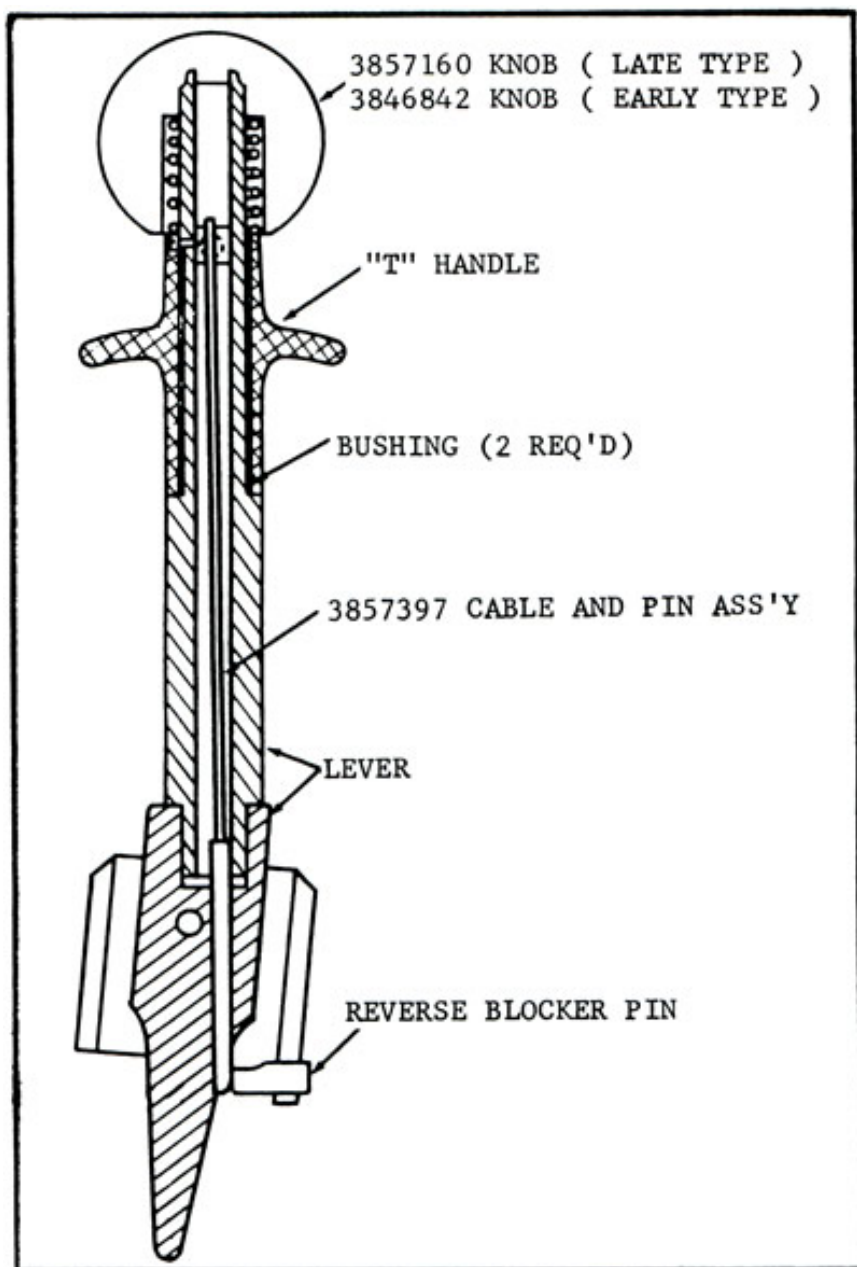
FIG. 1 - SHIFT LEVER CROSS SECTION

- Shifter knob thread damage - stripped or damaged threads in the chrome finished plastic knob due to burrs on the shift lever or "cross threading" the knob at time of installation.
- Cable breakage caused by bending of reverse inhibitor mechanism. This condition may result from the inhibitor pin being bent by heavy contact with the reverse blocker pin.
- Weld failures on reverse blocker pin. The pin may break away from the shift lever flange and allow undesired reverse engagement.

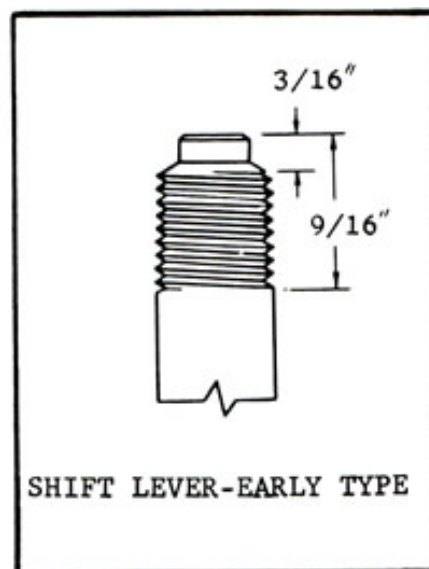
FIG. 2 - EARLY THREAD

Two shifter knob designs and two shift lever thread designs have been used in 1964 production. The early design all plastic knob, part number 3846842, may be used on either lever. The late design knob, which has a threaded brass insert sleeve, can be used only on the late design lever. Refer to Figures 2 and 3 for details.

Regardless of lever or knob design, the threads must be free of burrs. The slot edges of the threads should be chamfered and smooth. When installing a knob, use extreme care to avoid cross-threading.

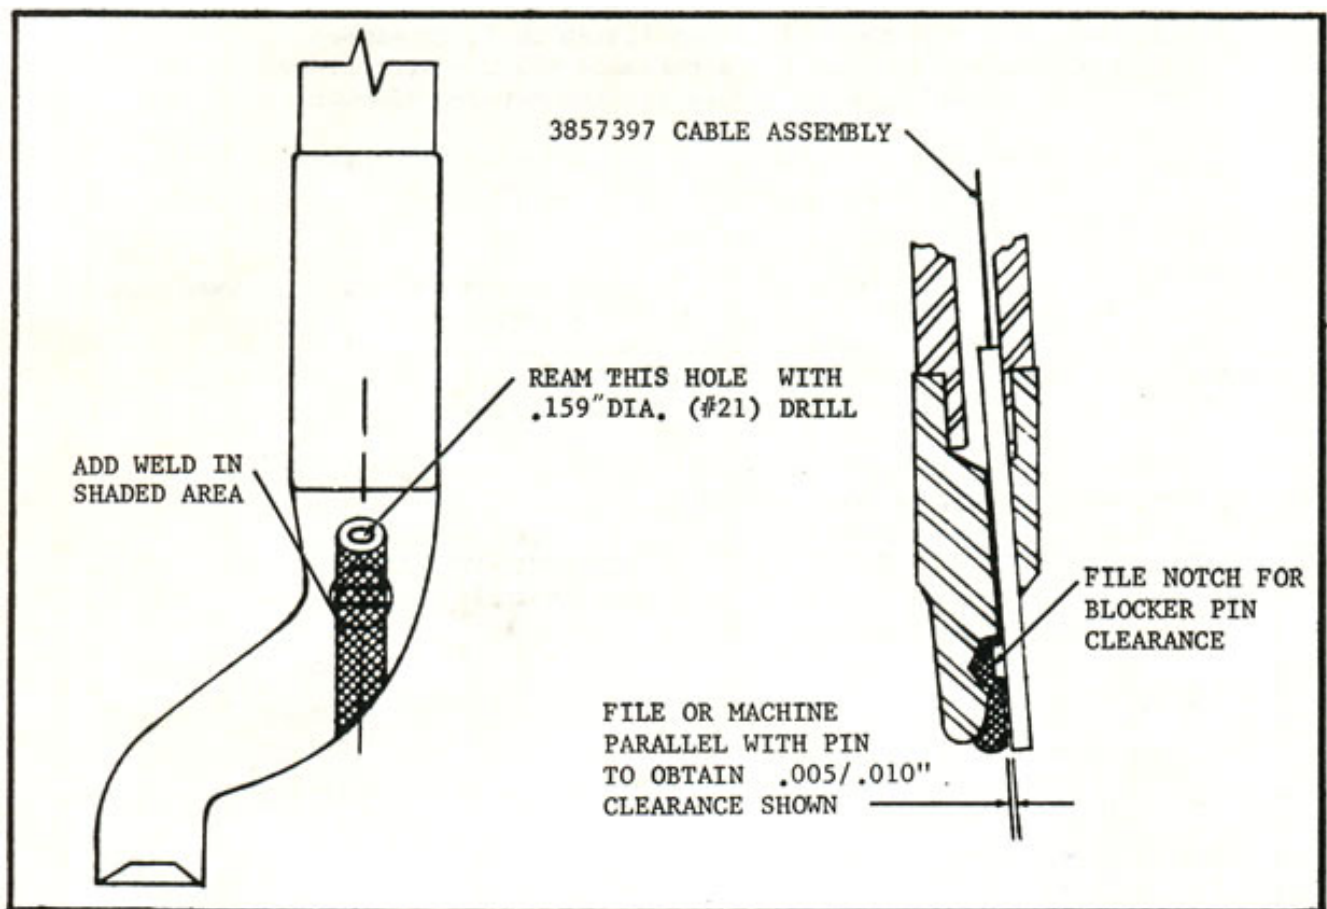
FIG. 4 - MODIFICATION OF SHIFT LEVER LOWER END

REVERSE INHIBITOR BINDS

2. Add a heavy weld or brass bead to the shift lever as shown by the shaded section of Figure 4.
3. File the bead flat and parallel to the reverse inhibitor pin with .005" to .010" clearance to the pin.
4. Remove and discard the pin and wire assembly from the "T" handle and enlarge the "T" handle hole to .082" with a 5/64" drill. Reassemble using the new pin and wire assembly, part number 3857397.

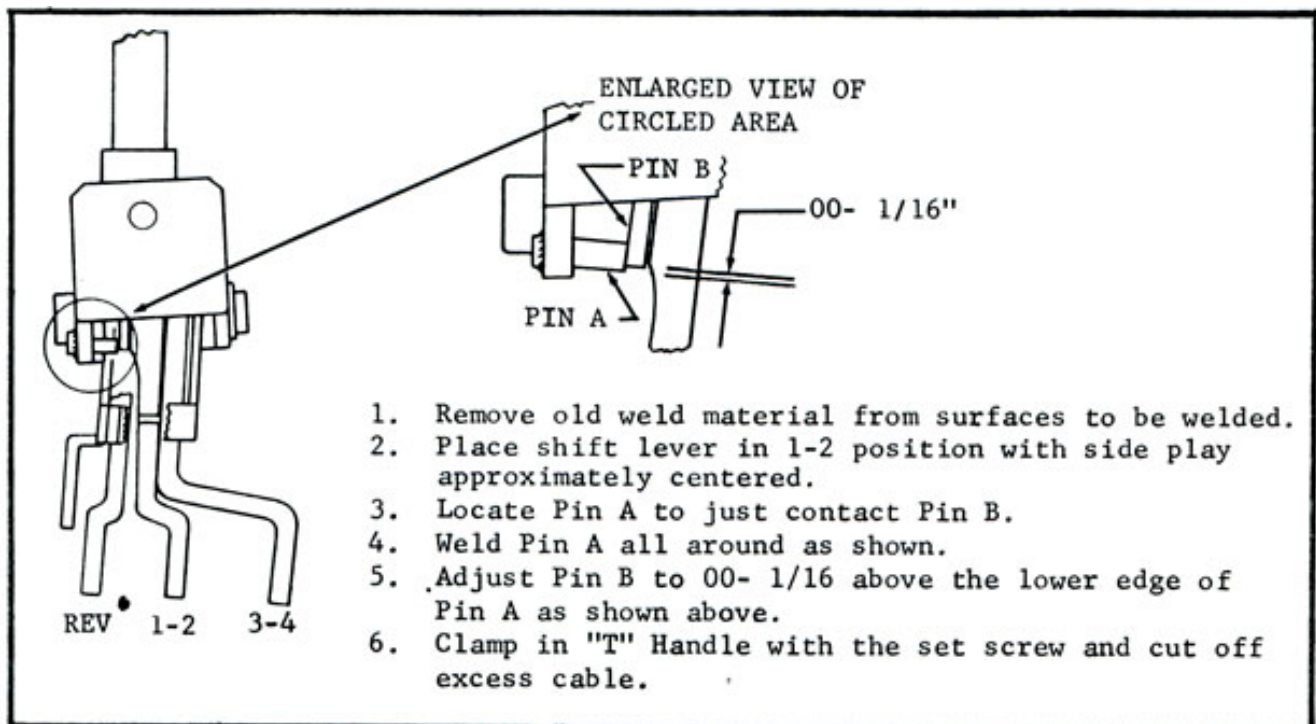
FIGURE 5 - REVERSE BLOCKER PIN LOCATING DETAILS

REVERSE BLOCKER PIN LOOSE OR MISSING

If the reverse blocker pin weld has broken, Figure 5 describes the proper locating dimensions for rewelding. If the original pin has been lost or damaged, a 1/4 inch by 5/8 inch hardened bolt, such as part no. 9409073, may

be used. The shift mechanism must be fully assembled before welding the pin so that the proper pin location may be achieved.
