# 1964 Corvette: Service Bulletin: 4-Speed Shift Lever Revision

**Source:** Chevrolet Technical Service Bulletin

**Bulletin No:** DR #691

**Date:** September 8, 1964

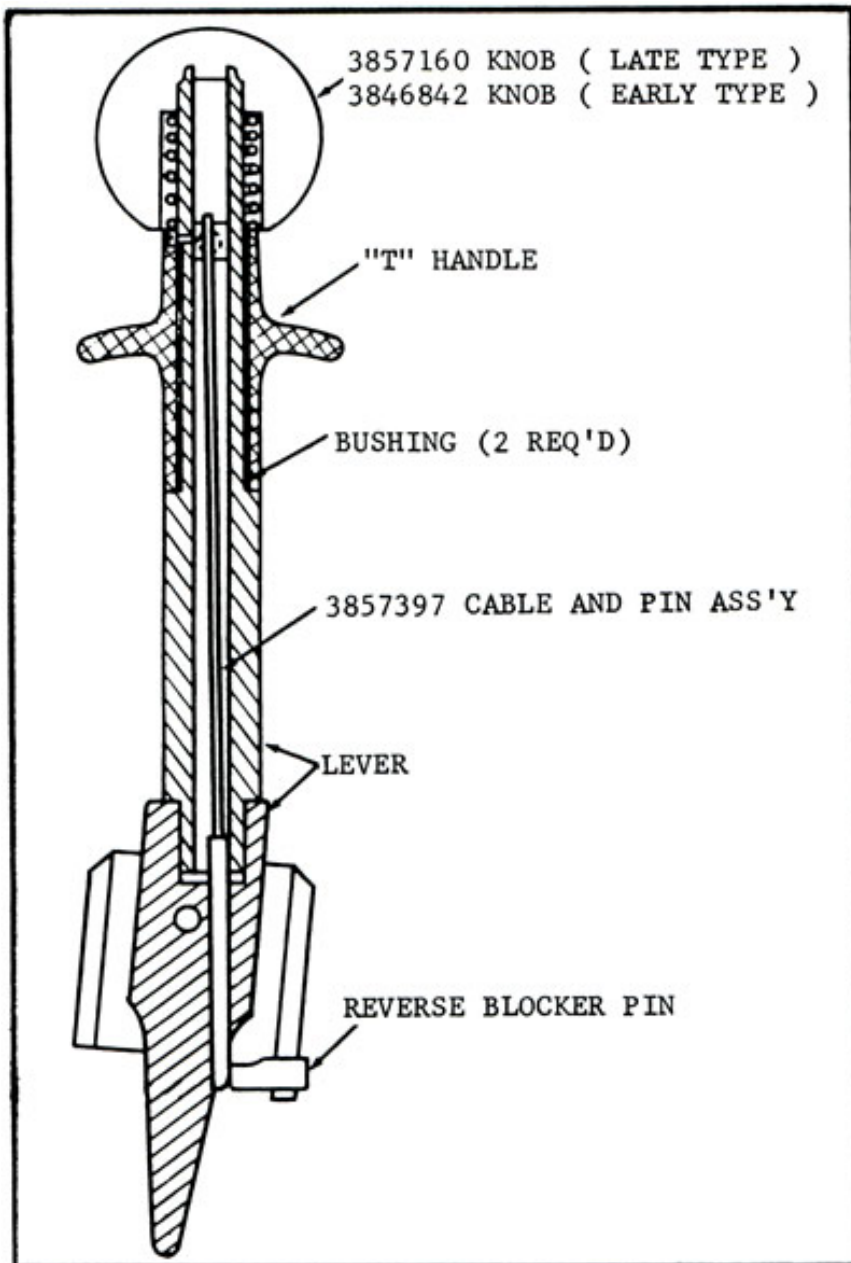
FIG. 1 - SHIFT LEVER CROSS SECTION

- Shifter knob thread damage - stripped or damaged threads in the chrome finished plastic knob due to burrs on the shift lever or "cross threading" the knob at time of installation.
- Cable breakage caused by bending of reverse inhibitor mechanism. This condition may result from the inhibitor pin being bent by heavy contact with the reverse blocker pin.
- Weld failures on reverse blocker pin. The pin may break away from the shift lever flange and allow undesired reverse engagement.

The possible occurrence of these problems has been eliminated in production by using a new design shift mechanism and knob. The new mechanism design includes, (1) a larger diameter inhibitor cable with revised material and heat treat, (2) additional metal on the shift arm to support the lower end of the inhibitor pin, (3) revised thread finish on lever assembly, (4) a new knob that includes a threaded brass insert sleeve, and (5) a revised weld procedure for the reverse blocker pin.

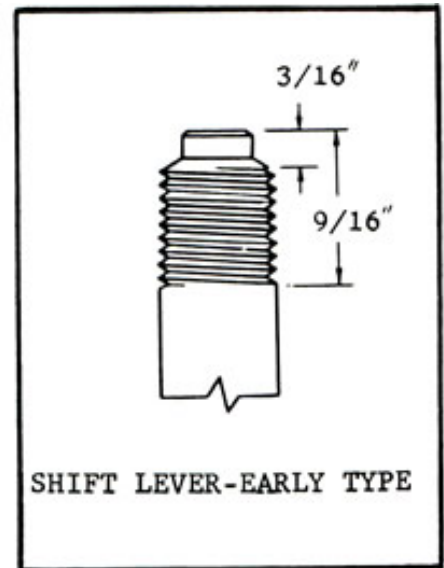
FIG. 2 - EARLY THREAD

Two shifter knob designs and two shift lever thread designs have been used in 1964 production. The early design all plastic knob, part number 3846842, may be used on either lever. The late design knob, which has a threaded brass insert sleeve, can be used only on the late design lever. Refer to Figures 2 and 3 for details.

Regardless of lever or knob design, the threads must be free of burrs. The slot edges of the threads should be chamfered and smooth. When installing a knob, use extreme care to avoid cross-threading.

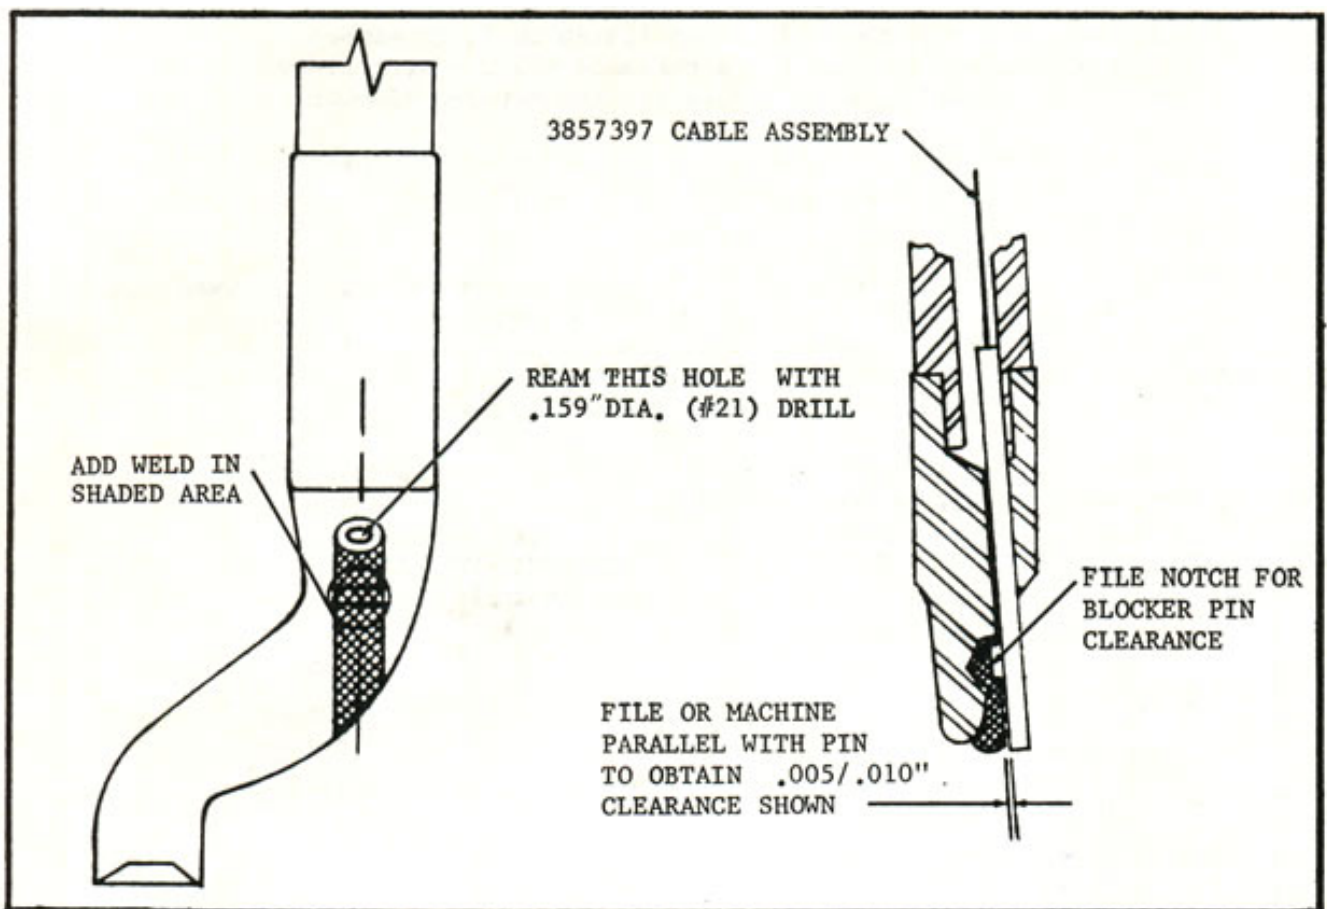
FIG. 4 - MODIFICATION OF SHIFT LEVER LOWER END

### REVERSE INHIBITOR BINDS

2. Add a heavy weld or brass bead to the shift lever as shown by the shaded section of Figure 4.
3. File the bead flat and parallel to the reverse inhibitor pin with .005" to .010" clearance to the pin.
4. Remove and discard the pin and wire assembly from the "T" handle and enlarge the "T" handle hole to .082" with a 5/64" drill. Reassemble using the new pin and wire assembly, part number 3857397.

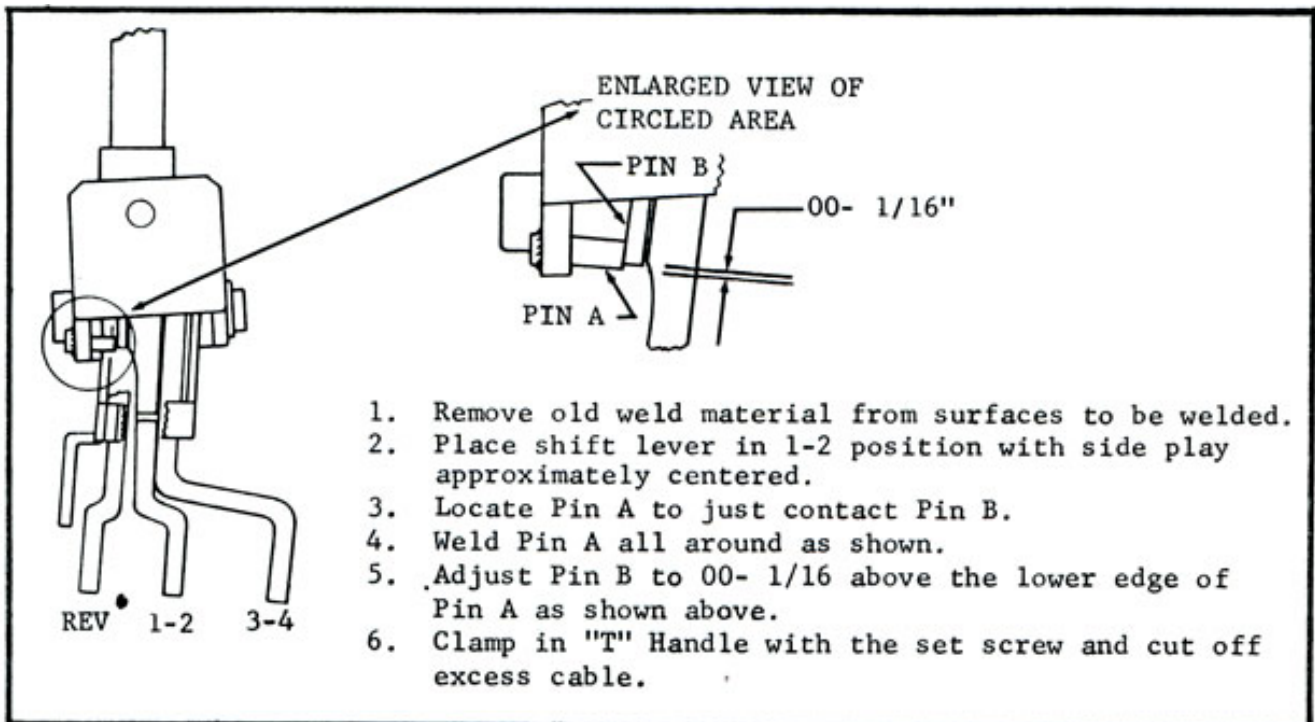
FIGURE 5 - REVERSE BLOCKER PIN LOCATING DETAILS

### REVERSE BLOCKER PIN LOOSE OR MISSING

If the reverse blocker pin weld has broken, Figure 5 describes the proper locating dimensions for rewelding. If the original pin has been lost or damaged, a 1/4 inch by 5/8 inch hardened bolt, such as part no. 9409073, may

be used. The shift mechanism must be fully assembled before welding the pin so that the proper pin location may be achieved.
