1960 Corvette: Service Bulletin: Generator Belt Misalignment

Subject: Generator Belt Misalignment

Model and Year: 1960 Corvette

Source: G.M. of Canada Service Bulletin

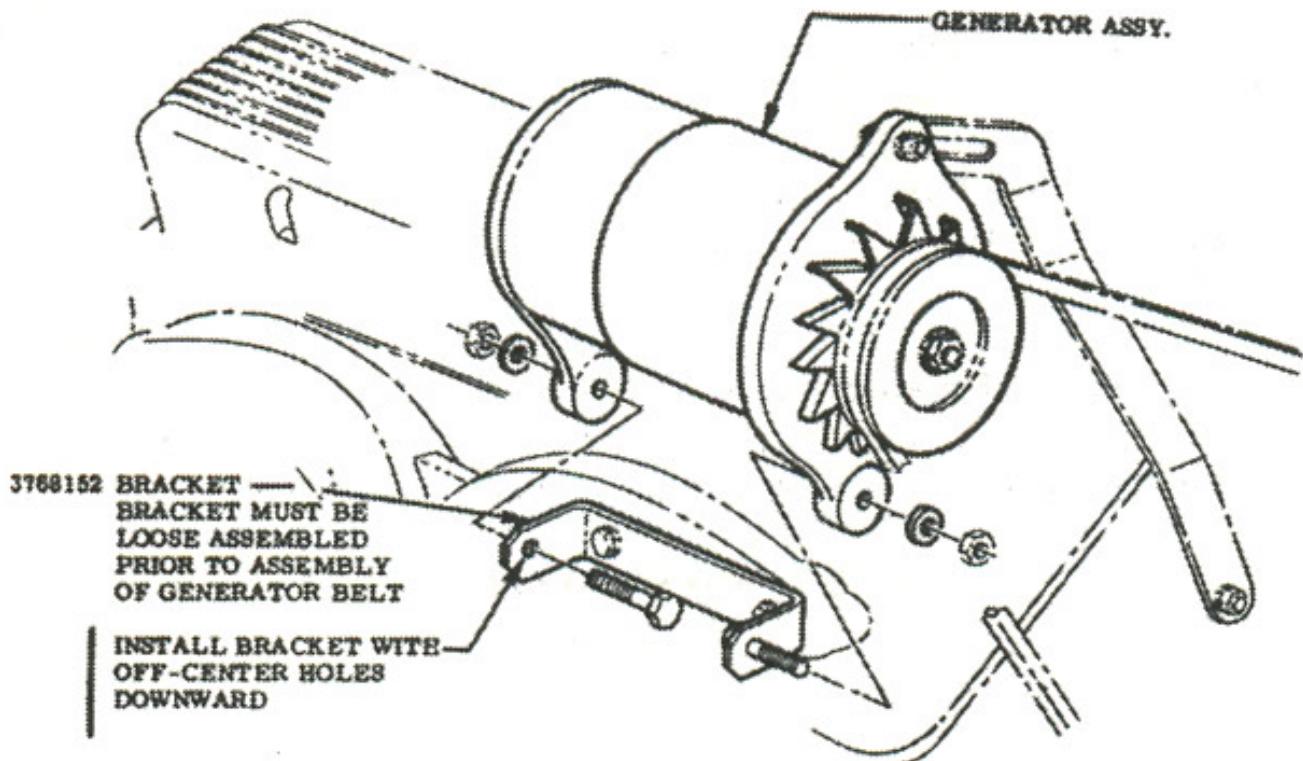
GENERATOR BELT MISALIGNED DUE TO IMPROPER INSTALLATION OF GENERATOR BRACKET - 1960 Corvette Equipped With Fuel Injection

In the event difficulty is experienced with fan belt misalignment on fuel injection Corvettes only, check to see that the generator mounting bracket is assembled properly. When bracket is installed upside down, the generator is moved 1/4" too far forward. The bracket must be installed with the off-centre holes downward, as shown in Fig. 20.
