# 1960 Corvette: Service Bulletin: Generator Belt Misalignment

**Subject:** Generator Belt Misalignment  
**Model and Year:** 1960 Corvette  
**Source:** G.M. of Canada Service Bulletin  
**Bulletin No:** NA  
**Section:** NA  
**Date:** April 30, 1960

## GENERATOR BELT MISALIGNED DUE TO IMPROPER INSTALLATION OF GENERATOR BRACKET - 1960 Corvette Equipped With Fuel Injection

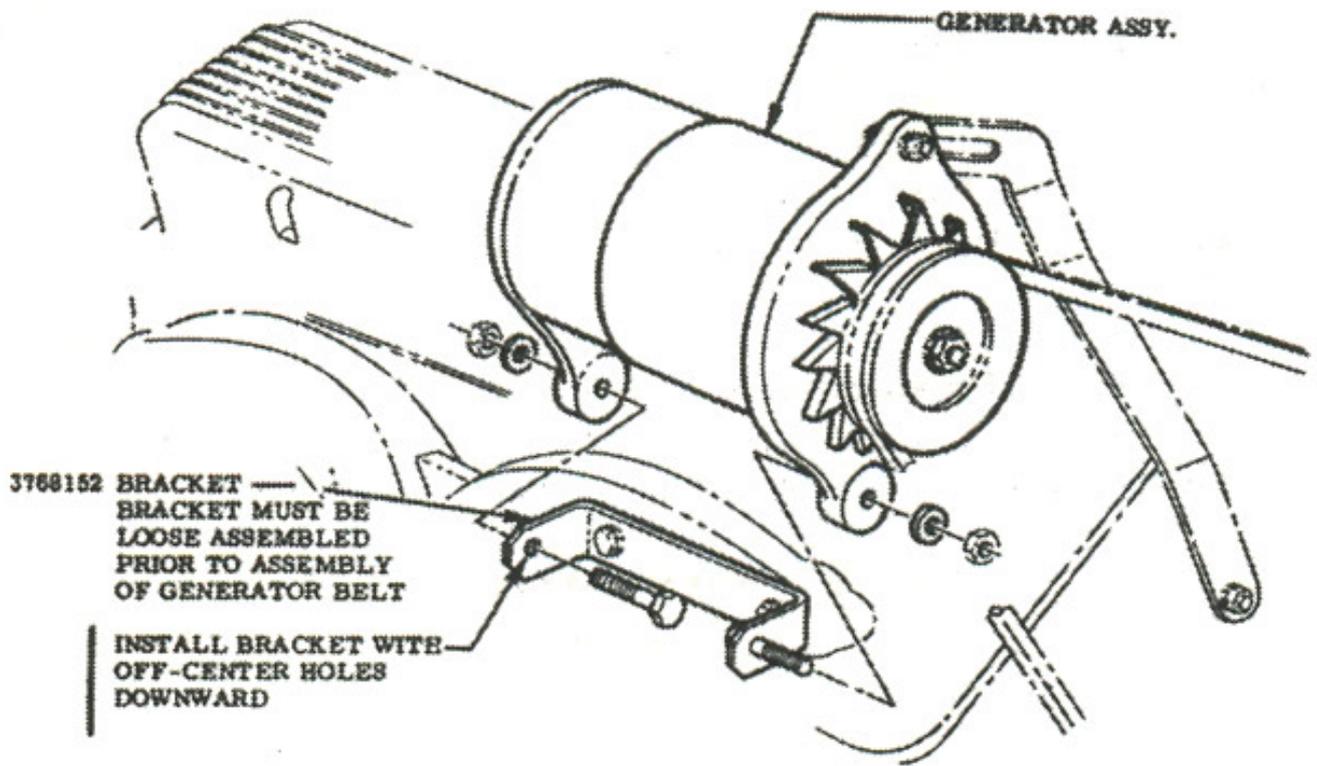
In the event difficulty is experienced with fan belt misalignment on fuel injection Corvettes only, check to see that the generator mounting bracket is assembled properly. When bracket is installed upside down, the generator is moved 1/4" too far forward. The bracket must be installed with the off-centre holes downward, as shown in Fig. 20.
