1984 - 1987 Corvette: Service Bulletin: Rattle From Turn Signal Lever

Subject: Rattle From Turn Signal Lever

Model and Year: 1983 - 1987 Chevrolet Vehicles with Multi-Function Turn Signal Levers

Bulletin Number: 87-224, Section 10

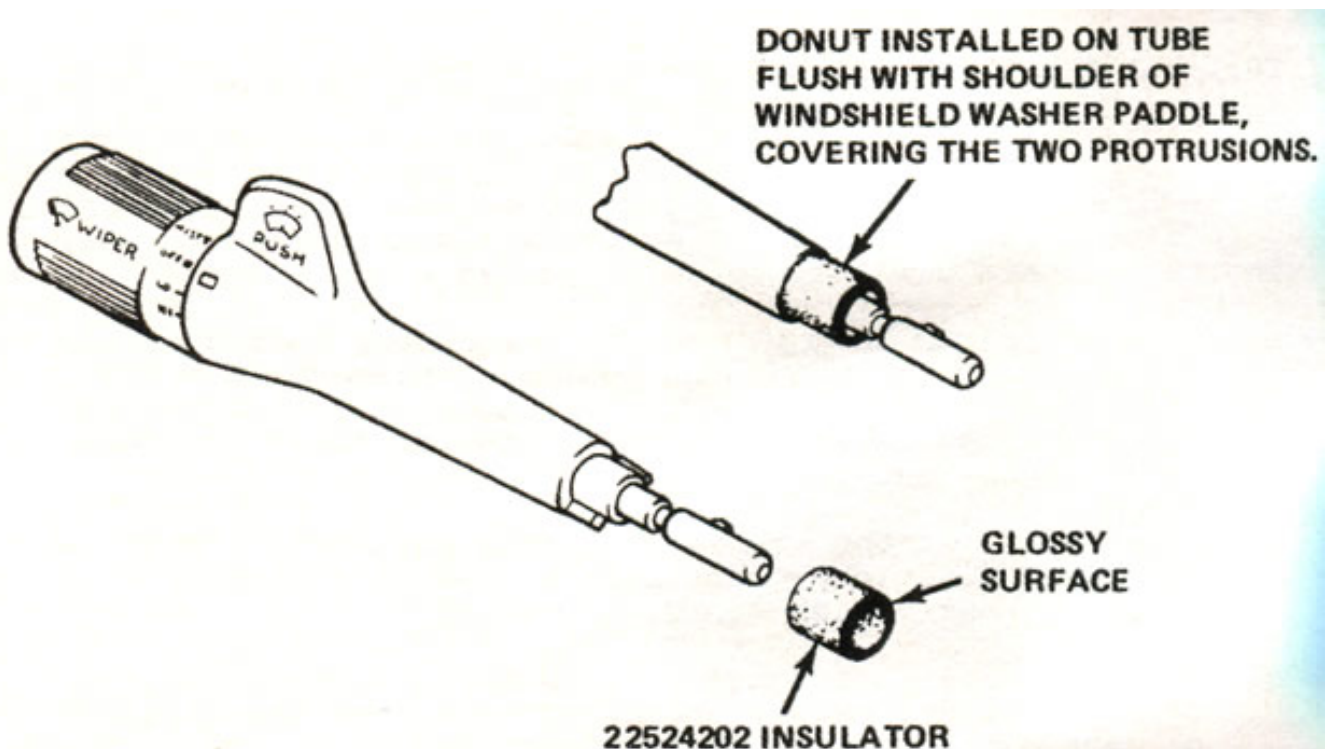
A rattle-type noise originating from the multi-function turn signal lever may be caused by excess looseness or play in the windshield washer actuator paddle.

6. Install the foam "donut" to the turn signal lever as shown on the illustration, making sure that the "donut" is positioned over the two (2) protrusions at the end of the windshield washer paddle and flush against the shoulder of the paddle. **NOTICE:** The "donut" has a glossy appearance at one end. It may be easier to install the "donut" with the glossy end **AWAY** from the shoulder of the paddle.
7. Re-assemble the turn signal lever assembly to the steering column by pushing it back into the turn signal switch. Check the lever for proper function of all switches.
