1984 - 1987 Corvette: Service Bulletin: Rattle From Turn Signal Lever

Subject: Rattle From Turn Signal Lever

Model and Year: 1983 - 1987 Chevrolet Vehicles with Multi-Function Turn Signal Levers

Bulletin Number: 87-224, Section 10

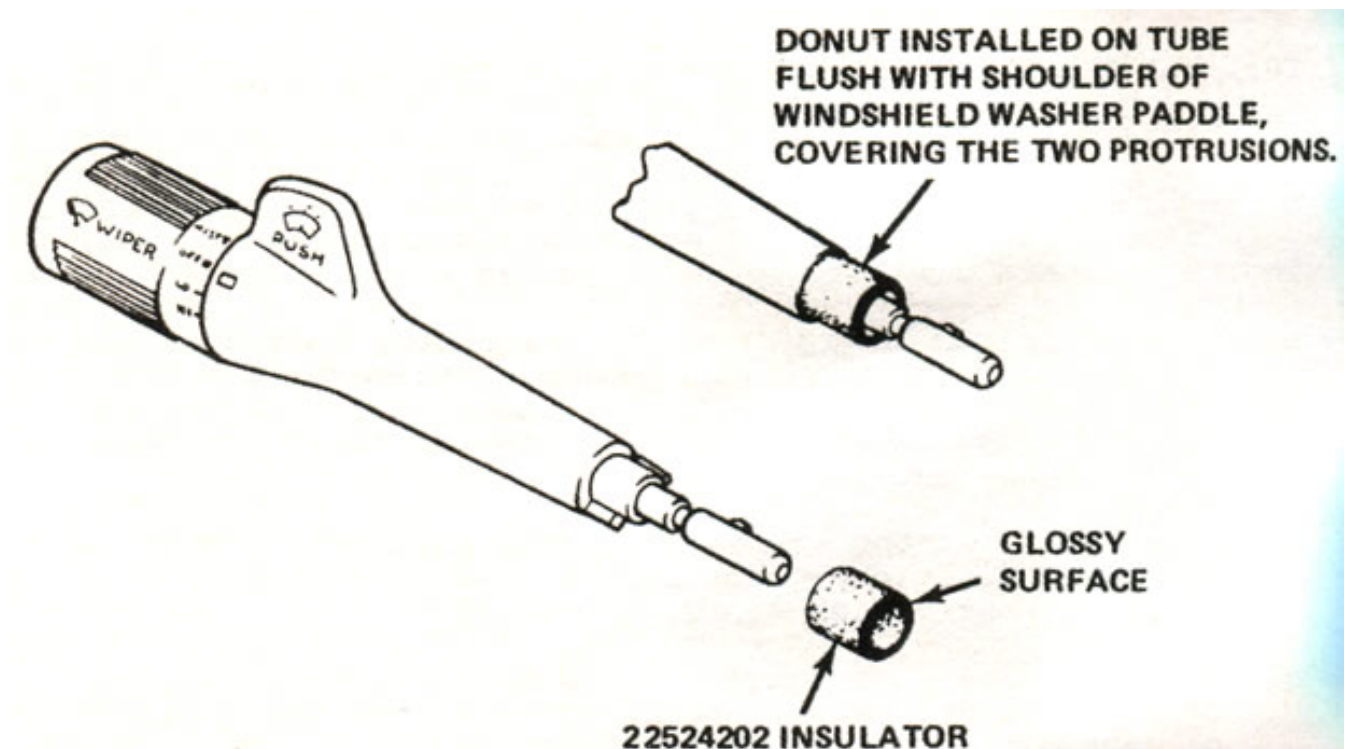
A rattle-type noise originating from the multi-function turn signal lever may be caused by excess looseness or play in the windshield washer actuator paddle.

6. Install the foam "donut" to the turn signal lever as shown on the illustration, making sure that the "donut" is positioned over the two (2) protrusions at the end of the windshield washer paddle and flush against the shoulder of the paddle. NOTICE: The "donut" has a glossy appearance at one end. It may be easier to install the "donut" with the glossy end AWAY from the shoulder of the paddle.
7. Re-assemble the turn signal lever assembly to the steering column by pushing it back into the turn signal switch. Check the lever for proper function of all switches.
