1963 - 1967 Corvette: Service Bulletin: Fuel Gauge System Diagnosis

Subject: Fuel Gauge System Diagnosis

Source: Chevrolet Technical Service Bulletin

Bulletin Number: DR #752, Section VIII

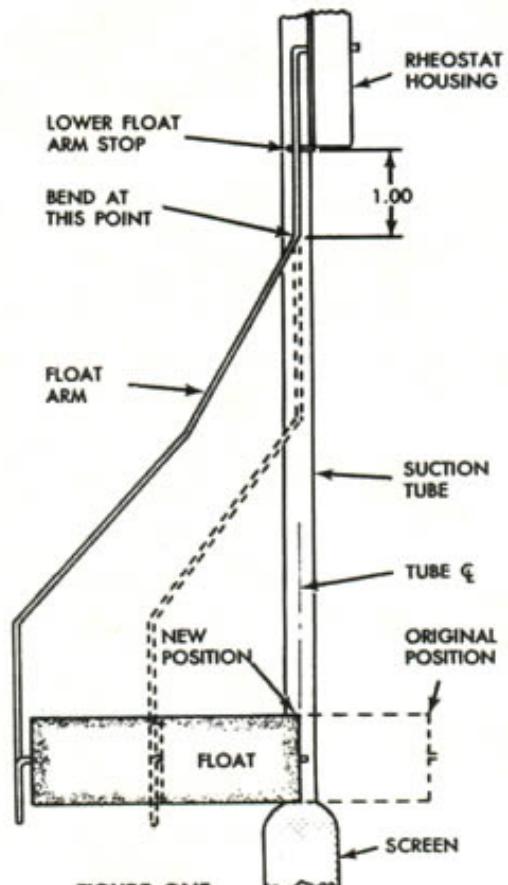
FIGURE ONE

On the 1965 Chevrolet Station Wagon tank units, complaints of "never reads less than 1/4" or "tank rattle" may be caused by an interference between the tank unit float and the tank ribs due to an improper mounting flange angle. This problem has been corrected in production and identified by an orange paint mark at the sender mounting area.

CAUTION: In the above procedure, there is a possibility of breaking the solder joint where the suction tube passes through the mounting plate. If this occurs, or if a new tank sending unit is installed on tanks without the orange paint identification, the replacement sending unit should be reworked per Figure 1 (Page 6) prior to installation.

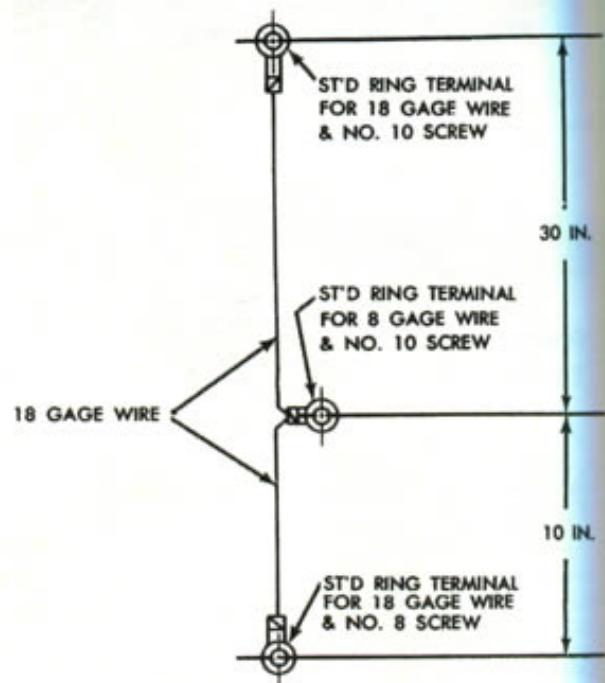
FIGURE TWO

- a) Dash unit ground - the 1965 Chevrolet uses two stud mounted clips to both ground and retain the instrument cluster. This circuit is sensitive to dimensional variation and may be tested with a jumper wire from each stud to the chassis.

If ground circuit correction is needed, make a ground wire assembly as shown in Figure 2, Page 6. Install as shown in Figure 3, Page 6.
