# 1963 - 1967 Corvette: Service Bulletin: Fuel Gauge System Diagnosis

**Subject:** Fuel Gauge System Diagnosis

**Source:** Chevrolet Technical Service Bulletin

**Bulletin Number:** DR #752, Section VIII

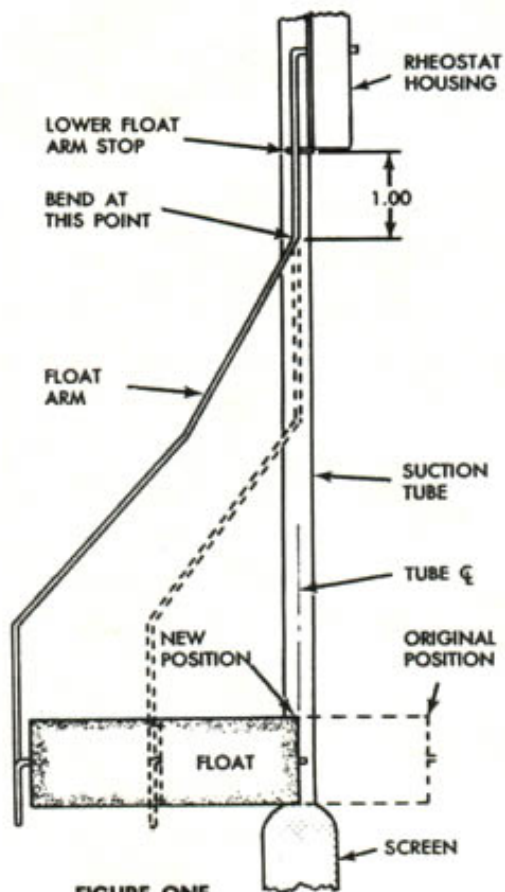
On the 1965 Chevrolet Station Wagon tank units, complaints of "never reads less than 1/4" or "tank rattle" may be caused by an interference between the tank unit float and the tank ribs due to an improper mounting flange angle. This problem has been corrected in production and identified by an orange paint mark at the sender mounting area.

CAUTION: In the above procedure, there is a possibility of breaking the solder joint where the suction tube passes through the mounting plate. If this occurs, or if a new tank sending unit is installed on tanks without the orange paint identification, the replacement sending unit should be reworked per Figure 1 (Page 6) prior to installation.

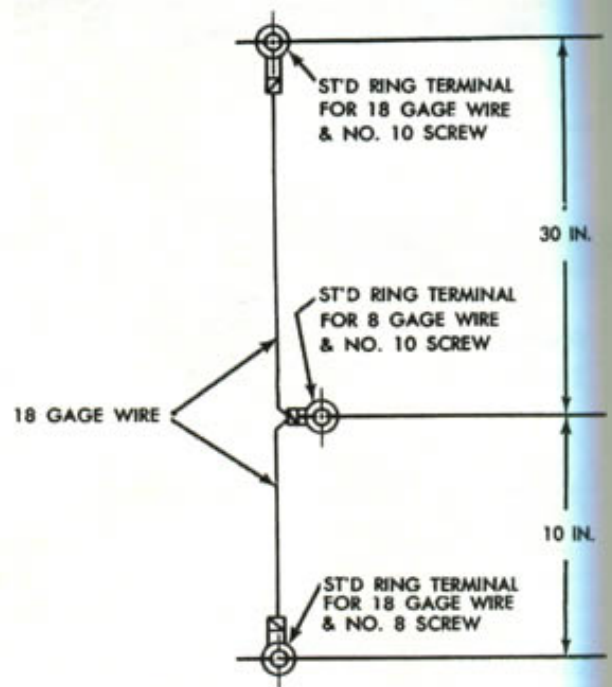
a) Dash unit ground - the 1965 Chevrolet uses two stud mounted clips to both ground and retain the instrument cluster. This circuit is sensitive to dimensional variation and may be tested with a jumper wire from each stud to the chassis.

If ground circuit correction is needed, make a ground wire assembly as shown in Figure 2, Page 6. Install as shown in Figure 3, Page 6.
